Incorrect Street Light “Switch-On” Times?

Presenter & author: Wayne King

This paper explores the method we currently use to trigger the switch-on time for the street lights, asks "why we get it wrong?", explains the history and suggests a superior methodology.

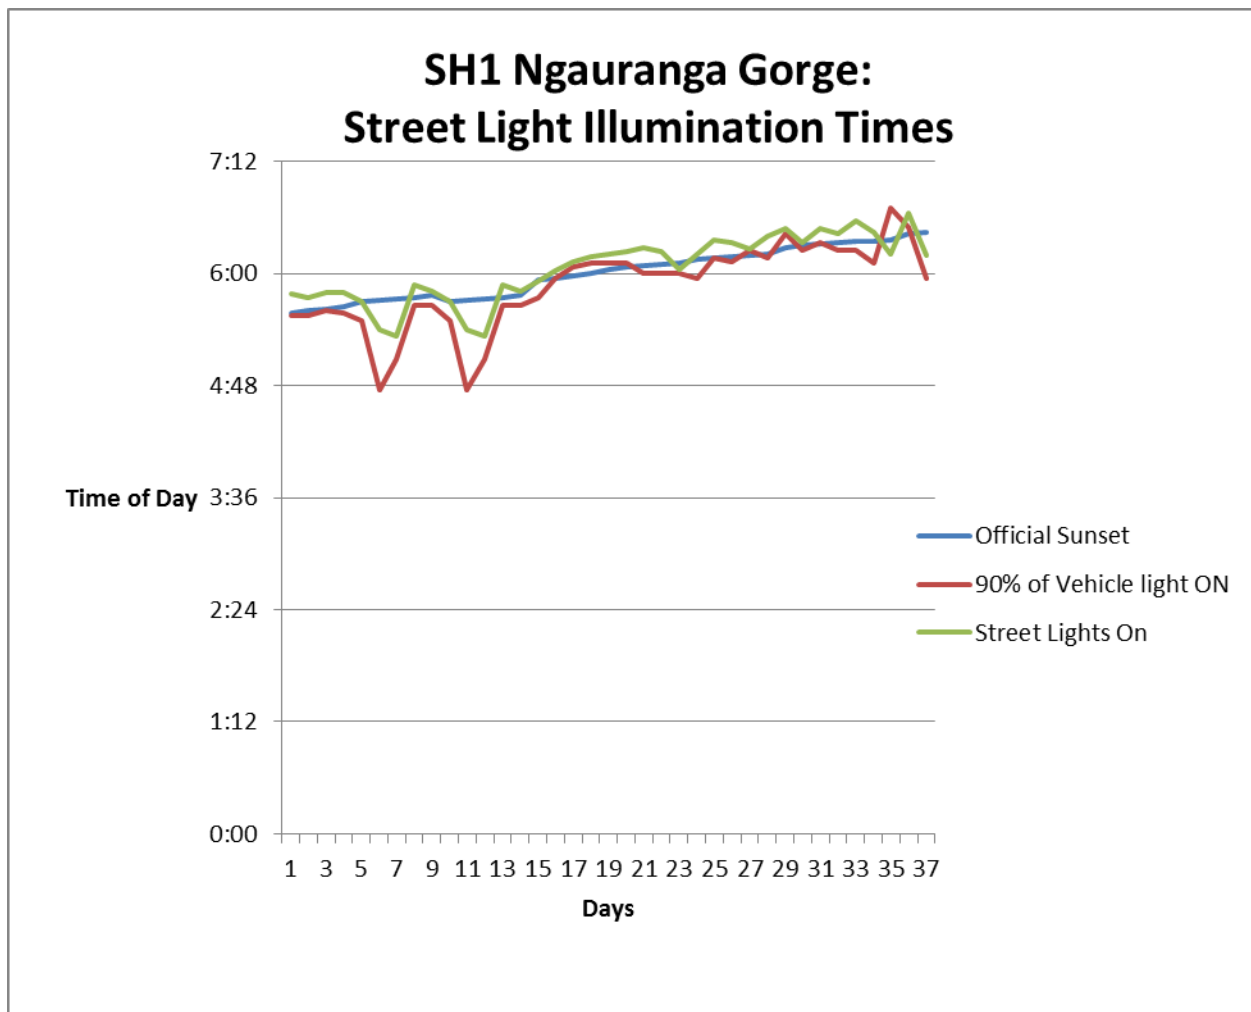
Figure 1: Observed Street Light "Switch-On" (2005)

The plotted data shown in Figure 1 suggests that on average we are 12 minutes late (with a couple of extreme aberrations of 29 & 39 minutes late) based upon the sample of 35 winter evenings in 2005.

The fact that the entire Wellington Region street lighting is controlled by a single sensor located in Petone, Lower Hutt may explain some of the variations.

This trigger value is similar to value we believe the current sensor operate at, yet the 90% headlights-on test suggests that this on average it is 12 minutes late. The author believes that this indicates the 50-70 lux trigger value is too low, or the current sensor is poorly calibrated.

- Have WElectricity raise the Lux Trigger to the pre Power Crisis level of ~140/150 Lux a trial period.
- Have NZTA WTOC repeat the *90% headlights-on* trial for the same period for the same trial period. Consider a parallel travel time survey
- Consider a travel time survey to determine if poor illumination disrupts the steady flow of traffic.
- Do some analysis to see if travel times improve and/or crashes diminish.
- Have the electrical engineers review the trigger mechanism methodology with the possible aim of adding additional automatic sensors or manual methods (WTOC CCTV observations and a telephone call to WElectricity may be a very practical solution?)

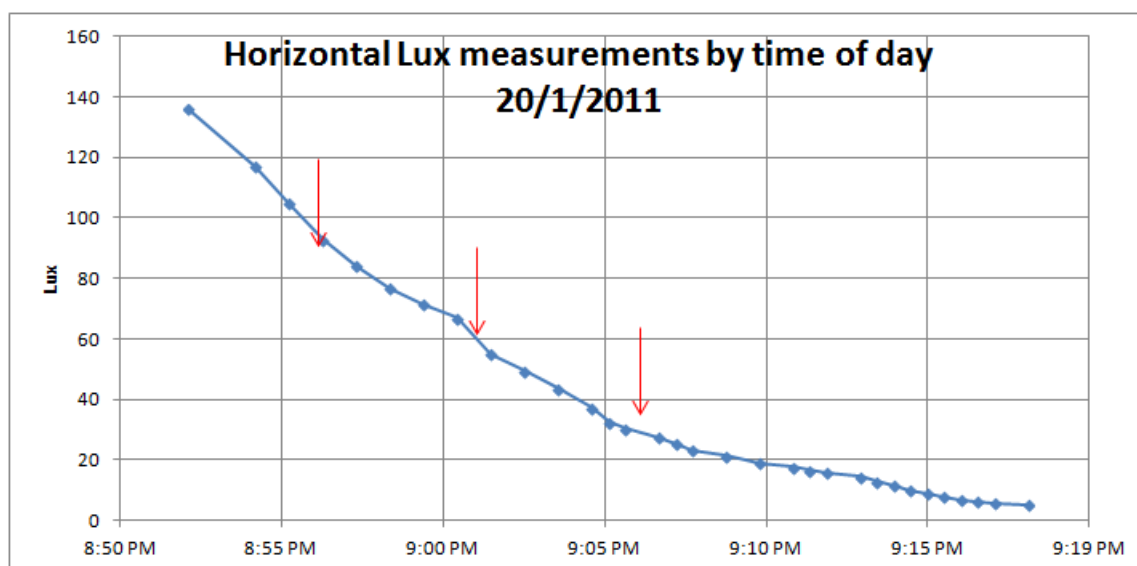
Figure 2: Decline of Sunlight around Sunset (gathered near Paraparaumu).

coincides with sunset.) Figure 2 shows the rapid decline in light values that occurs on a 10-15 minute period at sunset.

Measured data (Lighting level (LUX) vs Time of day Figure 2) provided by Mike Jackett shows that horizontal LUX drops from ~140 Lux to ~30 Lux over a 15 minutes period. This rapid decline in light level is of similar magnitude to the warm up time for street lights. With current incandescent lamps and ramp-up illumination times we are probably reacting just too late.
