## **DIANA FALLS LANDSLIDE RECOVERY A LAND TRANSPORT RISK MANAGEMENT CASE STUDY**

Deane McNulty NZCE, BE (Hons), FIPENZ, CPEng, Nat Cert (Ambulance), Paramedic (St John)  
Director McNulty Engineering Management Limited Hokitika & Christchurch (deane@mem.co.nz)  
(Presenter)

Emily Stevens, BE (Hons), ME (Mgmt), MIPENZ, CPEng, Level 3 National Certificate in Industrial  
Rope Access  
Geotechnical Engineer, Opus International Consultants Limited (emily.stevens@opus.co.nz)

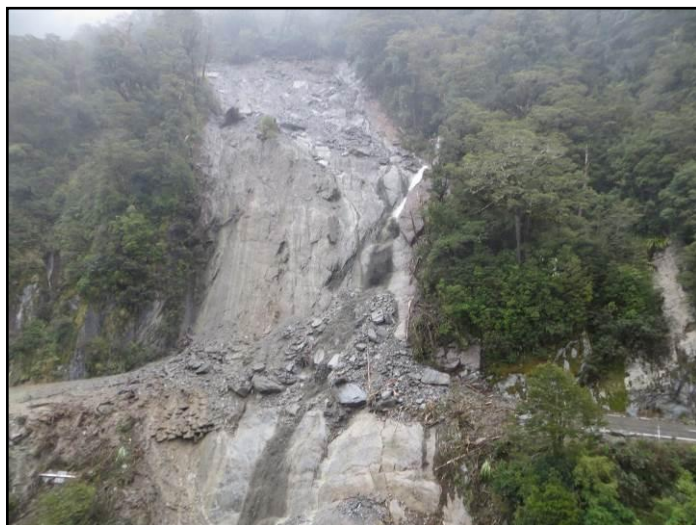
**Figure 2: Landslide after the initial event on 10 September 2013**

The initial event (approximately 20,000 m<sup>3</sup>) occurred overnight on 10 September 2013 during very heavy rain (>300 mm in 24 hours<sup>2</sup>). It blocked the highway between Makarora and Haast, also destroying the bridge over the Diana Falls stream (see Figure 2). This slip was cleared and the highway re-opened on 20 September 2013 with full time traffic control. A large upslope extension of the slip (around 10,000 m<sup>3</sup>) occurred on 27 September 2013, producing a long narrow slip scar, with a height of approximately 300 m and a 60 m width containing a large volume of unstable slip debris. Further numerous smaller failures continued to occur on a regular basis.

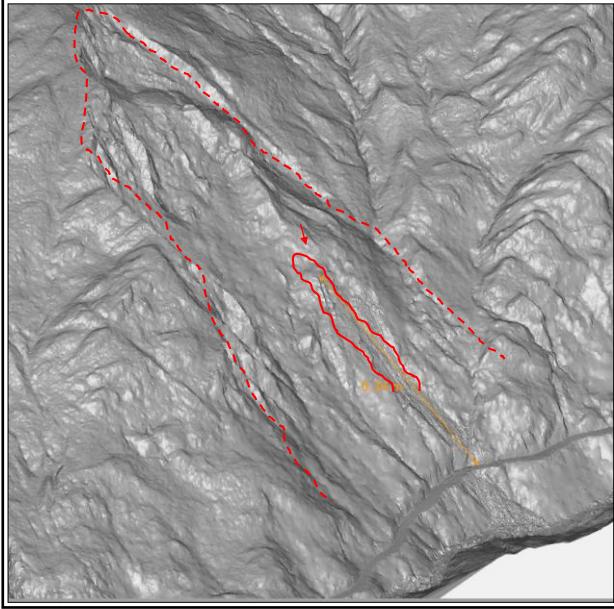
**Figure 3: Initial ground surface model of lower half of slope**

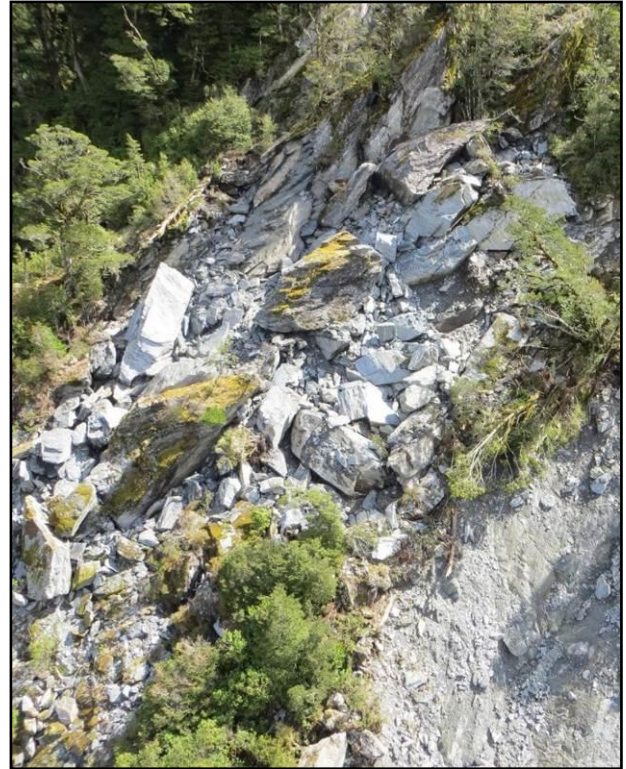
**Figure 4: The Giant's Rock Garden Area October 2013**

1. An unstable, complex and extremely high risk head scarp area.
2. A huge volume of slip debris remaining within the slip scar itself, comprising silty gravel landslide debris with large boulders commonly 30t to 50t / 12 m<sup>3</sup> to 20 m<sup>3</sup> and up to around 300t / 125 m<sup>3</sup>. The slip debris became extremely mobile when saturated, causing large volume debris flows and releasing huge boulders that ran over top of the debris gathering large momentum by the time they reached road level some 200 metres below.
3. The unknown risk of planar failure occurring on the lateral margins of the slip, in particular on the Wanaka side (named the 'Wanaka Chute').

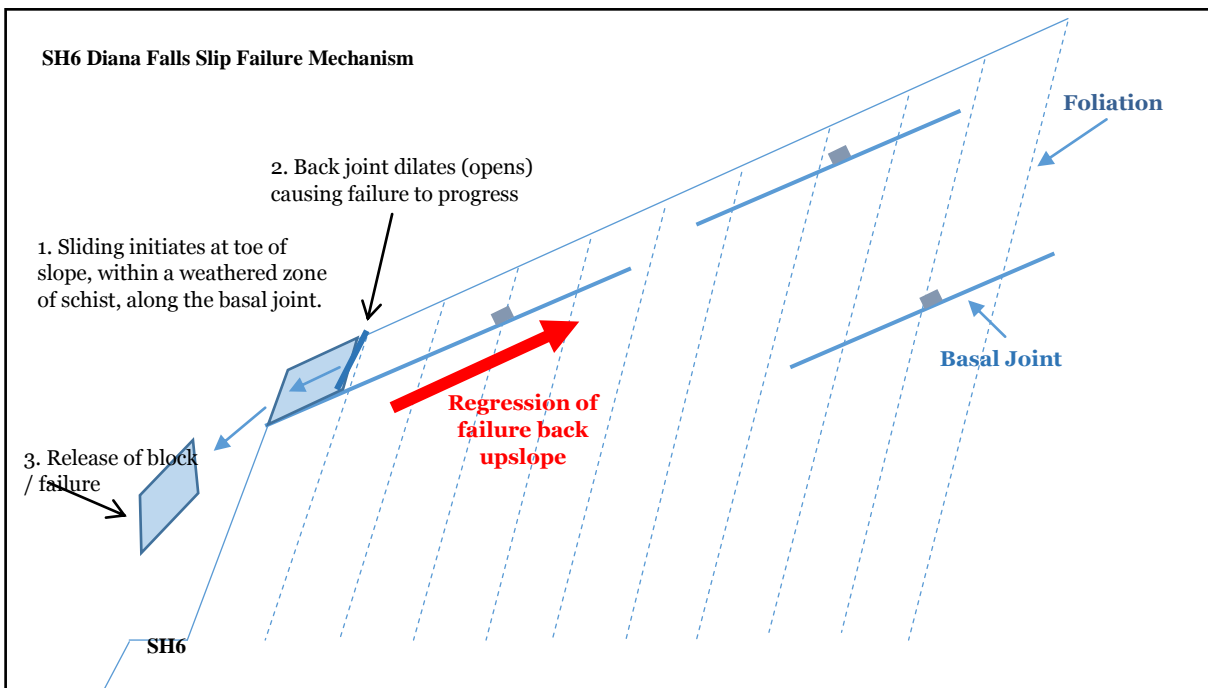
The recent slip failure mechanism is considered essentially to be as follows (Figure 5).

1. Sliding initiates at the toe within a weathered zone of schist bedrock. Sliding occurs along the basal joint (172 / 27° E). This is shown in the Wanaka (south) margin of the slip through rotation observed in the schist foliation, which is typically 021 / 70° E and has rotated to lesser dips such as 010 / 36°E.
2. Dilation of the basal joint occurs and the deformation progresses at an increasing rate due to water ingress into the dilating joint. Some tension cracks and thrust ridges may be observed in the colluvium cover.

3. Failure eventually occurs, releasing blocks and colluvium. The schist is not homogeneous, as it contains zones of more quartz rich material that is more resistant to weathering. This causes the failure to occur in blocks ('steps' in the back face) and leaves a varying thickness of overlying colluvium debris. Each failure event results in exposure of a new less weathered surface and associated head scarp that in turn is subject to weathering and relaxation processes that will repeat the cycle in due course.

Figure 5: SH6 Diana Falls Slip Failure Mechanism (not to scale)

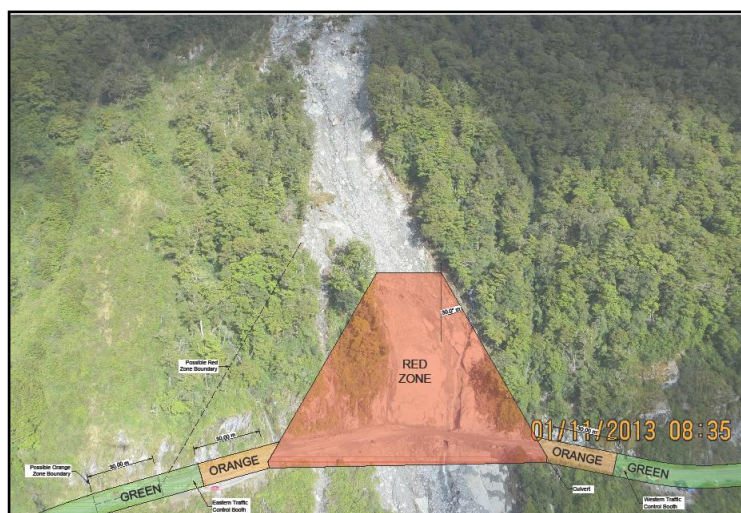
Due to the relatively short warning time from rocks moving lower in the slope compared to vehicle traversing time, combined with a lack of visibility of the slope hazard from road level, a proactive warning system was essential. A simple but effective system was established to pass information about rocks rolling from the slip back face to the staff controlling traffic on the road below. Three observational abseilers were located at the top, middle and bottom of the slip. A local radio telephone call stating either ‘rocks rolling’ or ‘green for go’, meaning that vehicles could pass through the bottom of the slip on SH6 safely one at a time, as well as ensuring the safety of the staff on site. Each vehicle was advised by traffic management to drive straight through the site with no stopping and staff were stationed at each end of the Red Zone to proactively signal vehicles through with hand movements.

**Figure 6: Site Road Level Access and Occupancy Zones**
