## **ROAD SAFETY STUDY – CANDIA ROAD CRASH EVALUATION - 'BEFORE' AND 'AFTER'**

Bruno Royce – *BScEng (Civil) (Hons), MBA, CPEng, IntPE(NZ), MIPENZ, MIPENZ TG, APEC Engineer*  
Director / Principal Traffic Engineer, Traffic Engineering Solutions Ltd (TES)  
Email: [bruno.royce@tes.net.nz](mailto:bruno.royce@tes.net.nz)

8 March 2017

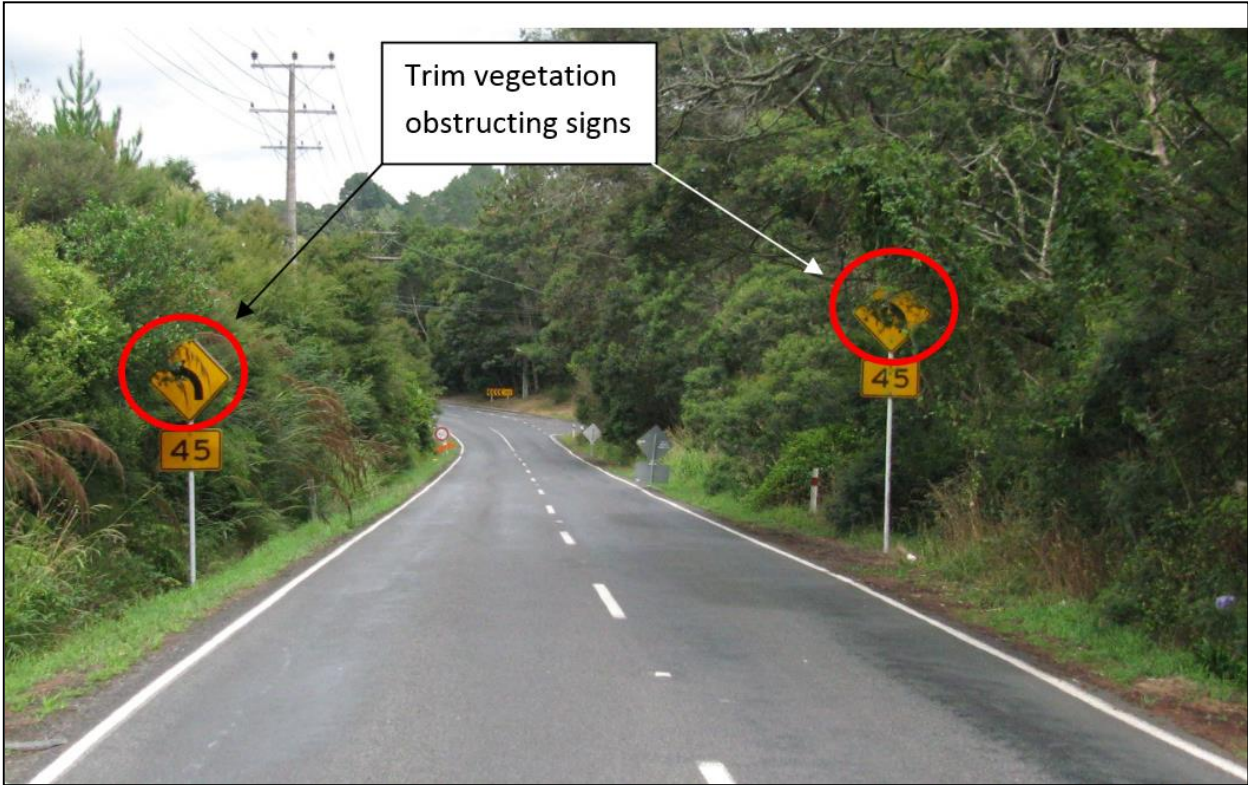
- Excessive vehicle speeds for the road environment, with two relatively sharp bends and one moderate bend on a road with a posted speed of 70km/h;
- Lack of conspicuity of curve warning signage, with the existing curve warning signage being technically correct but limited in terms of visibility (number, location, size, and obstructed by vegetation);
- Narrow and unforgiving road shoulders, reducing the space available for motorists to correct an errant vehicle;
- Ineffective road-marking delineation (faded edgeline and centreline);
- Irregular road surface condition (patch seal repairs and evidence of seal failure);
- Inconsistent super-elevation (undulating road surface);
- Insufficient road surface skid resistance (visual evidence of longitudinal cracking and flushing of seal surface).

Figure 2: Visibility of Advance Warning signs obstructed by vegetation (facing Vineyard Road)

- **Edge marker posts:** Maintain posts and install additional posts, for improved delineation, particularly at night;
- **Vegetation trimming:** To improve forward visibility of existing and proposed signage;

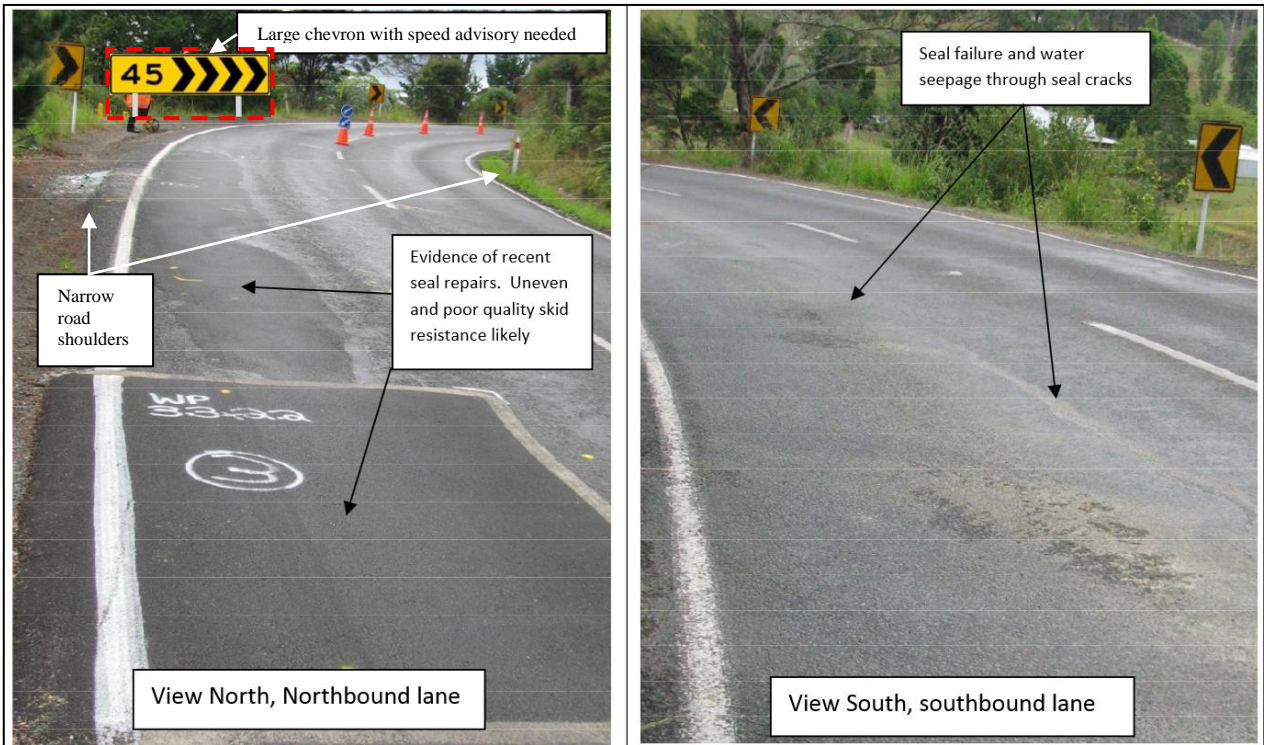
Figure 3: Signage and Road surface issues at the bend north of Vineyard Road

- **Curve warning signage and chevrons:** Upgrade quantity, size, visibility and double-gate;
- **Embankment:** Cut-back embankment to improve forward visibility on the inside of bend;

- **Shape correction:** To provide a smooth road surface and consistent super-elevation around the bends;
- **Skid resistant surface:** A highly skid-resistant road surface (Polished Stone Value > 70) at two bends, reducing likelihood of loss-of-control at the bends;

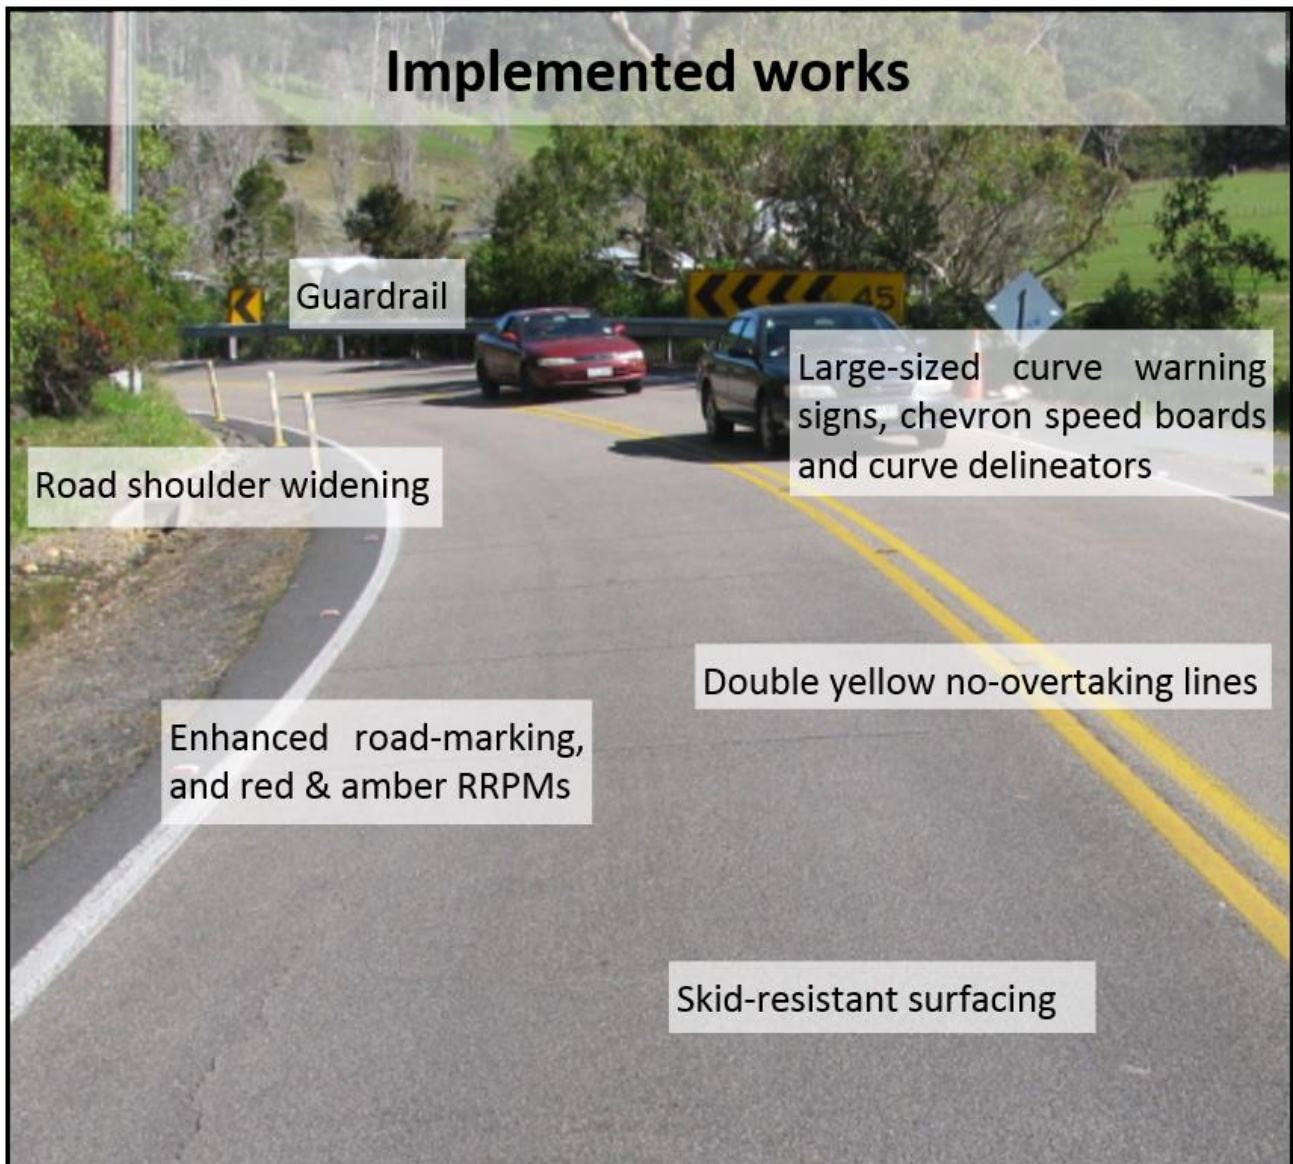
**Figure 4: Constructed works on the northern approach to the bend north of Vineyard Road. Similar works were implemented on the southern approach to this bend.**

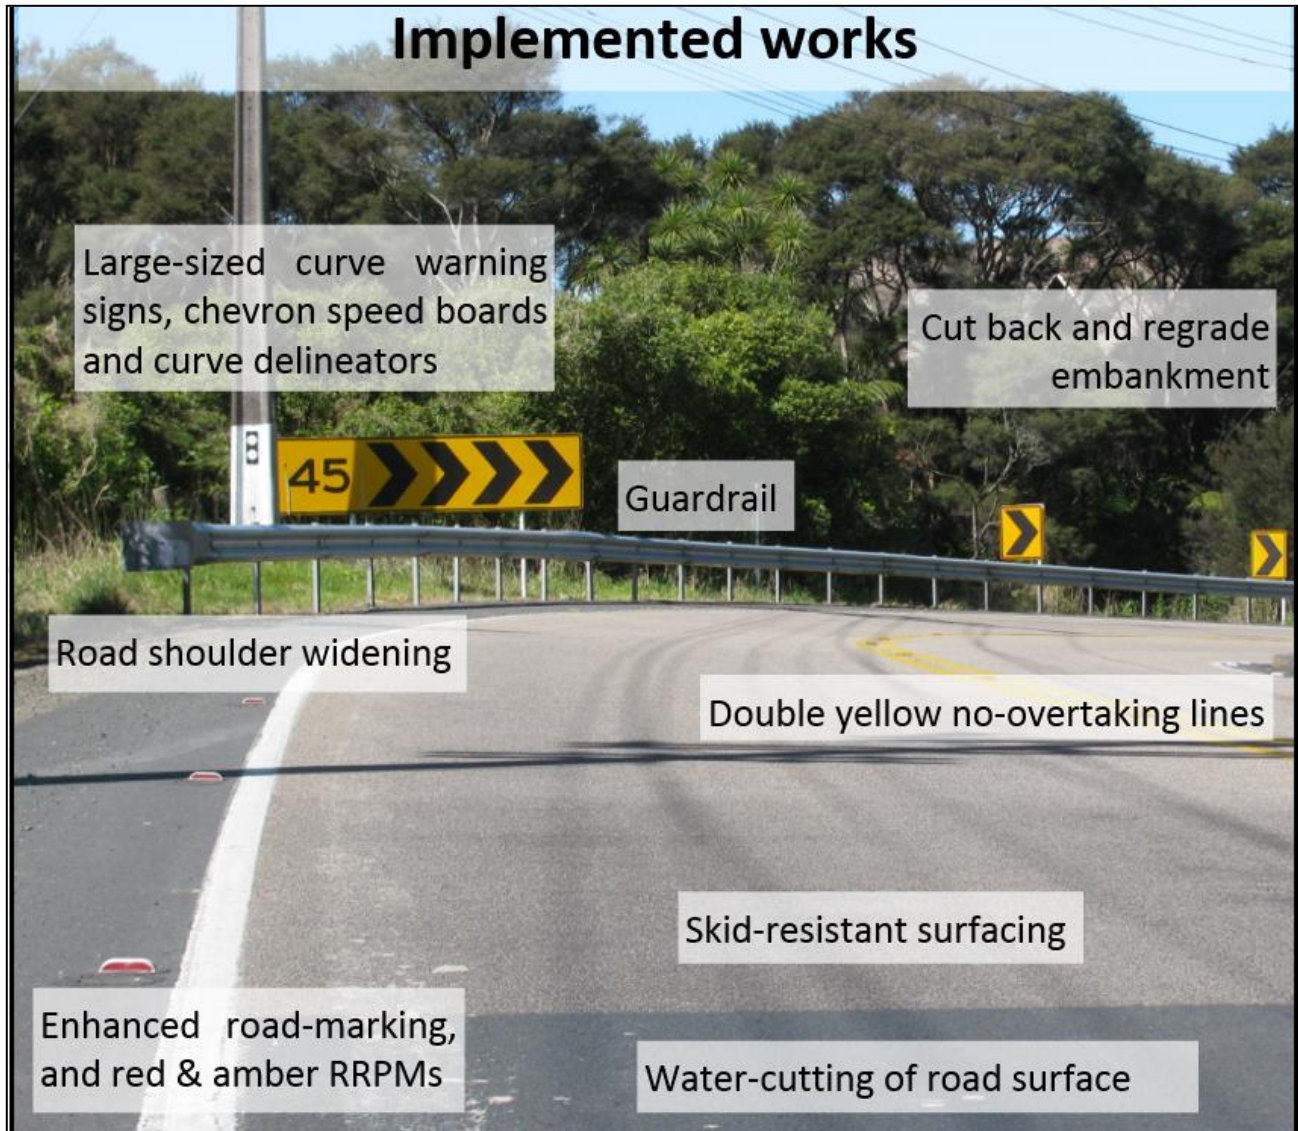
**Figure 5: Constructed works on the northern approach to the bend south of Vineyard Road. Similar works were implemented on the southern approach to this bend.**

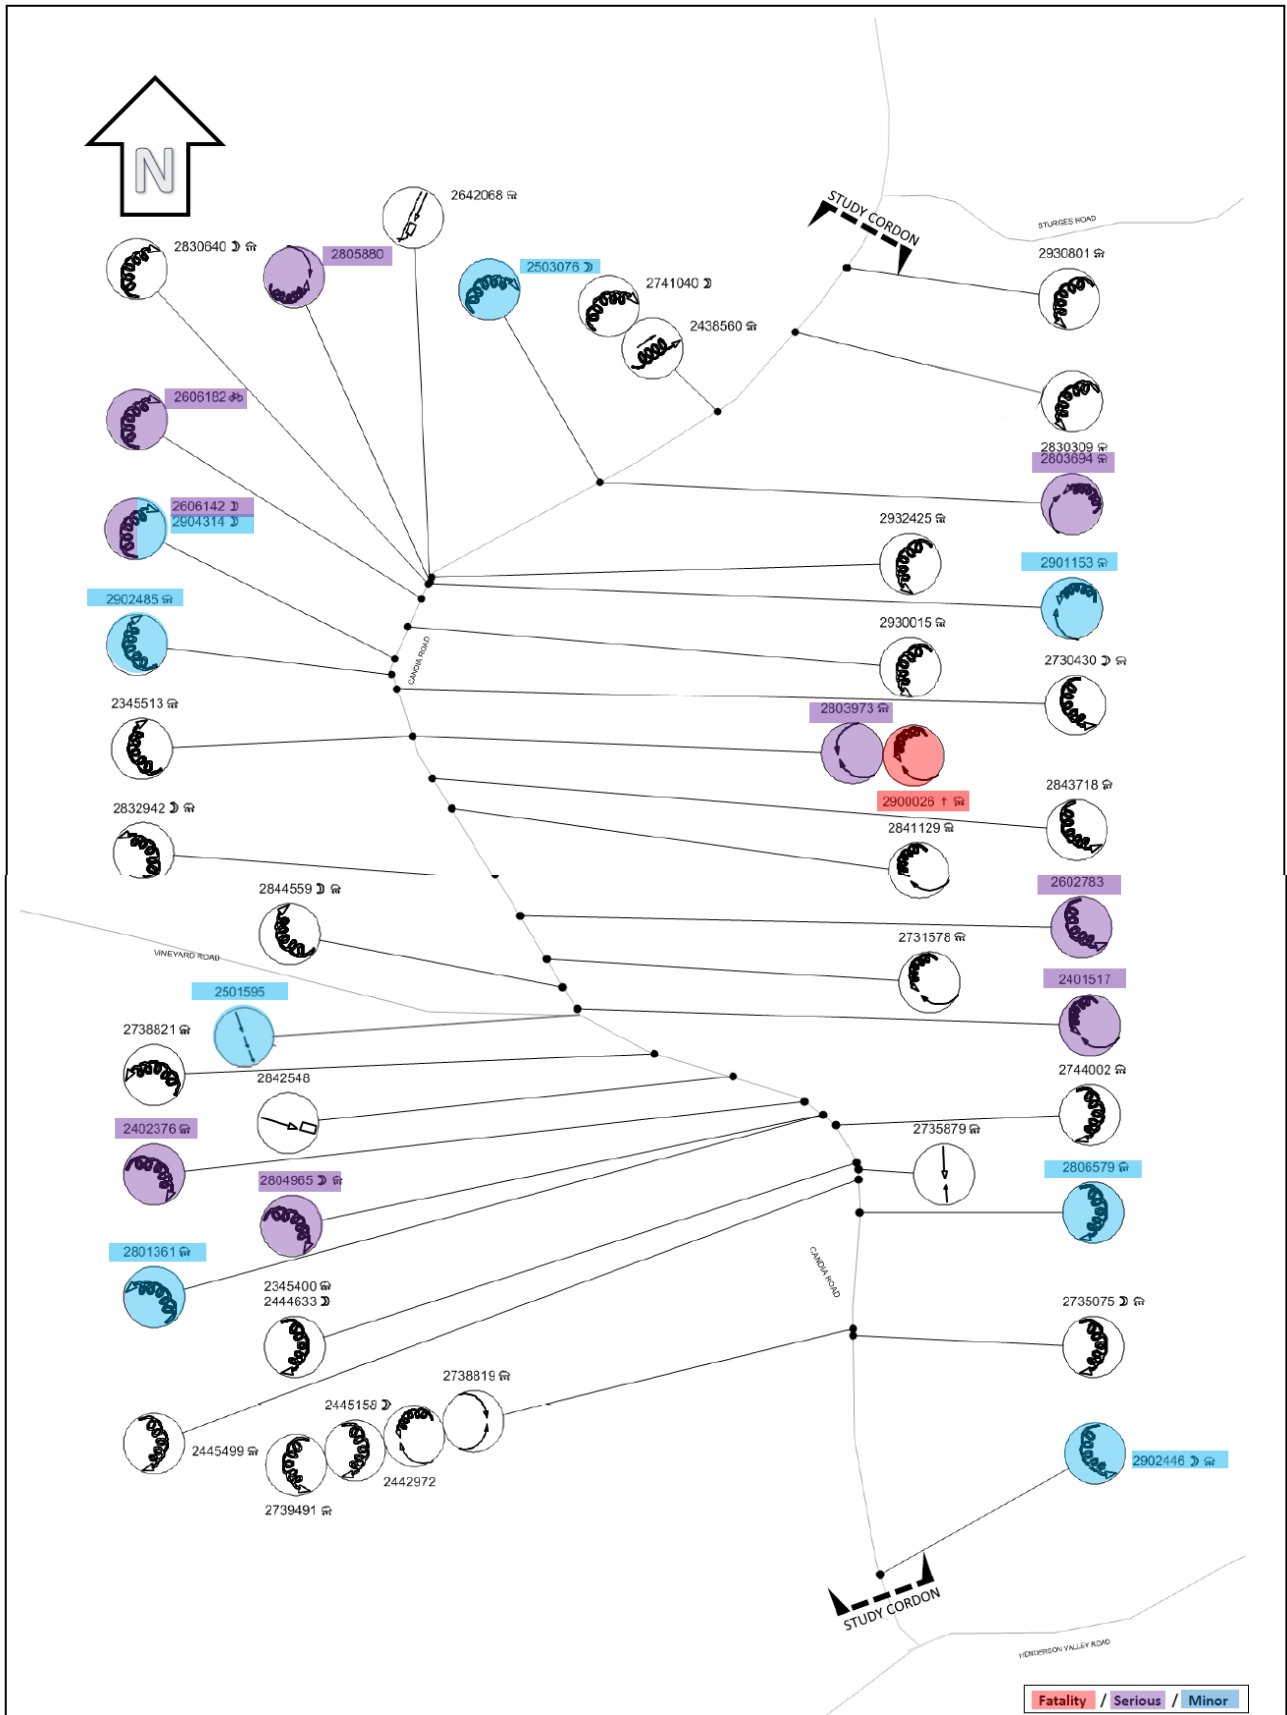
Figure 6 illustrates a CAS plot of reported crash statistics 'before' the crash remedial measures were installed. The position of most crashes has not been edited, and the crashes appear to be distributed along the entire route.

Figure 6: Candia Road – All Reported Crashes 2003 – 2009. In total, 45 reported crashes over seven years, including 1 fatality, 9 serious injury, and 8 minor injury crashes. Crashes plotted along the route, similar to the original CAS plot.

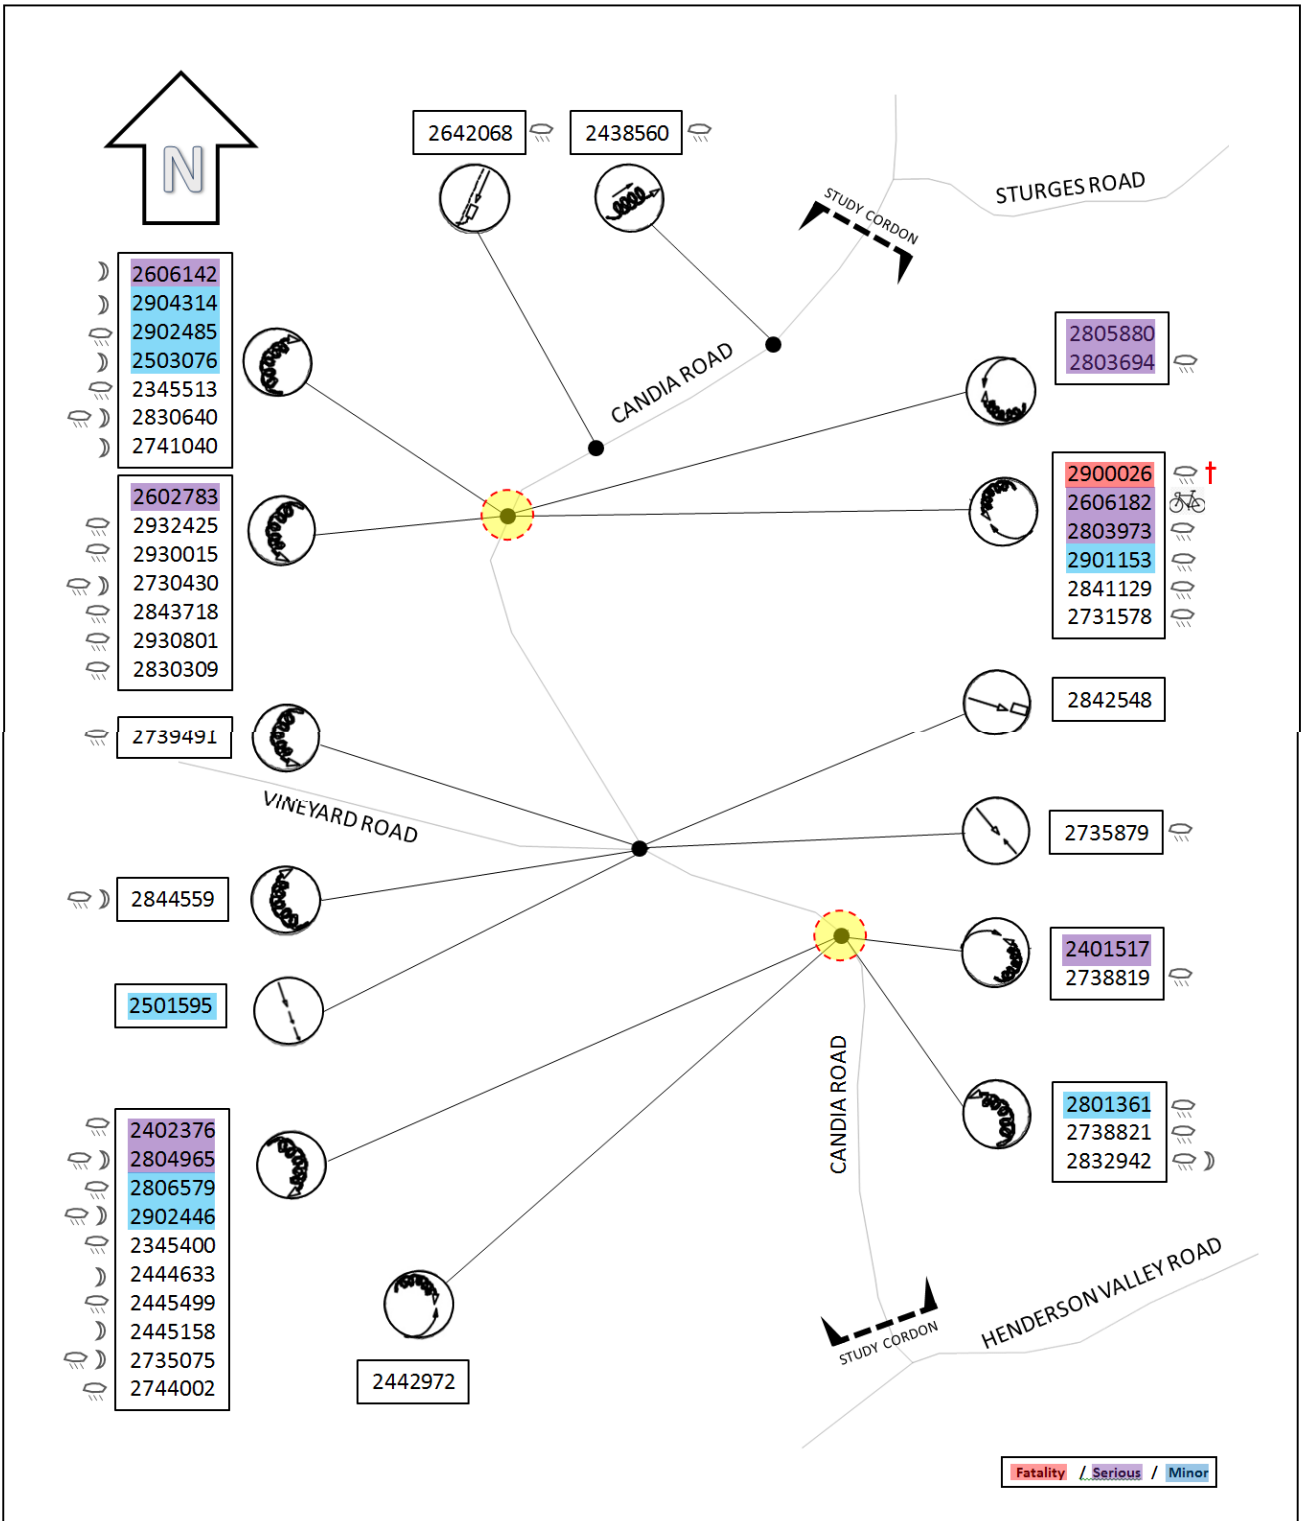
Figure 7 illustrates the same crashes as Figure 6, but Traffic Crash Reports have been analysed in detail and the exact nature, position and direction of each crash re-plotted. Correct interpretation of Traffic Crash Reports can require significant experience and technical expertise. This further analysis results in crash patterns being much stronger and more evident. This enables the causal factors to be identified more accurately, and any proposed remedial works to be focussed on the main issues.

- 45 reported crashes over 7 years, including 1 fatality, 9 serious, and 8 minor injury
- 32 crashes in wet conditions (71%) ☔
- 13 crashes at night (29%) 🌙
- 1 vulnerable road user crash 🚲

**Figure 7: Candia Road – All Reported Crashes 2003 – 2009. In total, 45 reported crashes over seven years, including 1 fatality, 9 serious injury, and 8 minor injury crashes. Traffic Crash Reports analysed and crashes re-plotted and grouped accurately.**

- The key causal factors relating to the crash patterns (excessive speed and loss of control at the two main bends) were precisely identified by reading all the available Traffic Crash Reports, with most of the reported crashes re-positioned and re-plotted (Figure 7). The initial crash plot (Figure 6) indicated crashes distributed relatively evenly along the route, which was misleading, and necessitated preparation of Figure 7. Also, non-injury crashes were considered important to help identify crash patterns/locations;

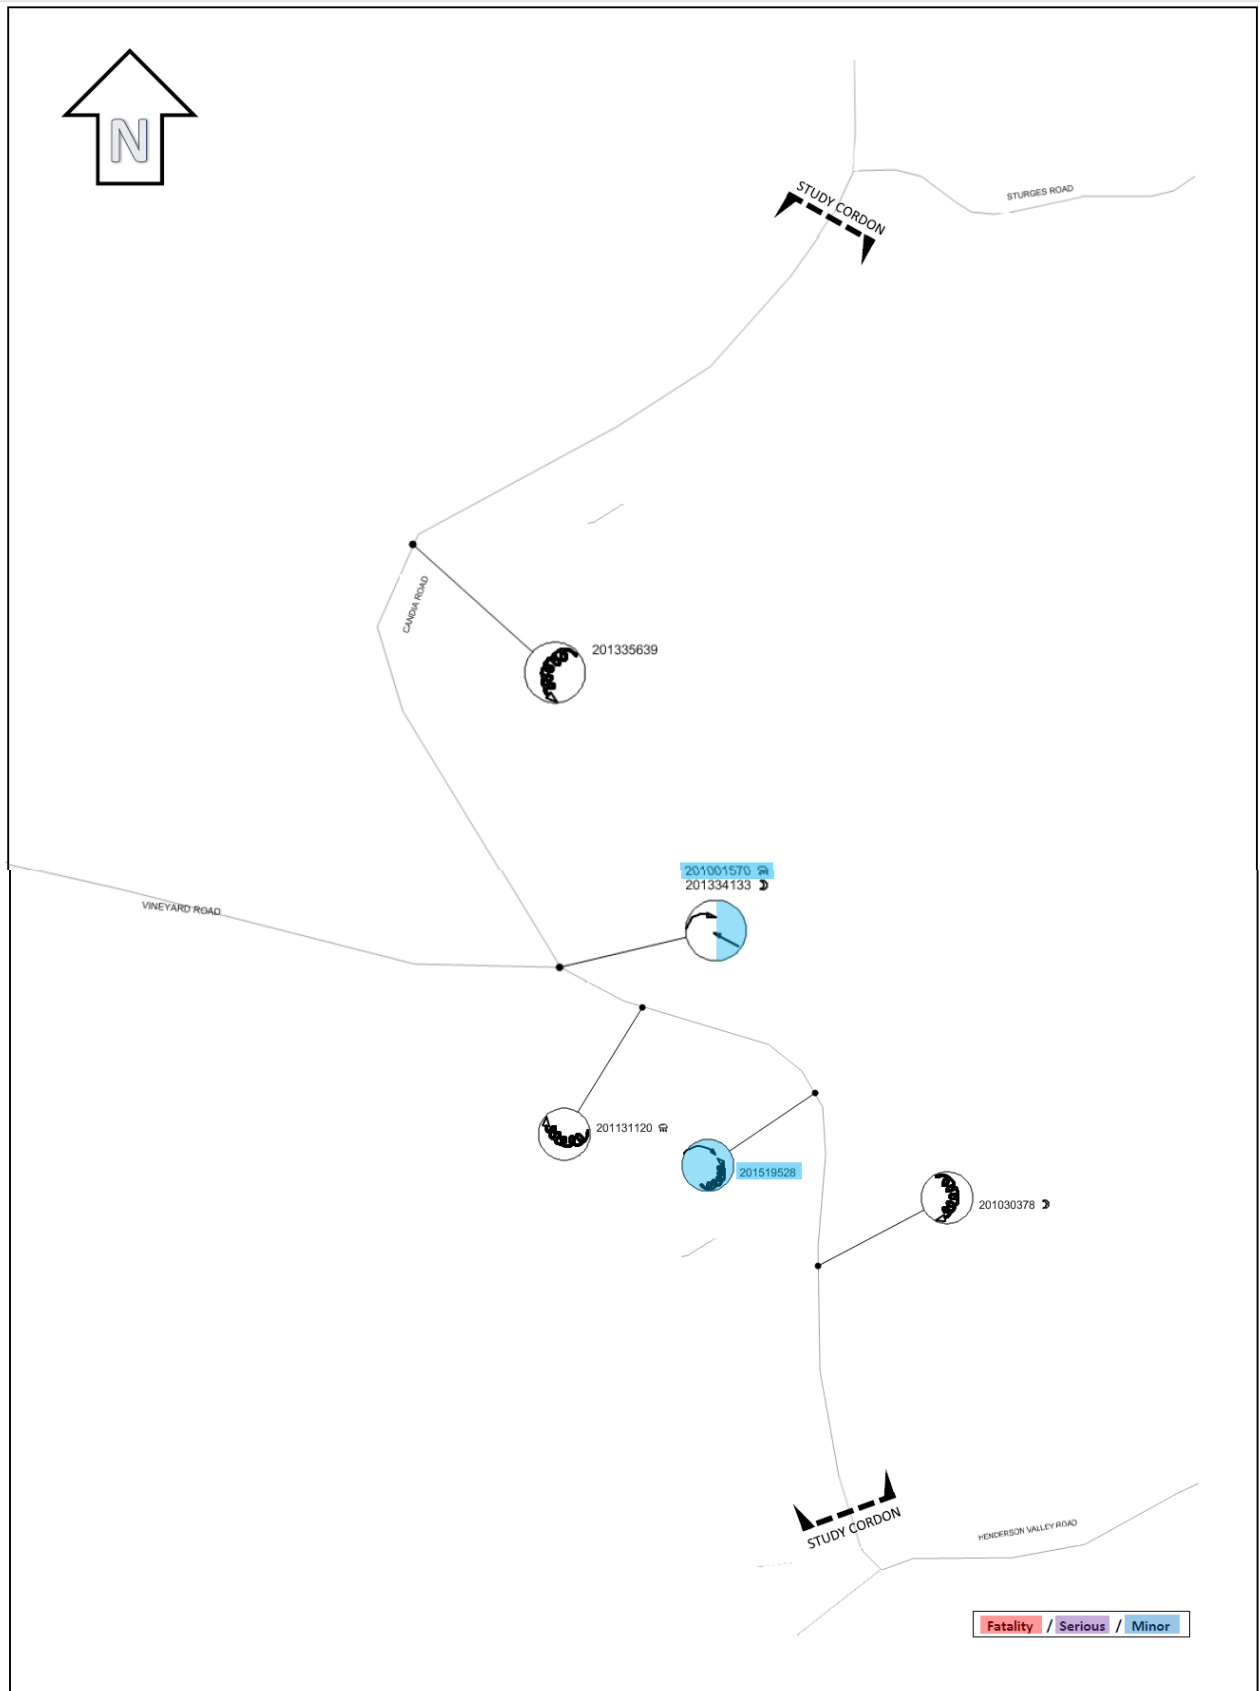
Figure 8 illustrates a CAS plot of reported crash statistics 'after' the crash remedial measures were installed. In this case the Traffic Crash Reports were not analysed for accuracy of the crashes' positions and directions, as it is evident that there have been significant crash savings achieved, and the exact nature of the crash patterns are less relevant at this stage of the analysis.

**Figure 8: Candia Road – All Reported Crashes 2010 – 2016. In total, 6 reported crashes over seven years, including 2 minor injury crashes. These crashes are in the locations provided by the Crash Analysis System.**

- From 2003 to 2009, 45 crashes were reported within the study cordon. Only 6 crashes were reported from 2010 to 2016. Thus, reported crashes along the study cordon have reduced 87%. This result achieves statistical chi-squared significance greater than 99.9%. Also, over the intervening time periods, traffic volumes on Candia Road were estimated to have increased by around 40%;
