Candia Road - Auckland

'Before' and 'After' Crash Study

Bruno Royce

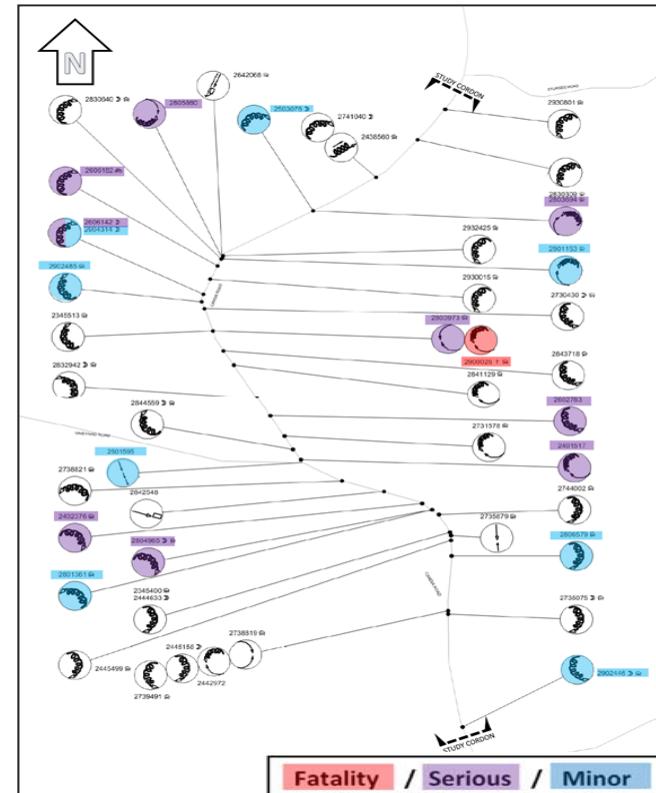
- 1 fatality & 9 serious injury
- Predominantly **loss-of-control** crashes

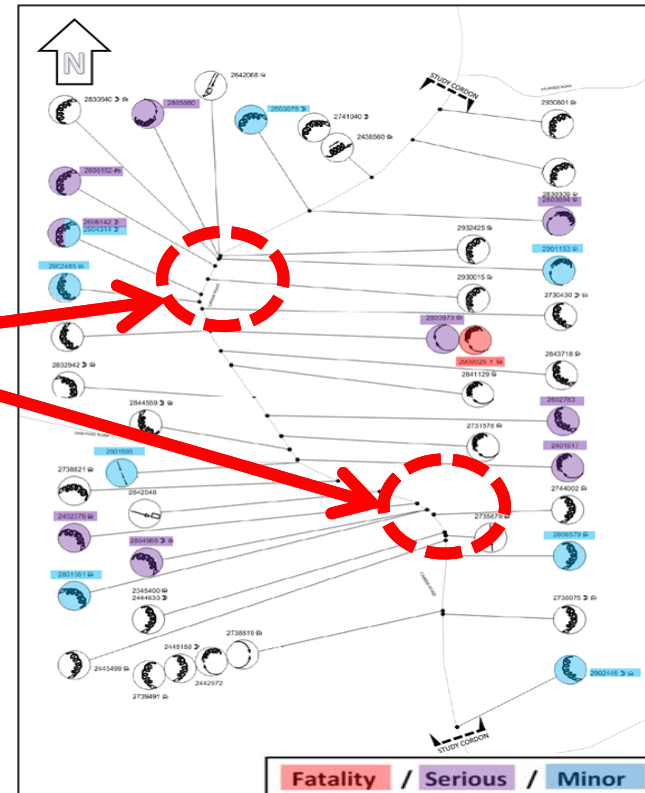
Detailed review of Traffic
Crash Reports shows
most crashes at 2 bends
(in both directions)

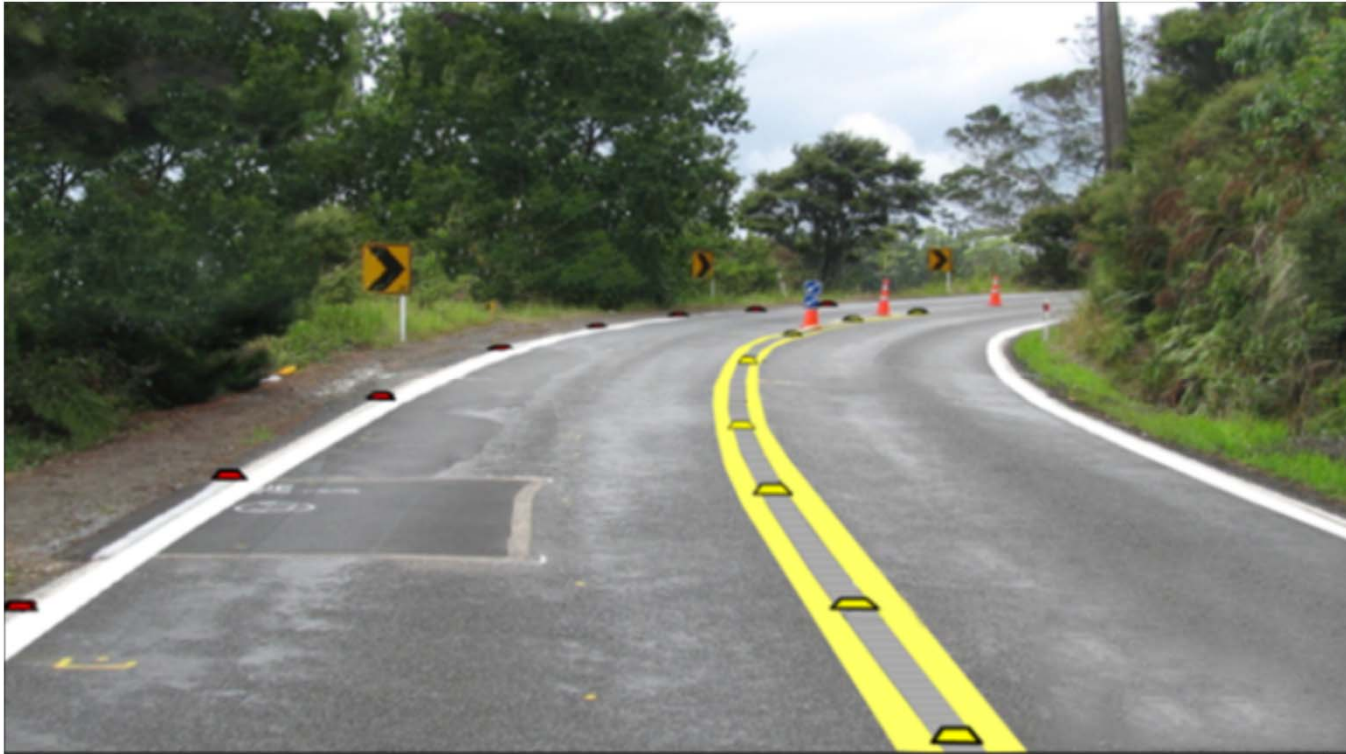
'Before' works photos - photo montage with proposed road-marking superimposed
