TECHNICAL PAPER

BENEFITS OF NEW AND IMPROVED PEDESTRIAN FACILITIES: CASE STUDIES

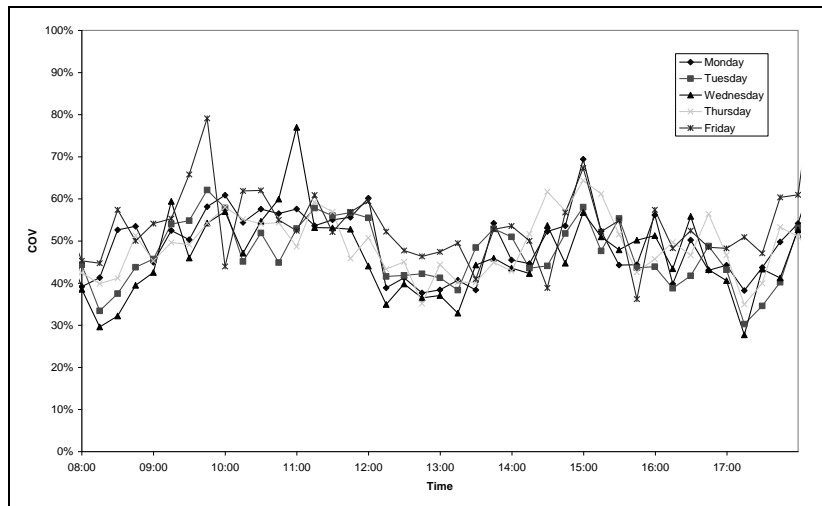
Figure 1 shows that the coefficient of variance of pedestrian counts on different weekdays is similar and generally between 40% and 60%. It is important to note that Figure 1 does not indicate that it is suitable to use counts collected on different weekdays during the same week. Although no analysis has been carried out for this scenario, it is likely that the coefficient of variance of counts obtained using such a technique would be quite high.

Figure 1: Coefficient of variance between quarter hour counts on weekdays

Figure 1 also suggests that the coefficient of variance is lowest around noon, and this is therefore potentially the best time to survey. Higher variability around the afternoon and morning peaks is possibly due to the lack of an allowance being made for school holidays in the analysis. If school holidays are avoided this would still appear to be a suitable time to conduct pedestrian counts. Based on these results survey data was collected at most sites between 12 and 1-30pm.

To evaluate the likely variability in pedestrian counts by time of day, base data from a control site used in the research study “Predicting Accident Rates for Cyclists and Pedestrians” (Turner et al, 2001) has been used. The control site was located at a signalised crossing located near Christchurch Hospital and used pressure detectors that counted pedestrians that stand on them. Continuous pedestrian flow count data, reported in quarter hour periods, was collected over a period of a year between December 2003 and November 2004. To assist in determining when the best time is to collect accurate data, data from the control site was used to produce two graphs showing the coefficient of variance (COV) for weekdays and weekends (see **Figure 1 and 2**)

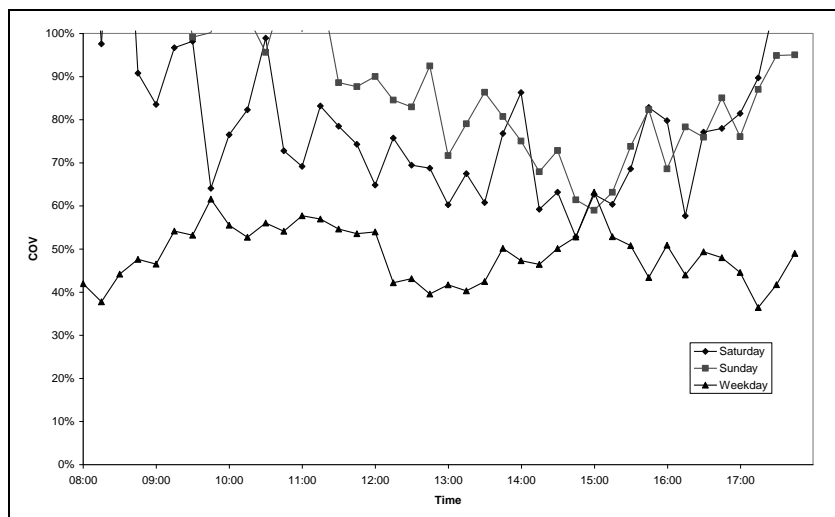
Figure 2: Coefficient of variance between quarter hour counts on weekends

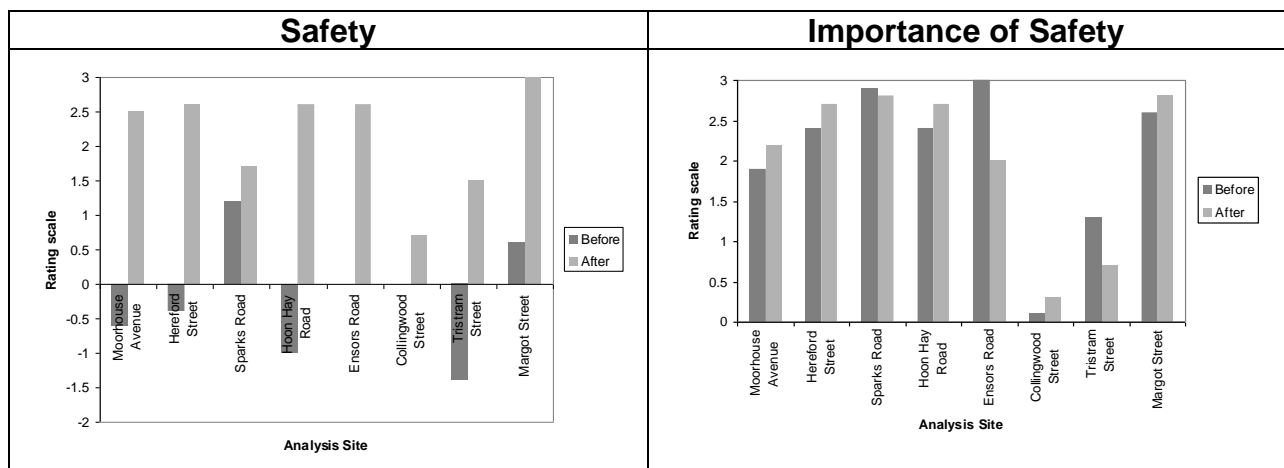
Figure 3: Changes in perceived level of safety and importance of safety

It is obvious from the above figure that pedestrians are unanimous in their perception that improved facilities at the above locations have provided a safer crossing environment. It can also be seen that at five out of the eight sites analysed (Moorhouse Ave, Hereford Street, Hoon Hay Road and Sparks Road in Christchurch and Margot Street in Auckland), the perceived level of safety after implementation of a new facility had a rating that was at or above 2.5 out of a maximum of 3. Each of these locations had a 'before' safety perception rating that was mildly negative, neutral or slightly positive. This suggests that pedestrians at these locations have derived great safety benefits from the construction of new facilities.

The other three locations (Collingwood Street and Tristram Street in Hamilton and Sparks Road in Christchurch) also displayed significant increases in perceived levels of safety, although not of a magnitude comparable to the five sites described above.

Figures 3 to 5 show the changes in the perceived levels of safety, delay and directness at the eight study sites. Survey respondents at each site gave a different degree of importance to each parameter. However, it was found that pedestrians across all of the sites were unanimous in rating safety as the most important factor while considering where to cross a road.

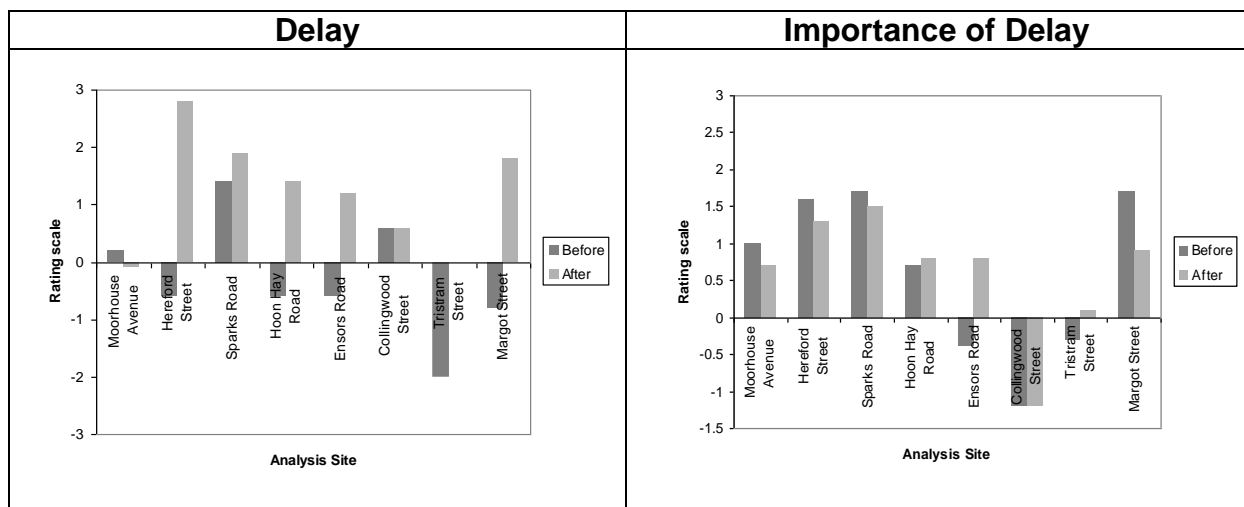
Figure 4: Changes in perceived level of delay and importance of delay

We can observe from the above figure that implementation of new pedestrian facilities has resulted in reducing the amount of waiting time experienced by crossing pedestrians at all but two of the locations analysed.

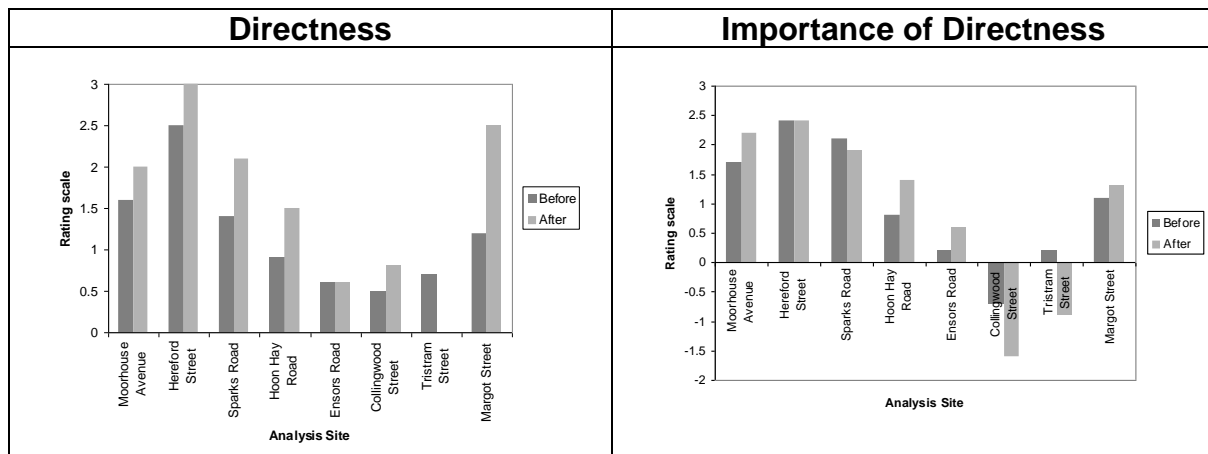
Figure 5: Changes in perceived level of directness and importance of directness

The above figure for directness indicates that six out of the eight sites have resulted in providing a more direct crossing path to pedestrians. The exceptions are the refuge islands and kerb extension at Ensors Road, where pedestrians did not report a change in directness, and the refuge island at Tristram Street, where pedestrians reported that the new facility did not lie on the most direct path.
