# Benefits of New and Improved Pedestrian Facilities

# Case Study 1 – Tristram Street, Hamilton

# Case Study 2 – Sparks Road, Christchurch

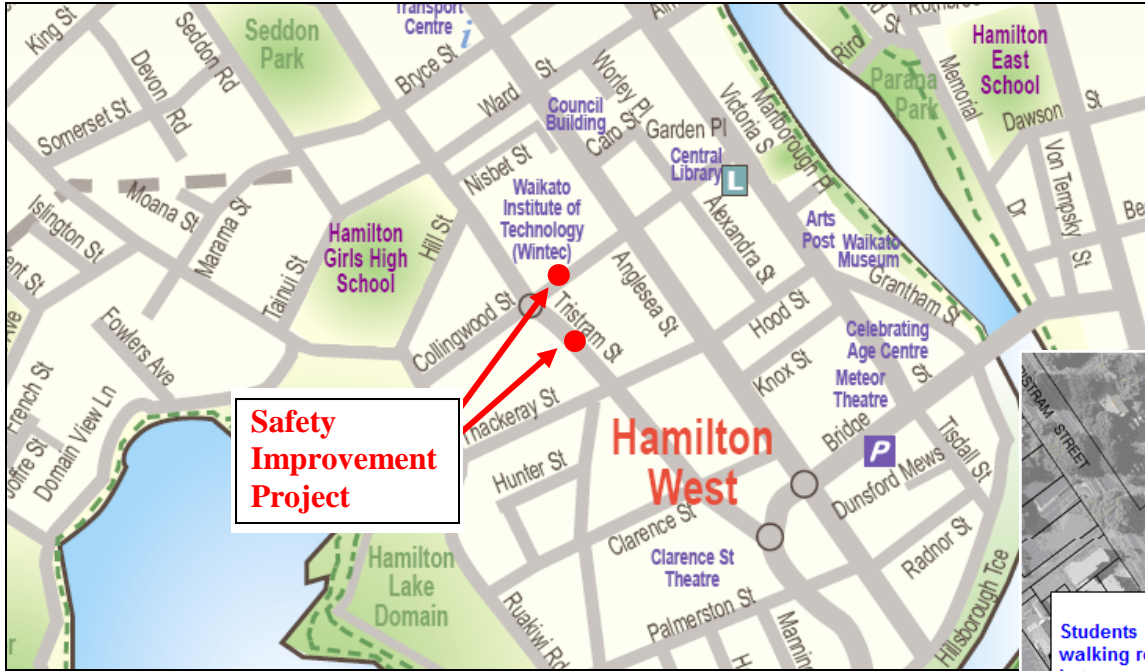
# Site Location

This site is also located close to the Waikato Institute of Technology in Hamilton West. There is a large pay and display car park facility on the southwest corner of the Tristram Street and Collingwood Street roundabout.

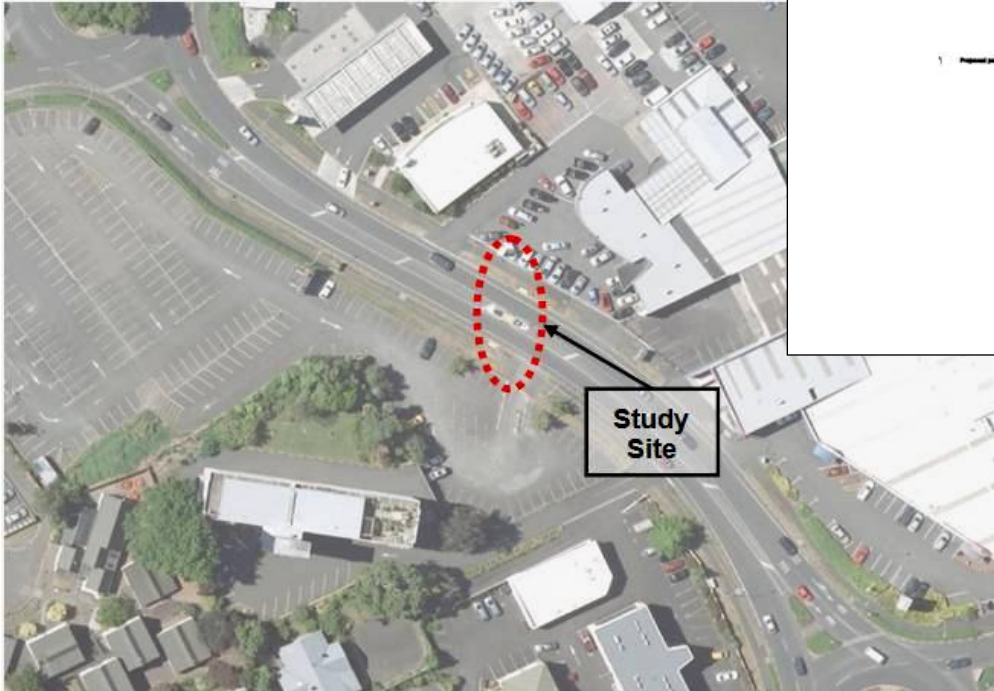
# Proposed Design

The pedestrian crossing facility at Tristram Street involved the construction of a mid-block pedestrian refuge island.

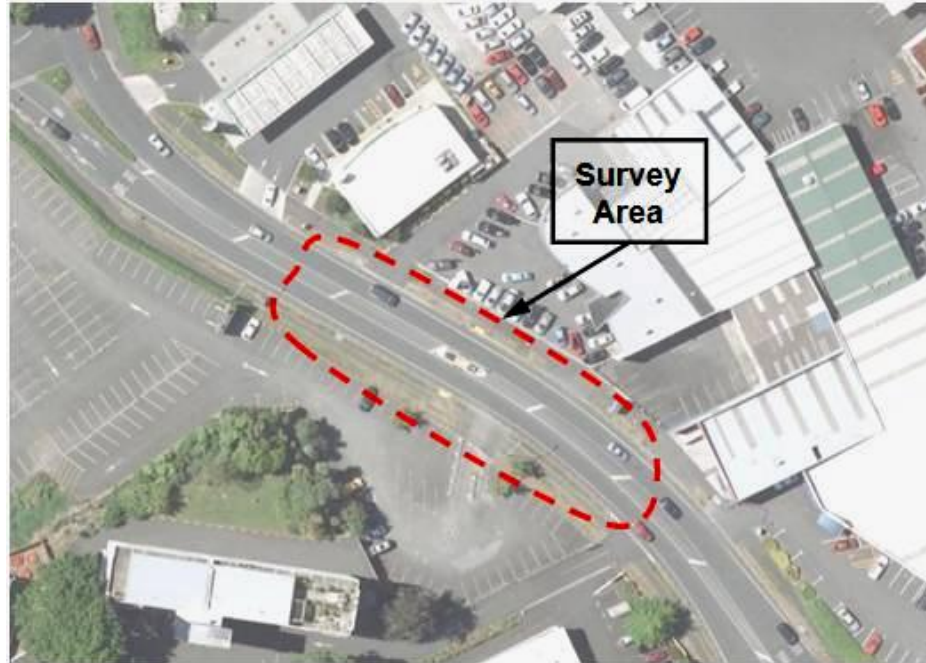
# Survey Area and Pedestrian flows

- Analysis of the survey counts shows a significant increase in pedestrians crossing within the observation area, **from 25 pedestrians per hour (February 2007 'Before' survey) to 46 pedestrians per hour (August/October 2007, 'After' survey).**
- As with the Collingwood Street facility, a doubling in use was observed and this confirms the facility as an attractive crossing for pedestrians.

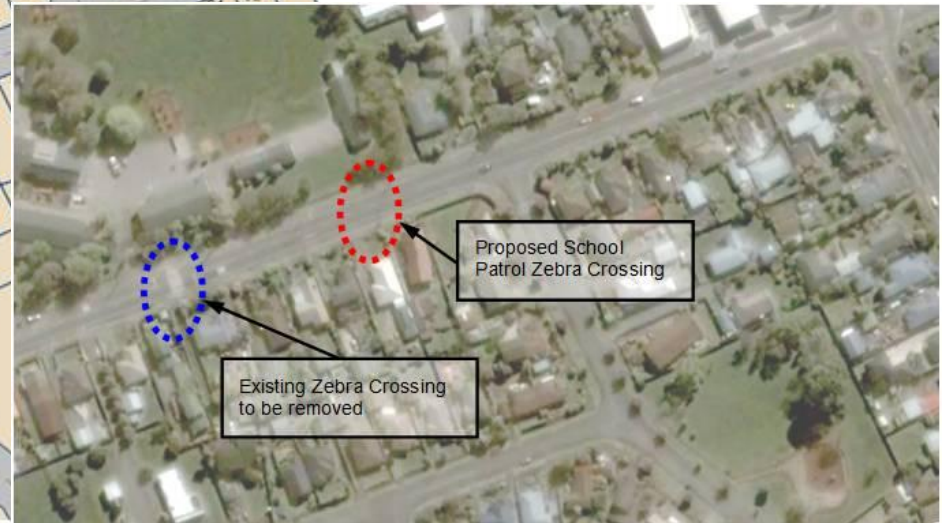
# Site Location

The site is located outside the entrance of Hoon Hay School and near the entrance to Our Lady of Assumption School (OLA) on Sparks Road.

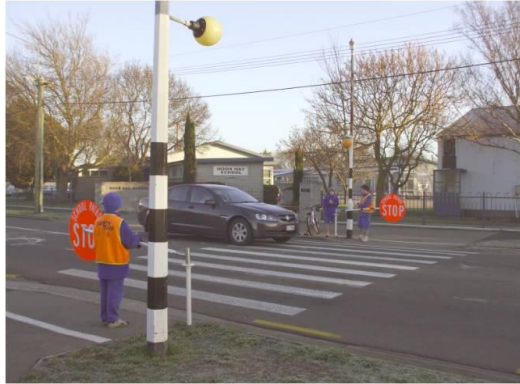
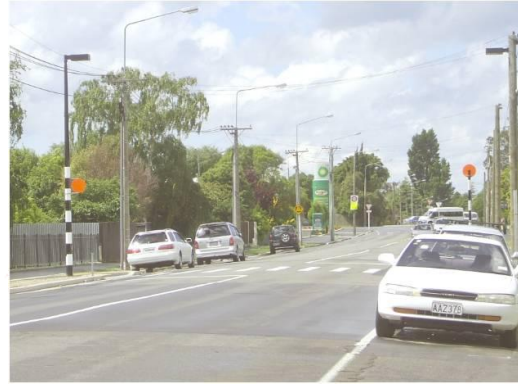
# Proposed Design

Improvements involved removal of the existing zebra crossing near the entrance to the Hoon Hay School and construction of a new school patrolled zebra crossing midway between the two school entrances.

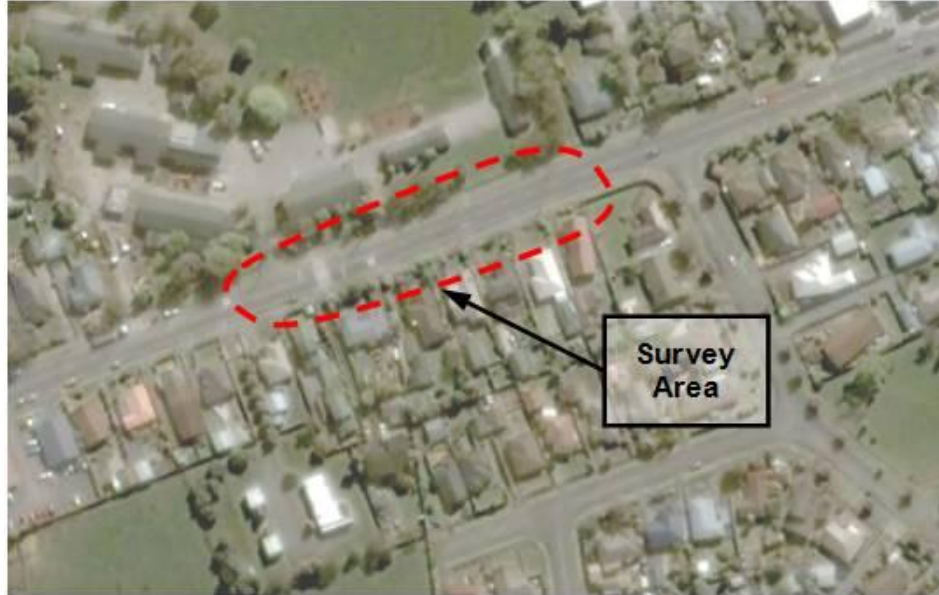
# Survey Area and Pedestrian Flows

- The number of pedestrians using the site per hour over the two periods (morning and evening) surveyed increased **from 148 ('Before' survey) to 228 ('After' survey)**.
- This represents **an increase of over 50%**, and suggests that removal of the existing zebra crossing and subsequent installation of the school patrolled zebra crossing resulted in making this site more attractive for pedestrians in general and school students in particular, since they derive considerable safety benefits by utilising the patrolled zebra crossing.
