School Bus Safety

Peter Baas, Presenter. BE(Mech), MIRTENZ, MCILT, Member of IPENZ Transportation and Sustainability Engineering Groups, Managing Director, TERNZ (Transport Engineering Research NZ Ltd), p.baas@ternz.co.nz

Evaluation of school bus signs

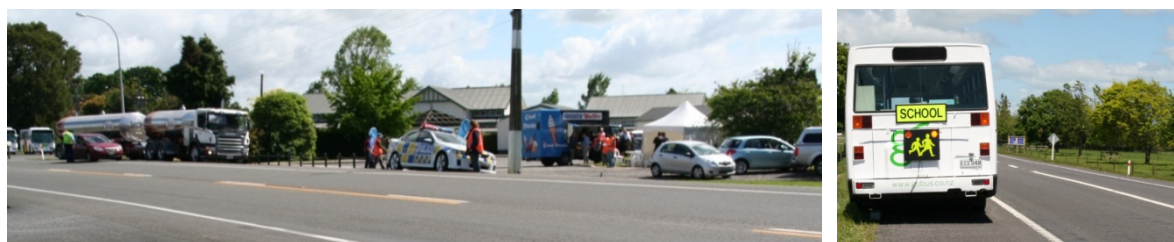
Figure 1 Intercept stop location and bus and sign used for the survey

At the end of the survey, the motorists were invited to comment on the other signs. Figure 1 shows the intercept stop and the bus that was used.

A perception survey was also undertaken to determine whether motorists consciously noticed flashing signs and to obtain their views on the effectiveness of the signs. The arrangements for the intercept were similar to those used by ACC for their roadside driver fatigue rest stop campaigns. Accident Compensation Corporation (ACC) and NZ Police assisted with the arrangements and conduct of the survey. Motorists were stopped by the police just past the intersection at the front of the school. They were invited to take part in the survey and were offered free coffee and food. Sign 4 (figure 2) was used for the intercept stop.

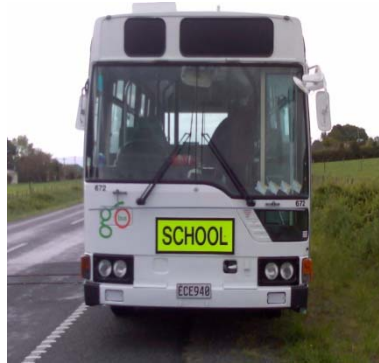
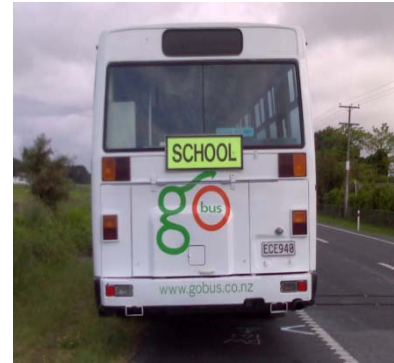
Sign 1: Baseline – (825 x 300) to establish ‘status quo’ (current sign)

Sign # 1	Northbound	Southbound
Vehicle count	175	202
Average speed	84	93
Standard deviation	13	10
Minimum speed	38	37
Maximum speed	104	129

- The current sign (sign 1) had only a small effect on vehicle speed, reducing speeds by approximately 6km/h. However this reduction may well have been simply because of the presence of the bus.
- The addition of the bus hazard warning lights on (sign 2) made no discernable difference to vehicle speeds.
- Replacing the current signs with the standard children walking symbolic sign (sign 3) also made no discernable difference.
- The children symbolic signs that included two closely spaced flashing lights (sign 4) reduced average traffic speeds by 12km/h compared with sign 1. Drivers surveyed said that they noticed the flashing lights because they were clustered together.
- The addition of words telling motorists to slow down (sign 5) slowed the traffic by a further 6km/h.

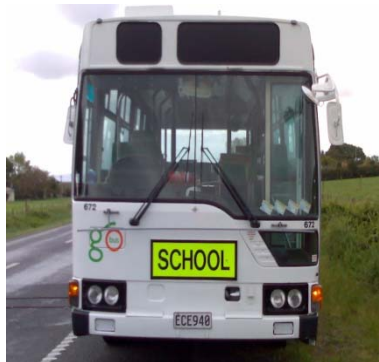
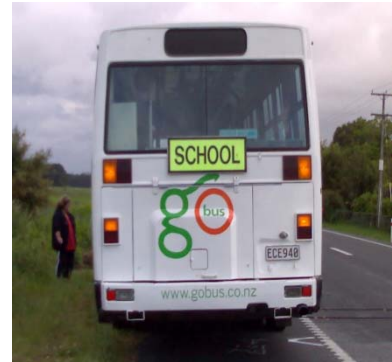
Sign 2: Current sign plus normal bus hazard lights flashing

Sign # 2	Northbound	Southbound
Vehicle count	237	220
Average speed	83.	91
Standard deviation	14	11
Minimum speed	16	19
Maximum speed	106	118

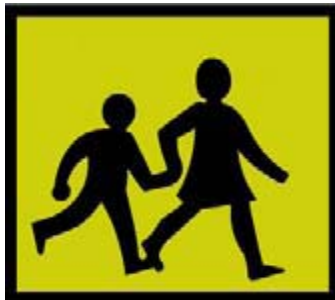
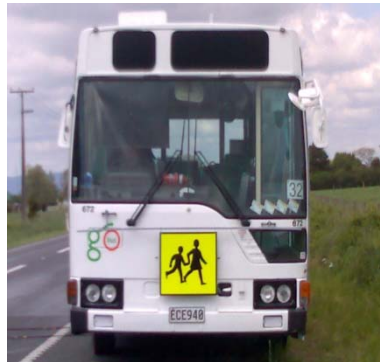
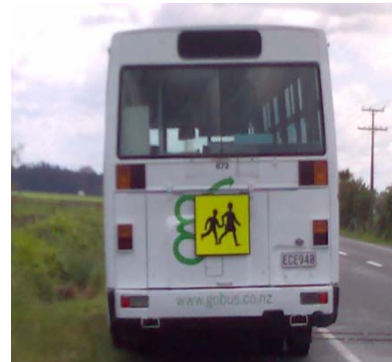
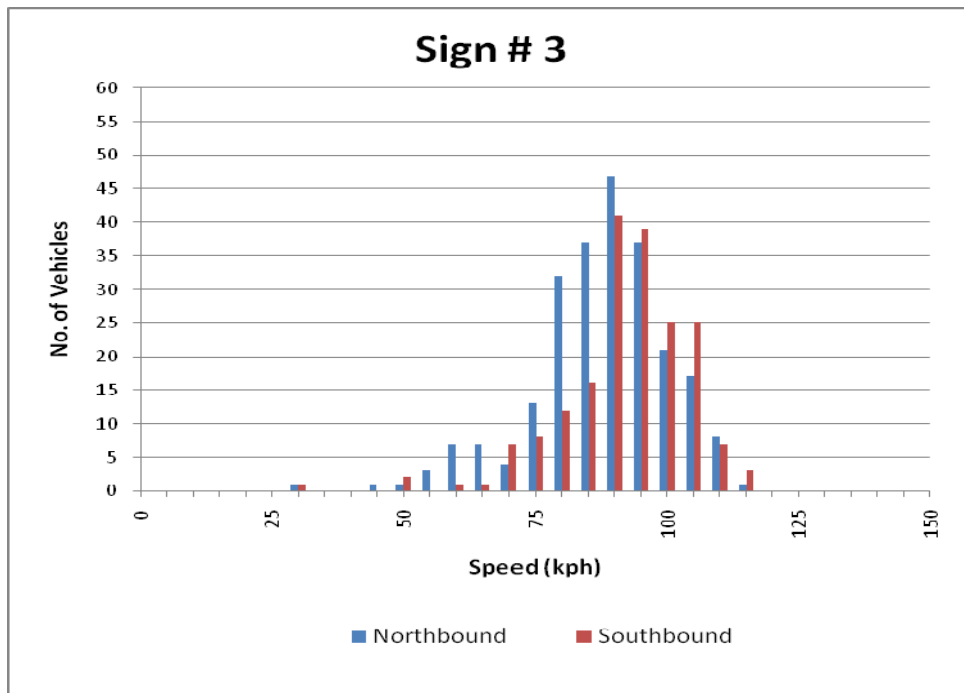
Sign 3: Symbolic sign (570 x 500) to establish value of using children symbol

Sign # 3	Northbound	Southbound
Vehicle count	237	188
Average speed	85	90
Standard deviation	13	12
Minimum speed	27	30
Maximum speed	113	113

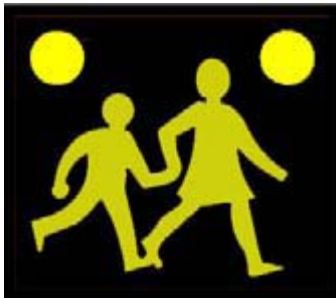
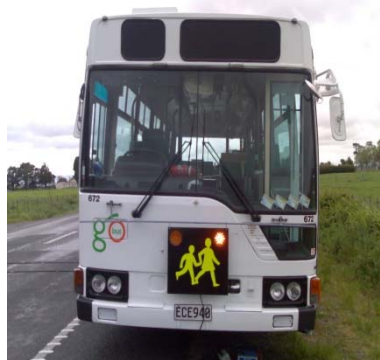
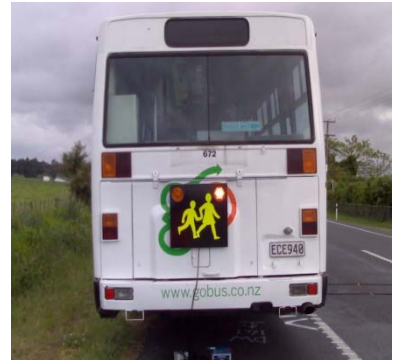
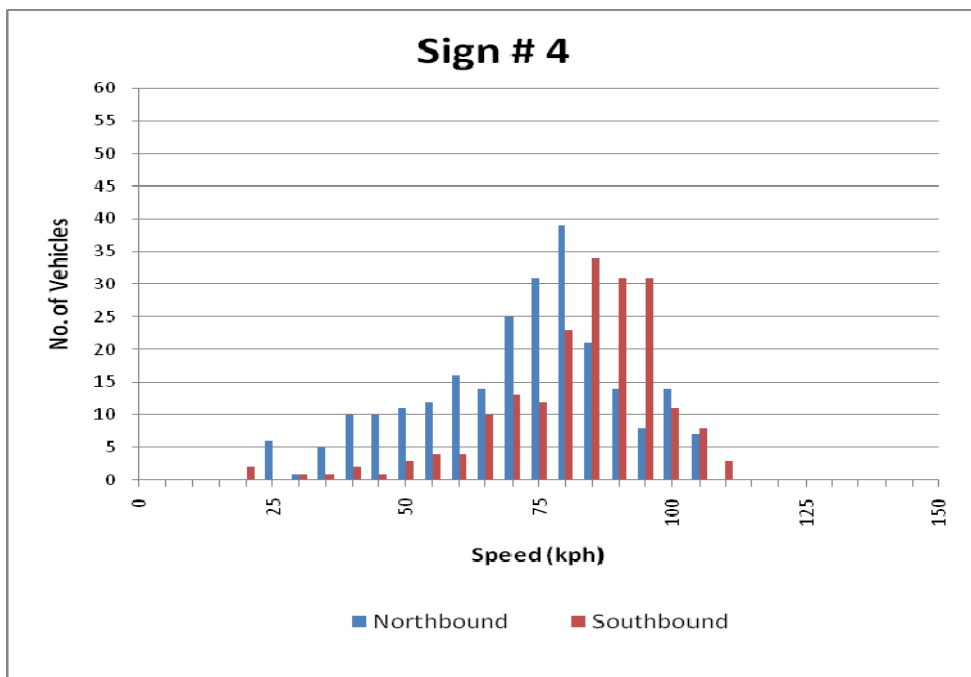
Sign 4: Dynamic sign (570 x 500) to establish value of symbol plus lights, and lights in proximity to signage

Sign # 4	Northbound	Southbound
Vehicle count	244	194
Average speed	69	80
Standard deviation	19	16
Minimum speed	20	15
Maximum speed	104	107

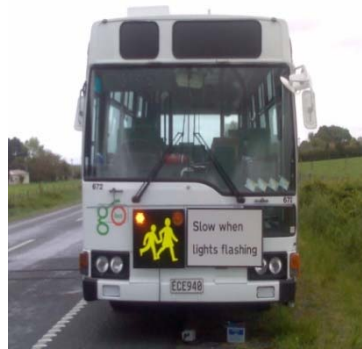
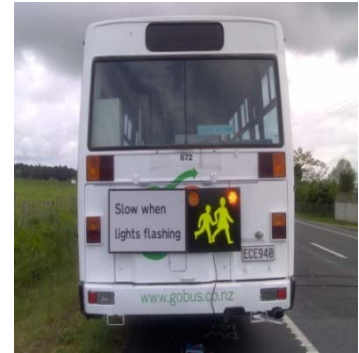
Sign 5: Sign 4 plus text to examine any benefits of the accompanying word message

Sign # 5	Northbound	Southbound
Vehicle count	180	196
Average speed	64	80
Standard deviation	21	17
Minimum speed	16	23
Maximum speed	106	111

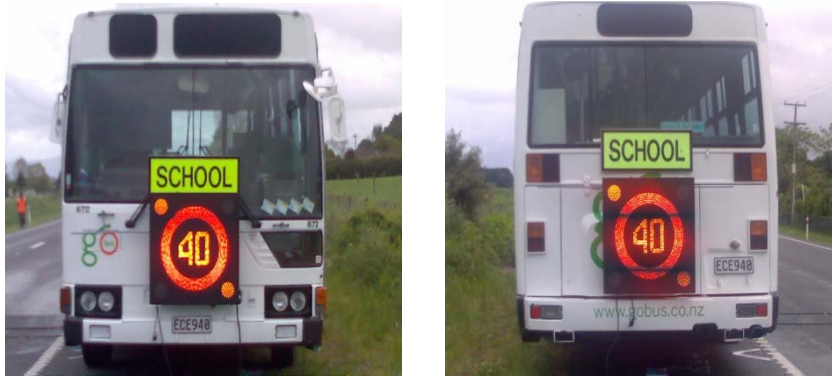
Sign 6: Speed LED sign used for school zones

Sign # 6	Northbound	Southbound
Vehicle count	228	217
Average speed	57	67
Standard deviation	15	17
Minimum speed	30	27
Maximum speed	99	104

- The flashing LED '40' signs (sign 6) reduced average speeds by 23km/h compared with the current sign (sign 1).
- There were, on average, 1.5 incidences of 'dangerous' driving per hour during the trial. The sample size was too small to determine if there were any differences between signs.

- Sign 6, which displayed the '40' sign, would have suggested to motorists that the speed limit was 40km/h rather than 20km/h. It is common at road works and other speed restricted sites for motorists to slow down to a speed that is close to but higher than that posted.

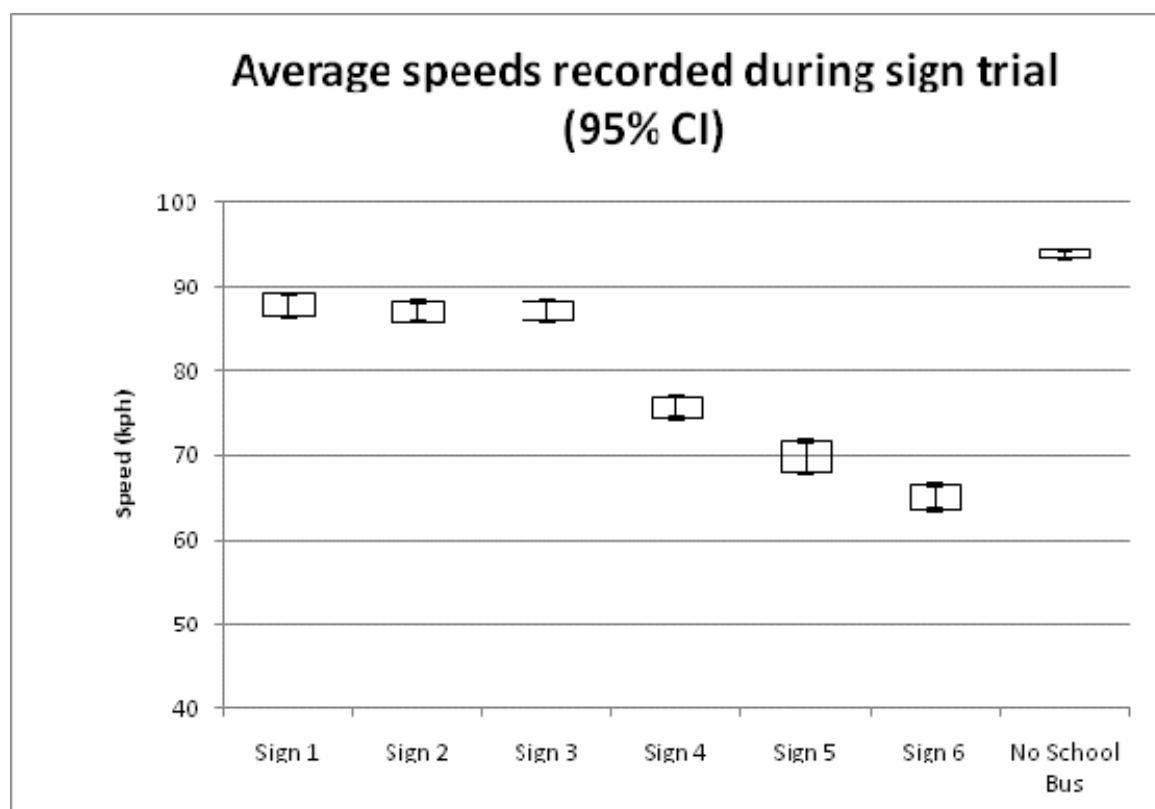
Figure 3 Average speeds passed a school bus with signs 1 to 6

Figure 3 shows the average speeds for both directions of travel for the six signs and when no school bus was present. The boxes show the 95% confidence estimates of the average speeds. The results indicate that:

- in the presence of the bus with the current 'school' sign mean speeds were lower by approximately 6km/h
- there was no discernable difference in speeds in the presence of signs 1, 2 and 3
- in the presence of signs 4, 5 and 6 mean speeds were lower by 12km/h, 18 km/h and 23km/h respectively compared to the speeds when the school sign that is currently on nearly all school buses was present.

The results suggest that:
