MOTORWAY CRASH ANALYSIS USING GIS

A case study of St. Marys Bay, Auckland

Completed the requirements of BE(Hons) in Civil Engineering, University of Auckland 2010

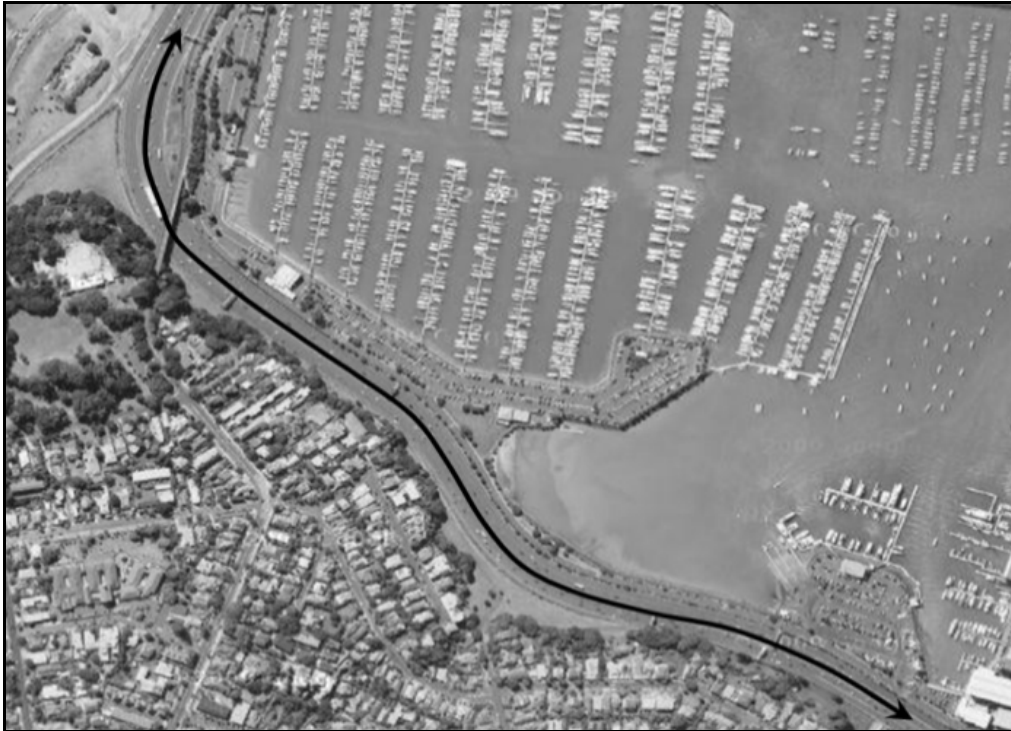
The St Marys Bay section of motorway extends from the Fanshawe Street interchange to the southern side of the Auckland Harbour Bridge as shown in Figure 1. The horizontal alignment includes four reverse curves connected by three short tangents while the vertical alignment is mostly level. Between 6-8% superelevation is provided through the central circular arc of each curve and the road surface is an open graded porous asphalt over the entire section. There have been no significant site infrastructure changes during the five year study period between 2005 and 2009.

Figure 1: Aerial photo of St Marys Bay, Auckland

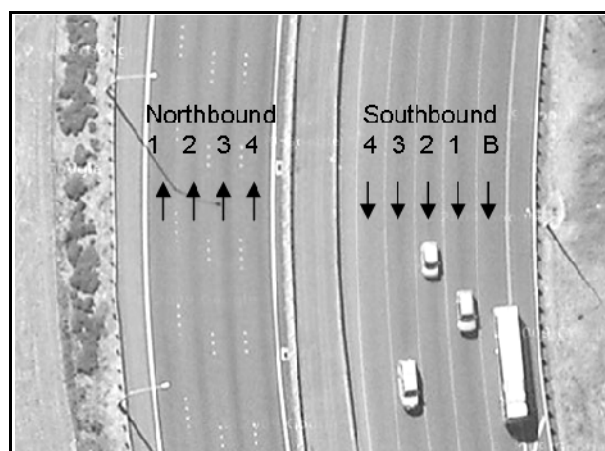
Because the crash coordinates originated from CAS, the plotted crash coordinates appeared in a single line between lane two and lane three. As a result, the points had to be manually offset into the correct lane based on information provided in the TCR's so the accuracy of the coordinates in CAS were limited to the accuracy of the information contained in the TCR. Features of ArcGIS were then utilised to aid visualisation of various crash patterns based on the crash variables outlined in section 3.1 and 3.2. Figure 2 shows the lane labelling system which is referred to in this report.

Figure 2: Lane labelling system used in this paper

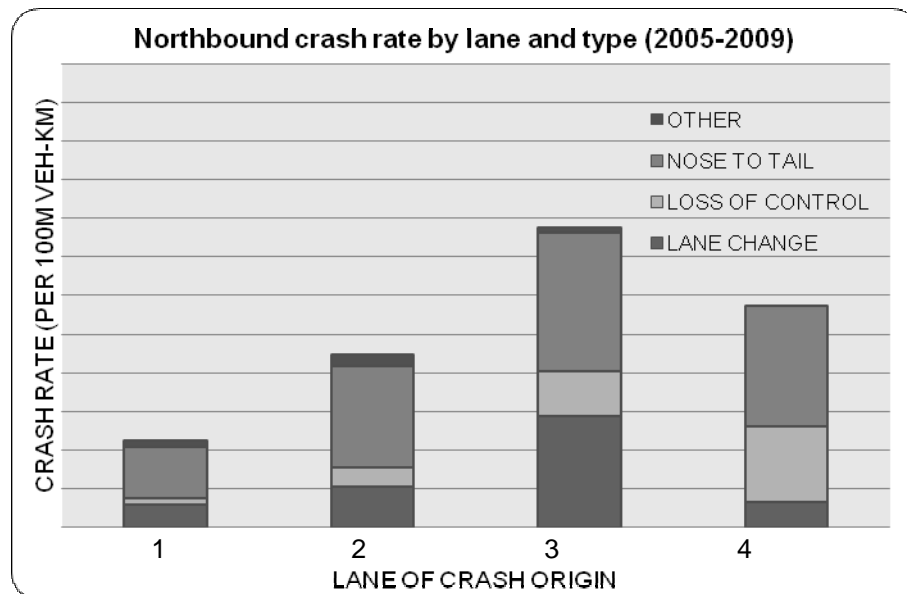
Figure 3 is a graph displaying the crash rate per 100MVKM (million vehicle-km's) travelled on a lane by lane and movement type basis for the northbound direction. This shows a number of interesting trends. Firstly it is clear that the crash rate in lane three is significantly higher than any other lane (155 crashes per 100M vehicle-km's travelled). This is due to the relatively high proportion of lane change crashes compared with other lanes which is thought to be a result of the high interaction between lanes two, three and four. The crash rate in lane one is significantly lower (45 crashes per 100M vehicle-km's travelled). This is due to the relatively low proportion of nose to tail crashes occurring in this lane compared with other lanes which are a result of lower traffic volumes (only 21% between 2005 and 2009) and generally more conservative driving behaviour.

Figure 3: St Marys Bay motorway northbound crash rate by lane and crash type, 2005 to 2009

The most common type of crash in all four lanes was nose to tail. These crashes are generally caused by a combination of road, driver and traffic characteristics. They were found to occur most often at times where there was congestion resulting in a variation in traffic speeds. Also in wet conditions, skid resistance can fall significantly which increases the stopping distance for vehicles. The vehicle can also become a factor if tyre condition is not maintained. These factors combine with the main factor being driver inattention and distraction.

Lane change crashes also make up a significant proportion of total crashes especially in lane three as noted earlier. These crashes were more common in the centre lanes as there is potential for interaction from both sides. Lane change crashes were also found to be concentrated at either end of the study section near the on-ramps simply due to more lane change manoeuvres occurring in these areas. Vehicle and driver factors are the predominant causes of lane change crashes, the majority of crash reports suggest that poor driver observation, decision making and vehicle blind spots are responsible.

Loss of control (LOC) crashes were found to increase in rate per lane the closer the lane was to the median (eg. one, five, eleven and twelve LOC crashes in lanes one, two three and four respectively). This could be due to the higher speeds and possibly related to more reckless driver behaviour in lanes three and four. The majority of these crashes occurred on horizontal curves in wet conditions suggesting that the loss of lateral skid resistance and drivers failing to adjust speeds are the predominant contributing factors. Traffic characteristics also have an effect as all 'loss of control' crashes occurred when traffic was flowing freely therefore at higher operating speeds. There were five 'other' category crashes. These mostly involved vehicles striking objects, three of which were ladders dropped from other vehicles.

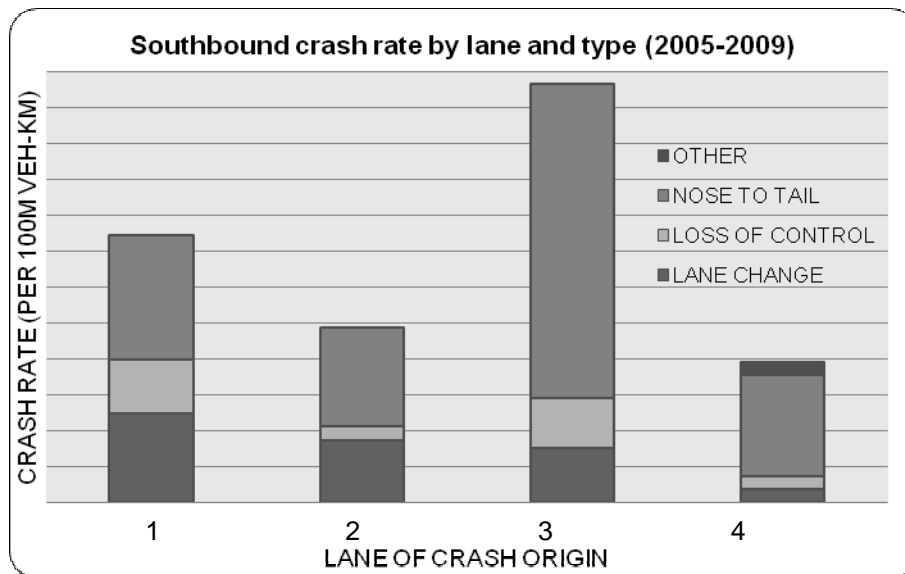
Figure 4 is a graph displaying the crash rate per 100M vehicle-km's travelled on a lane by lane and movement type basis for the southbound direction of the St Marys Bay motorway. This direction provides five lanes directly after the Auckland Harbour Bridge however the left lane becomes a bus lane shortly after the first left hand corner as shown in Figure 2. As a result, this lane has been omitted from the scope of the study due to the small number of crashes occurring in this lane.

Figure 4: St Marys Bay motorway southbound crash rate by lane and crash type, 2005 to 2009

Once again lane three has a significantly higher crash rate than any other lane (233 crashes per 100MVKM followed by lane one (149) followed by lane two (98) followed by lane four (78). However unlike the northbound direction, lane three's higher crash rate is mostly due to nose to tail crashes (75%) while this type of crash is similar between the other three lanes.

The crash rate for lane change crashes is significantly lower in lane four compared with the other three lanes. This is because vehicles wishing to travel south of Auckland are able to stay in lane four while there is much greater lane change activity in lanes one, two and three as vehicles attempt to position themselves for the dual lane Fanshawe Street off-ramp and subsequent central motorway junction. The relatively high 'lane change' crash rate in lane one and lane two is likely due to drivers who attempt to save time by pushing their way into the queue during the morning peak. During this time, lanes one and two are free flowing while lanes three and four are backed up from the Victoria Park viaduct. It is expected that the frequency of this type of crash will be significantly reduced once the Victoria Park tunnel (currently being constructed) that will provide additional capacity is completed.

There does not appear to be any obvious reason why loss of control crashes appear to be more common in lane one and lane three. However, as was seen with the northbound direction, loss of control crashes were more frequent on curves and in wet conditions for the same reasons.

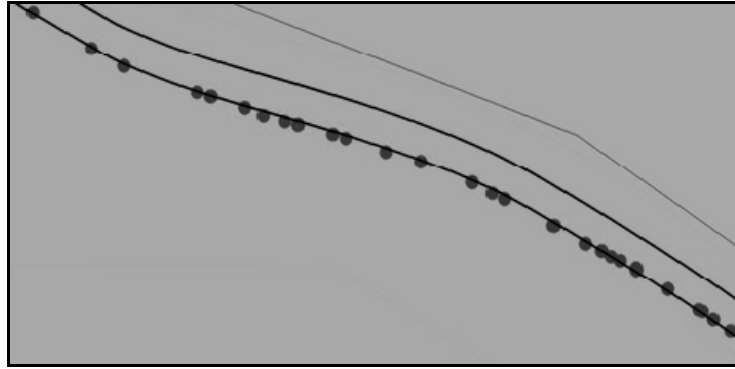
Figure 5 shows a screenshot from the existing CAS GIS package. This uses a vector system where each direction of the motorway is represented by a single line. In this image the crashes that have occurred between 2005 and 2009 are represented by points for the northbound direction. The position of these points is based on a distance along the motorway from a given intersection or landmark such as an on-ramp or an over-bridge. This system has several limitations as outlined in the following section.

Figure 5: Screenshot from CAS

Firstly, the crashes are only displayed on a linear basis which is adequate for analysis of single lane roads but not appropriate for a four lane motorway as this case study highlights. At the very least CAS should have an additional variable named 'lane' assigned to each crash so that the crashes can be sorted and viewed on a lane by lane basis. CAS currently has the ability to do this for all other variables listed in section 3.1 so it would not be difficult to expand CAS in this way.

There is also an accuracy issue. The crash locations on the motorway are usually based on a distance from an on-ramp or off-ramp. This distance is taken from the police TCR and the level of accuracy between reports varies from 10m to 100m. In some instances, it is clear from the TCR that little or no effort has been made to accurately locate the crash and locations have been estimated.

Due to this issue, several crashes often appear in exactly the same location. For example, a number of crashes may be estimated to have occurred 100m north of an on-ramp. When displayed in CAS these will appear as one point and other outputs such as the collision diagram feature must be analysed to determine the number of crashes at that point.

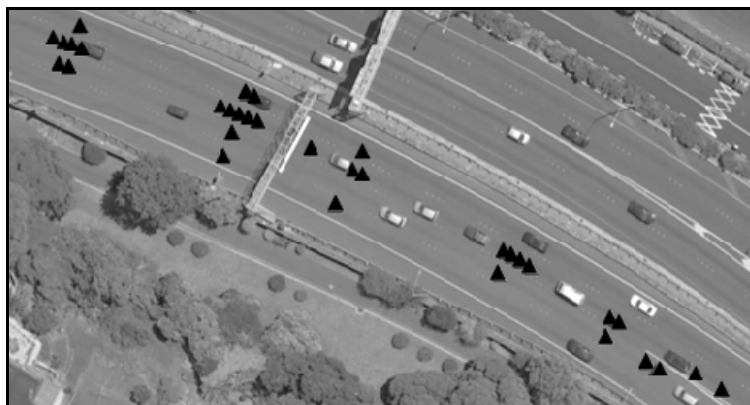
Figure 6 shows a screenshot from ArcGIS which is the program used in this study to plot crashes using a raster system. Each triangle represents a crash that has occurred in the northbound direction between 2005 and 2009. An aerial photograph was used as a base layer and the crashes were plotted based on northings and eastings using the Transverse Mercator coordinate projection system.

Figure 6: Screenshot from ArcGIS

The image shows that crashes can be displayed on a lane by lane basis which gives a clear idea of how crashes are distributed along the road and across each lane. The aerial

photograph layer enables road features to be viewed simultaneously so that these can be considered as contributing factors. For example, there is a cluster of nine 'nose to tail' crashes immediately following the visual message board shown in Figures 6 and 7 which suggests that this could be a possible distraction for drivers. It should be noted that in remote rural areas there may be an issue with aerial photograph quality. In addition some photographs may not be up-to-date therefore care must be taken during interpretation.

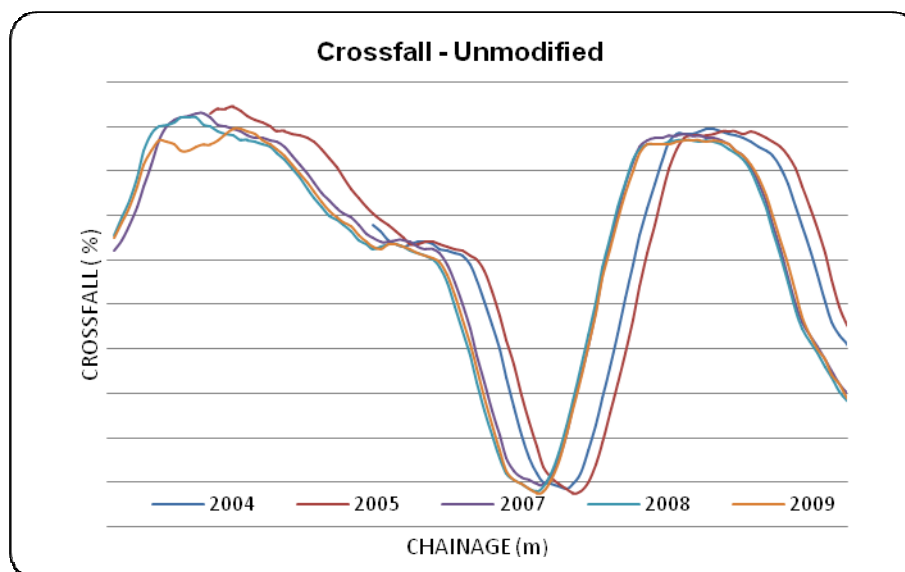
A second source of error found in the input data originated from the RAMM data. The high speed data that was gathered by a SCRIM+ truck was found to be slightly out of phase when comparing cross-fall data between different years as shown in Figure 8.

Figure 8: Graph of uncorrected lane 2 southbound cross fall against chainage showing variations from year to year

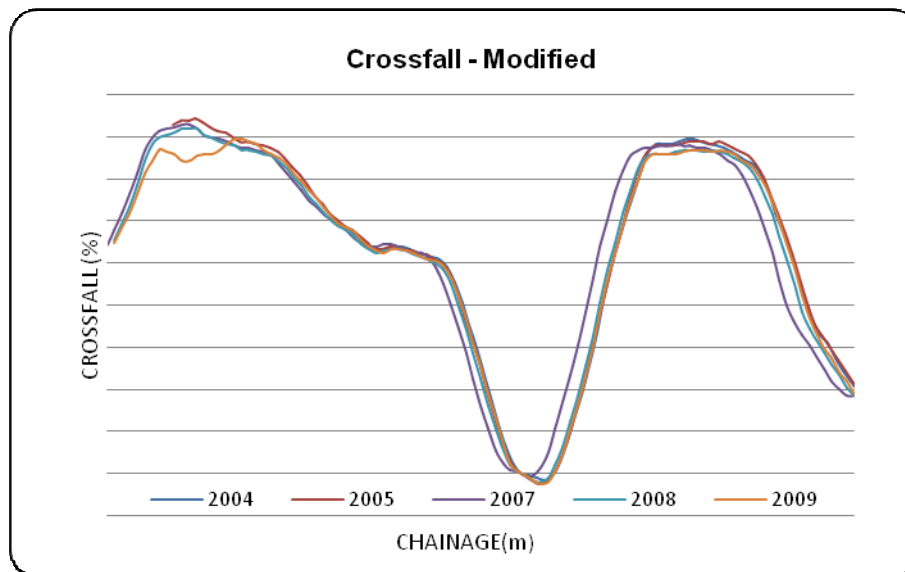
A horizontal phase shift was applied to the years previous to 2008, when a GPS unit was installed within the data collection truck. This ensured that all RAMM data including road macrottexture and ESC over the five year period are as accurate as possible. Figure 9 shows the improvement in the cross-fall data after adjustments have been made.

Figure 9: Graph of corrected lane 2 southbound cross fall with after data shift to minimise annual variation in other RAMM data.
