NZTA Wide Centreline Trial

1 Executive Summary

The NZTA Wide Centreline Trial aims to improve safety on rural State Highways through a reduction in head-on crash risk. This report summarises four trial sites:

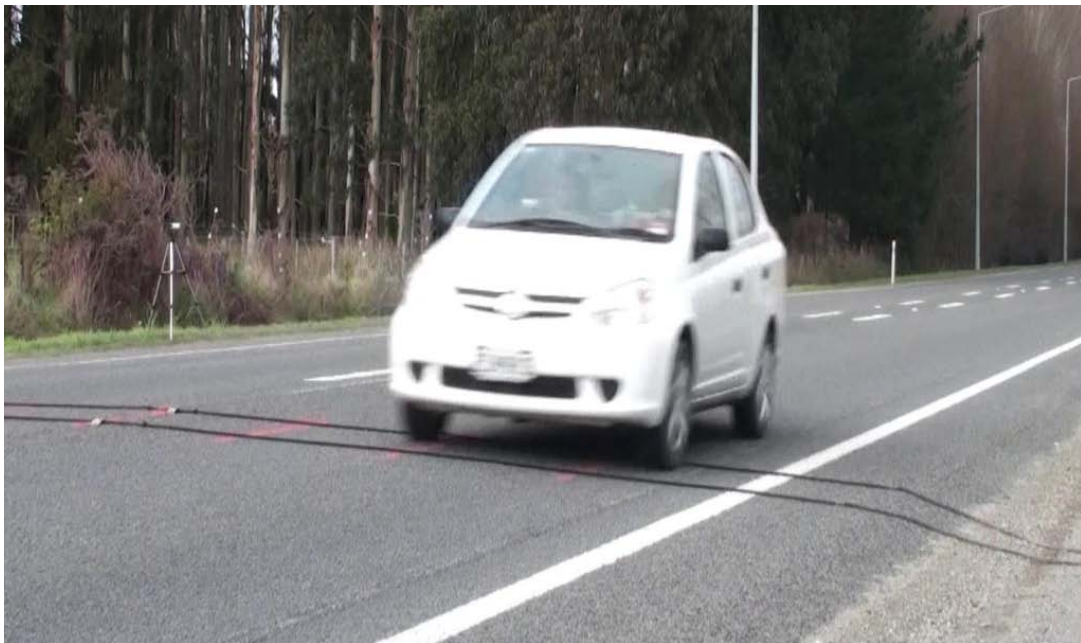
Figure 2 Example lateral position still shot

Vehicle position was measured from the video data, using motion-capture software to convert the video to a series of still shots. Only vehicles with at least five seconds headway to the vehicle in front were captured, to avoid effects of following on lateral position. An example still shot is shown in Figure 2.

To determine whether the trial resulted in a change in vehicle position relative to the centre of the road carriageway, video surveys were carried out for four hours in each direction at each site, before and after the markings were changed. The surveys were carried out on weekend days and weekdays (two hours per survey). The surveys coincided with the speed surveys, so that the pneumatic tubes themselves could be used to help calibrate the video, and so that data could be coordinated between the two surveys if required. The speed tubes were marked at 1.0m intervals to help calibrate the resulting lateral position data.

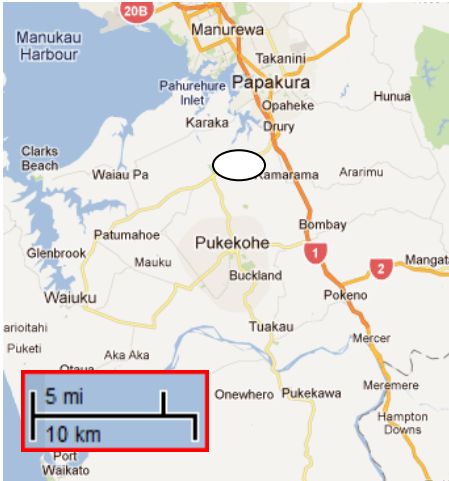
The trial site northeast of Pukekohe (SH22 RP 0/1.360 – 0/7.360) involved a section of the link between Pukekohe and the Auckland Southern Motorway, as shown below.

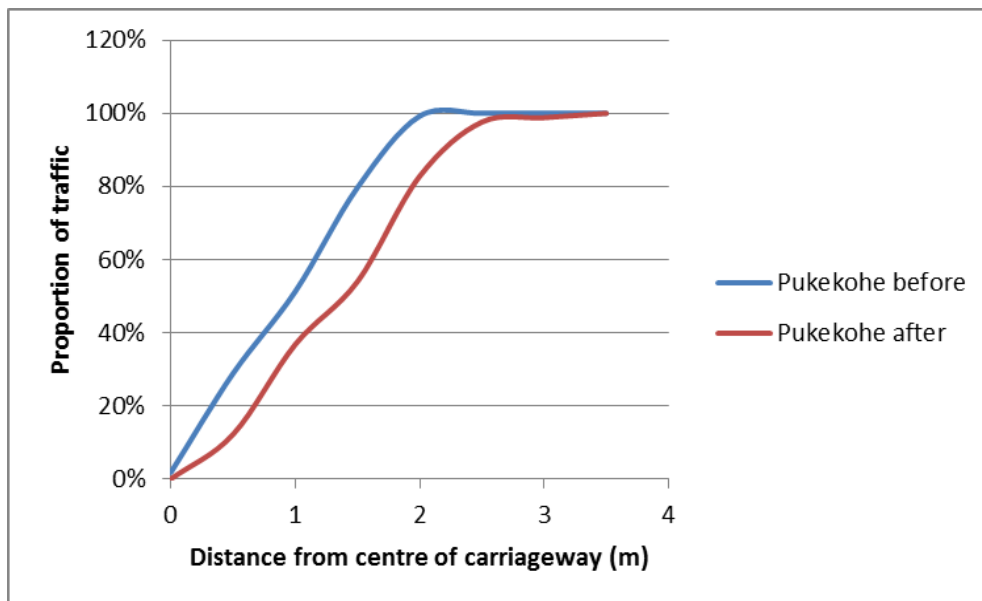
Figure 3 Lateral separation, SH22 Pukekohe

Results from this site show an average *increase* in lateral separation of 0.54m, from 2.5m to 3.0m. The 5th percentile separation (those vehicles travelling the closest to the centre of the road carriageway) *increased* from 0.5m to 1.0m.

Lateral separation results for the Pukekohe site are shown in **Figure 3**.

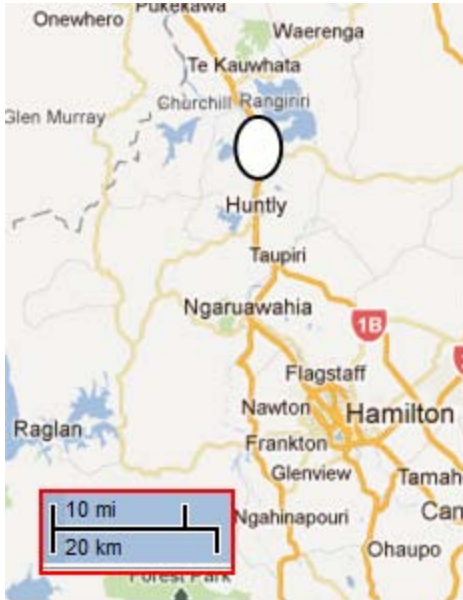
From the south, the trial site north of Huntly (SH1N RP 502/9.700 – 502/12.400) started at the 100km/h speed change north of Huntly and extended north to just south of the start of the Waikato Expressway, as shown below.

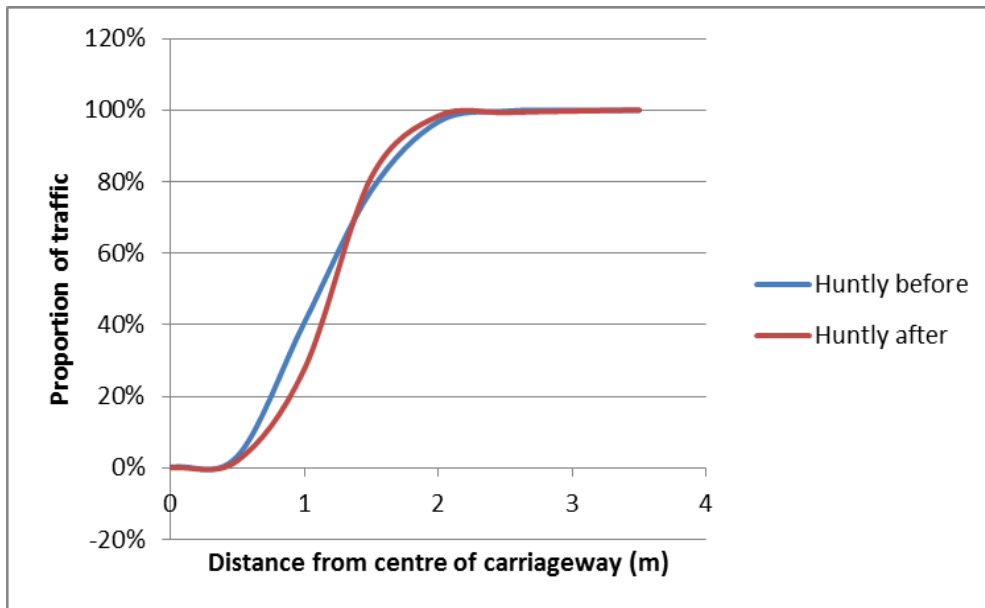
Figure 4 Lateral separation, SH1 Huntly

Results from this site show an average *increase* in lateral separation of 0.19m, from 2.7m to 2.9m. The 5th percentile separation (those vehicles travelling the closest to the centre of the road carriageway) *increased* from 1.6m to 2.0m.

Lateral separation results for the Huntly site are shown in **Figure 4**.

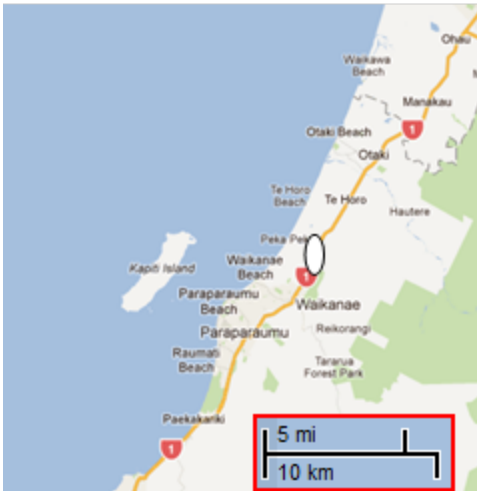
The trial site north of Waikanae (SH1N RP 1012/2.310 – 1012/3.712) started at the 100km/h speed change north of Waikanae and extends north for approximately 1.4km.

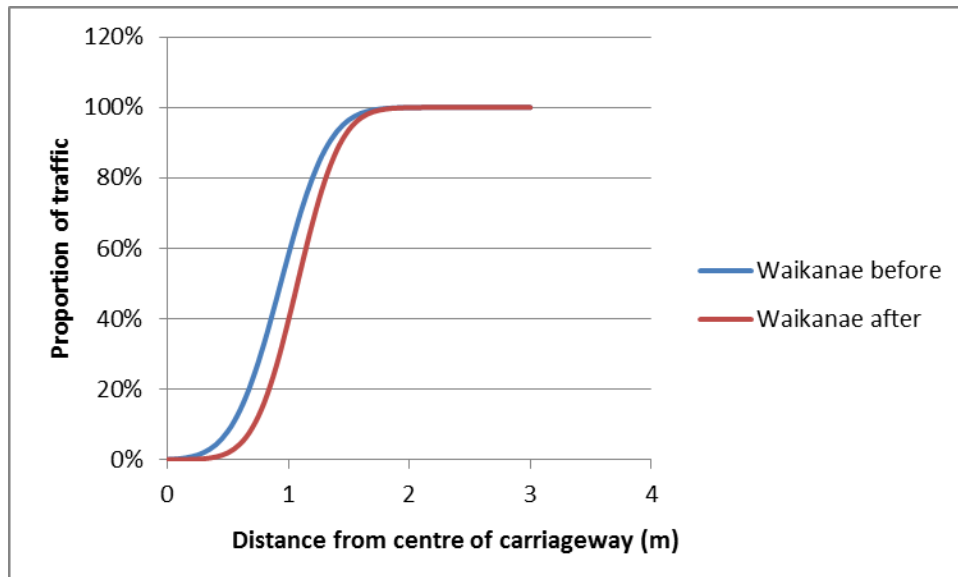
Figure 5 Lateral separation, SH1 Waikanae

Results from this site show an average *increase* in lateral separation of 0.28m, from 1.9m to 2.2m. The 5th percentile separation (those vehicles travelling the closest to the centre of the road carriageway) *increased* from 1.5m to 1.7m.

Lateral separation results for the Waikanae site are shown in **Figure 5**.

All sites showed a significant increase in lateral separation of opposing traffic. It is interesting to note however the wide range of separation changes, from an increase of around 0.2m at two sites, to a relatively large increase of 1.4m at the Waikanae site. There are likely to be several contributory factors to the variability in lateral position (for example, cross section, roadside features, upstream environments etc) but there is insufficient consistency in this data to enable meaningful comparison. It may be that with additional sites added to the trial, multiple linear regression techniques can be used to investigate the relative contribution of different factors to lateral separation.

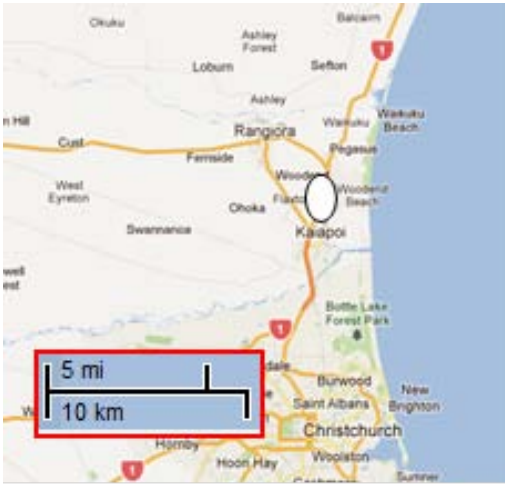
The trial site south of Woodend (SH1S RP 317/200 – 317/2200) starts north of the junction with SH71 ends south of the township of Woodend, as shown below.

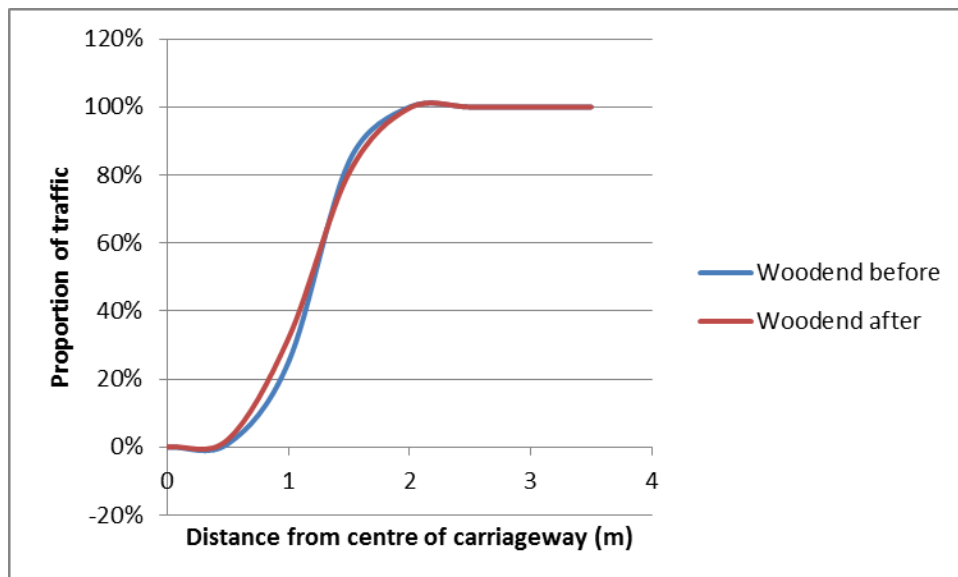
Figure 6 Lateral separation, SH1 Woodend

Results from this site show an average *increase* in lateral separation of 0.14m, from 2.6m to 2.8m. The 5th percentile separation (those vehicles travelling the closest to the centre of the road carriage way) *decreased* from 1.8m to 1.3m.

Lateral separation results for the Woodend site are shown in **Figure 6**.

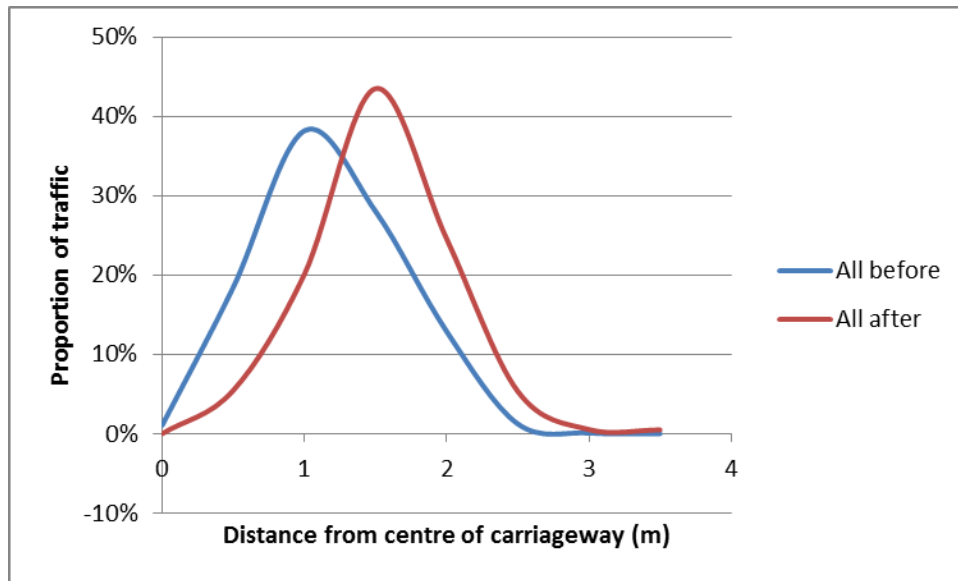
Figure 7 Combined lateral separation results

Though all sites are different in terms of marking type and lane dimensions, the combined change in distance from the centre of the road carriageway is a significant increase from 1.2m to 1.5m.

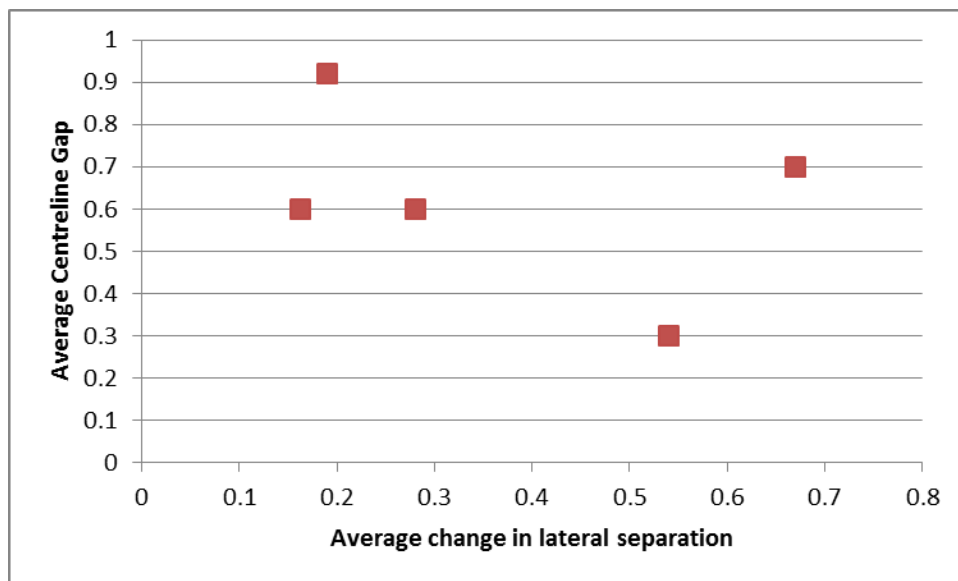
Figure 8 Change in lateral separation vs mean wide centreline gap*

Mean change in lateral separation was compared to the wide centreline gap, and annual average daily traffic volume, as shown in **Figures 8** and **9** below.

*note that these charts include data from a fifth site, SH3 Rukuhia, recently included in trial results

There is no meaningful correlation between the change in separation, either centreline gap, or AADT. Other site parameters investigated included lane width, change in carriageway width, presence of profiled markings and shoulder width. The large variation in these parameters within and between sites is considered too great to meaningfully compare them in terms of correlation with lateral separation changes.
