## **Effectiveness of Transverse Road Markings on Reducing Vehicle Speeds**

Andrew Martindale BE (Hons), GIPENZ  
Transport Engineer  
Opus International Consultants  
[Andrew.Martindale@opus.co.nz](mailto:Andrew.Martindale@opus.co.nz)

### **Abstract**

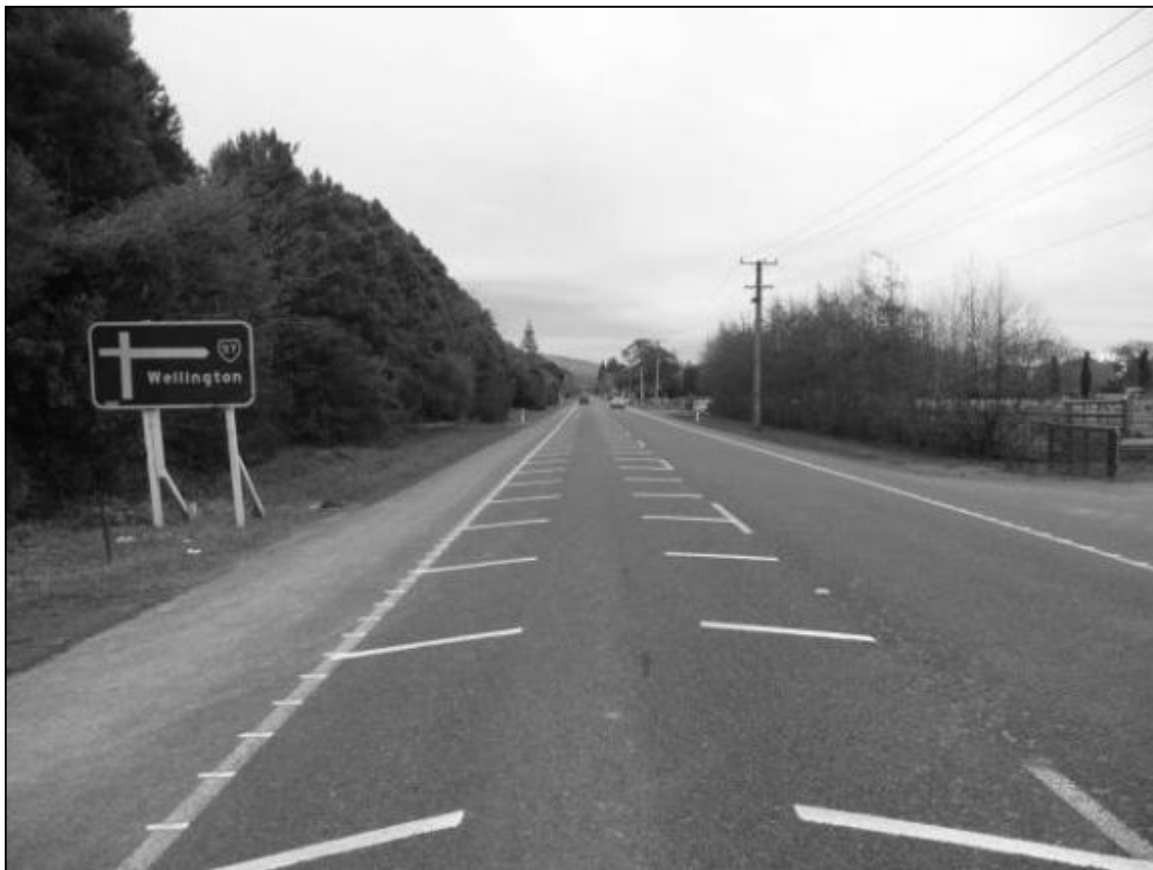
Transverse road markings can be defined as a series of marked (either flat or raised) transverse bars placed across the road in the direction of traffic flow as shown by the example in Figure 1. They are used to assist in raising driver awareness of risk through perceptual optical effects, thus encouraging drivers to reduce their speed in anticipation of an upcoming hazard.

**Figure 1 : An example of Transverse Road Markings**

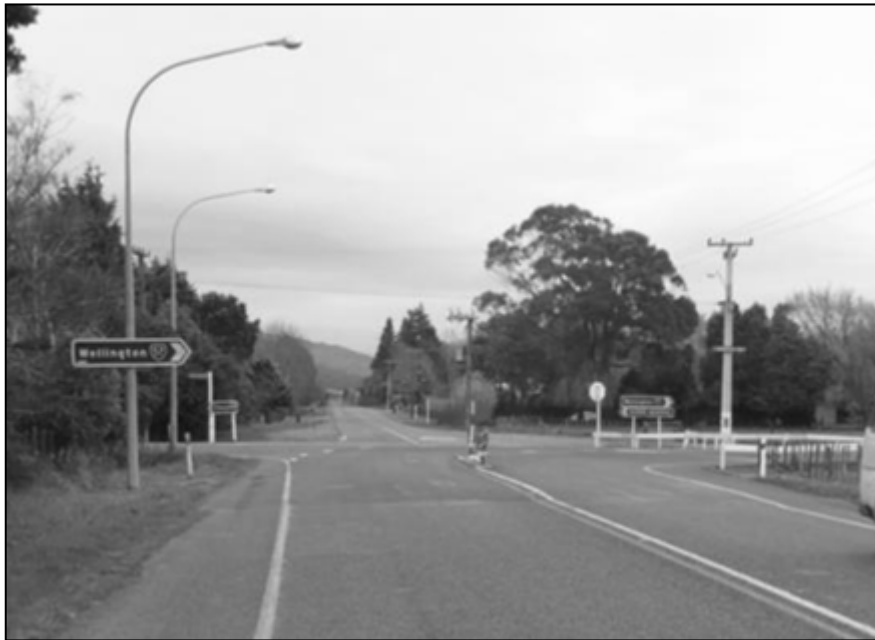
The priority cross-roads intersection is located near Levin on SH57 (route position 0/2.083), approximately 2km to the east of SH1. The intersection is arranged as an out-of-context curve, with SH57 traffic having priority from west to north (and vice versa) as shown in Figure 4. The southbound SH57 approach to the intersection is approximately 500m in length and has a posted speed limit of 100km/h. On the approach to the intersection, a major speed reduction is required by southbound traffic to negotiate the

**Figure 4: Southbound approach to the SH57 trial site (50m from the intersection)**

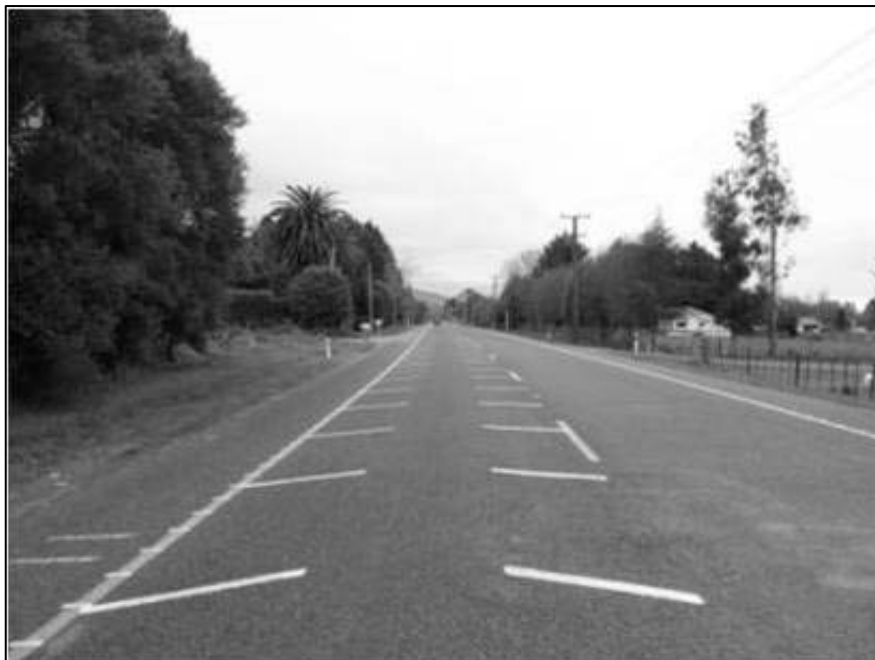
**Figure 5: Established SH57 trial site (410m from the intersection)**

intersection safely. A review of the NZTA crash database noted that 15 crashes occurred at the intersection between 2004 and 2008. Six of the 15 crashes were caused by drivers travelling too fast on the southbound intersection approach, losing control when making the right-hand turn. One crash was attributed to losing control at excessive speed on the southbound approach when making a left-hand turn. An image of the established SH57 treatment site is shown in Figure 5.

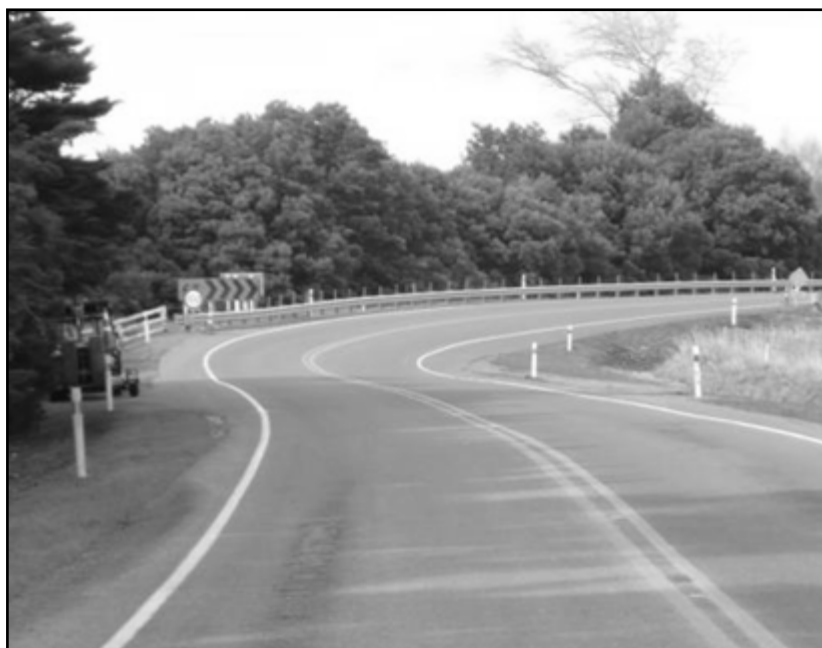
Figure 6: Eastbound approach to the SH53 trial site (50m from the bridge)

The Waihenga River Bridge is located on SH53 (route position 0/14.755) between Featherston and Martinborough. The bridge is situated approximately 575m to the east of the Jenkins Dip Floodway bypass. The eastbound bridge approach is characterised by a straight section approximately 580m in length prior to a right-hand horizontal curve leading up the bridge abutment as can be seen Figure 6. The approach operates with a 100km/h posted speed limit and requires a reduction in speed to drive over the bridge safely. Although the NZTA crash database showed only one minor injury crash at the bridge over the five-year period between 2004 and 2008, the bridge is regularly used by oversized farming vehicles which can become a hazard because of the lack of forward visibility. An image of the established SH53 treatment site is shown in Figure 7.

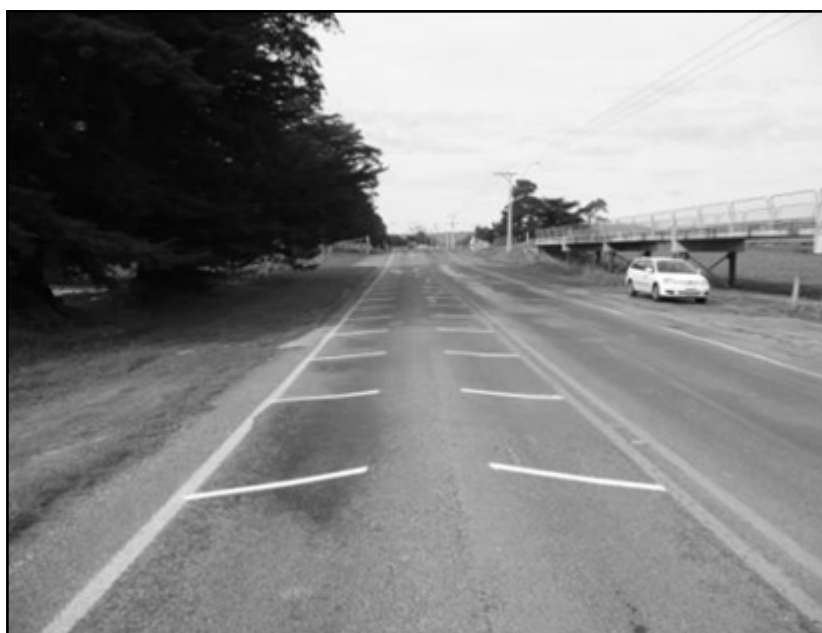
Figure 7: Established SH53 trial site (410m from the bridge hazard)
