OPPORTUNITIES TO IMPROVE CYCLIST SAFETY IN BUS LANES

Author/Presenter: Daniel Newcombe, MEngSt (Transportation), BPlan, MNZPI

Senior Transport Planner, Auckland Transport

19th March 2012

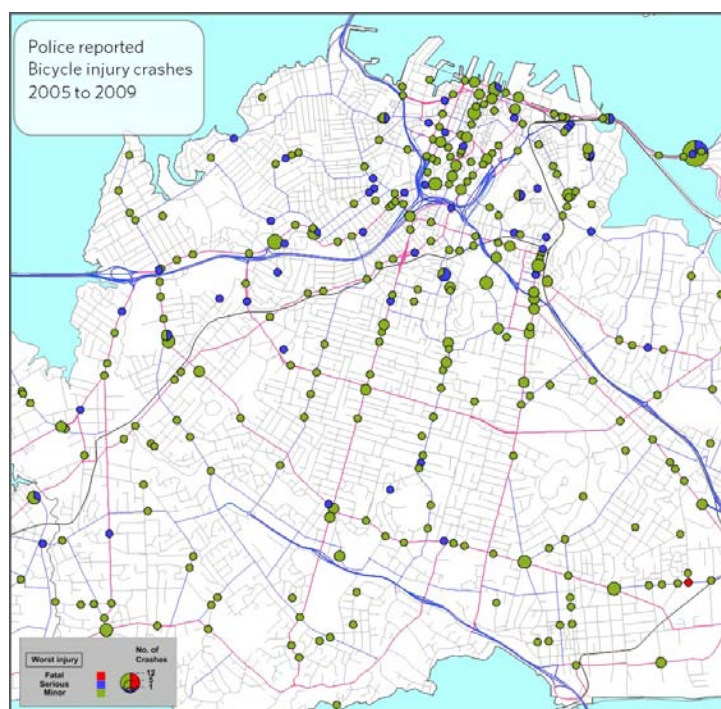
Figure 2- Auckland city injury crashes involving cyclists 2005-2009

Figure 2 indicates that most crashes occur on major arterial routes, particularly close to the CBD. Such locations are also commonly where bus lanes are found. Of the 1044 cycle crashes in the 2005-2009 period, 58% occurred at intersections, 95% on urban roads, 86% in daytime, with the worst month being March and with the worst period being 3pm to 6pm. This strongly suggests commuter cyclists make up the majority of casualties.

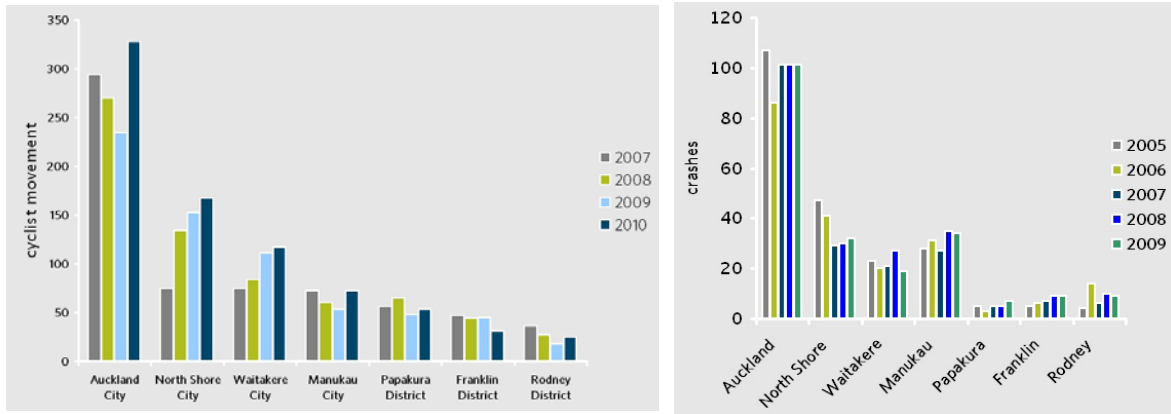
Figure 3 – Average total cyclist peak period movements and injury crashes involving cyclists by (former) local body (2007-2010)

Auckland Transport undertakes an annual cycle count at a total of 84 sites across the Auckland Region during the morning and evening peaks. In 2010, a total of 12,625 cyclist movements were recorded, an increase of 27% over 2009. The cyclist volumes are noticeably higher in dense urban locations, again indicating that a large proportion of those cyclists are commuters. Comparing this to cycle injury crashes grouped by the same geographical areas, there is clearly a correlation between commuter cyclist volumes and cycle crash injuries (see Figure 3).

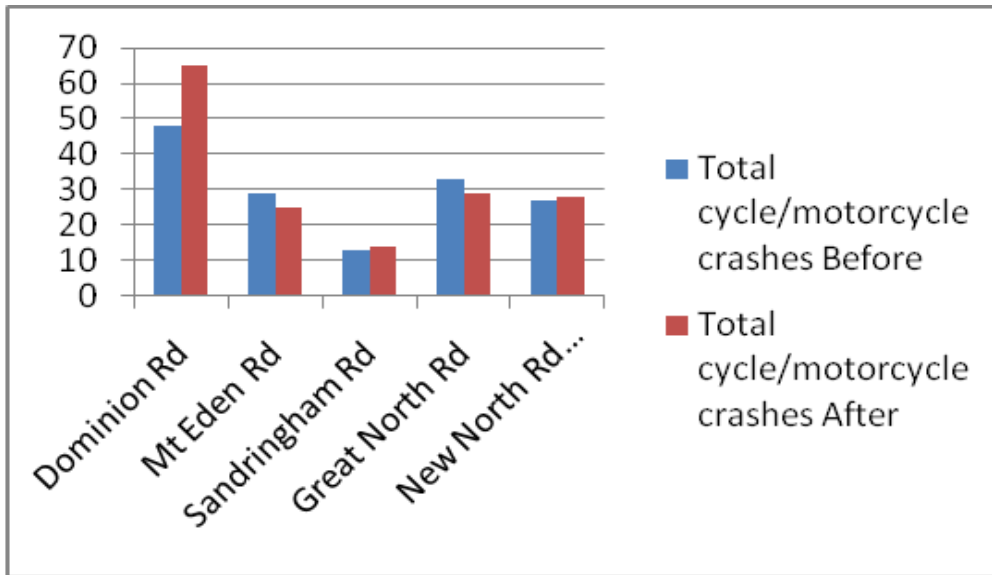
Figure 5 - Total cycle/motorcycle crashes before and after bus lane implementation

As can be seen in Figure 5 below, the number of crashes in the years following the introduction of bus lanes along Dominion Rd rose by over 30%, whereas each of the other routes experienced a reduction or slight increase (which, given traffic volume increases, is effectively a reduction). These results would indicate that the implementation of bus lanes on these routes had little, if any, overall effect on the safety of cyclists or motorcyclists – pending the identification of the factors contributing to the Dominion Rd crash increase.

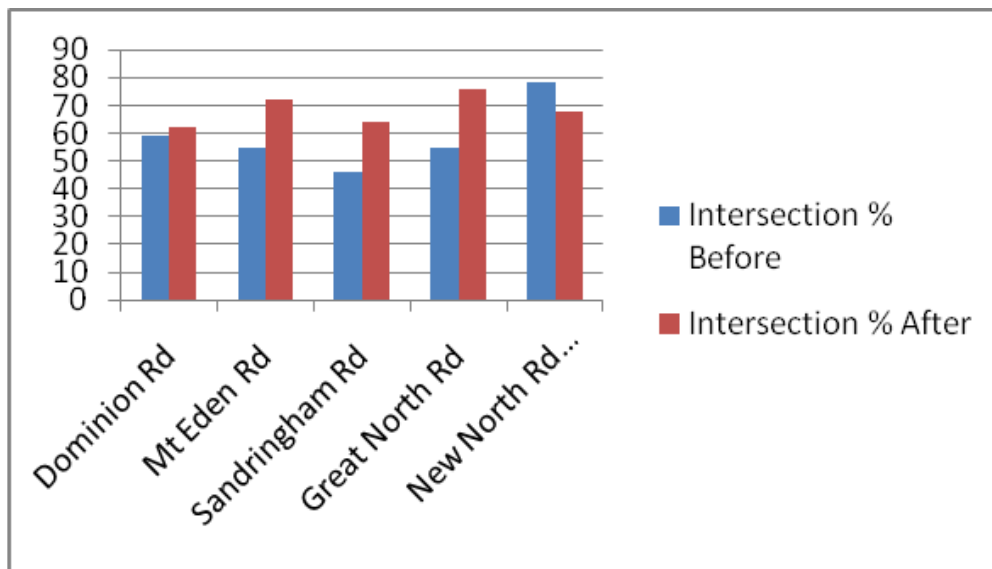
Figure 6 - Percentage of cycle or motorcycle crashes occurring at intersections before and after bus lane implementation

Whilst the small sample size limits the ability to apply the findings far, one issue where the previous study found that those bus lanes created a change was in relation to the crash location. The results showed a consistent increase in cycle or motorcycle crashes at intersections after bus lanes had been installed (refer Figure 6). In comparison, the control route of New North Rd experienced a substantial decrease in such crashes. A reason for this may be the reduction in conflicting interaction between cyclists or motor-cyclists and general traffic along midblock locations, where bus lanes are more typically present.

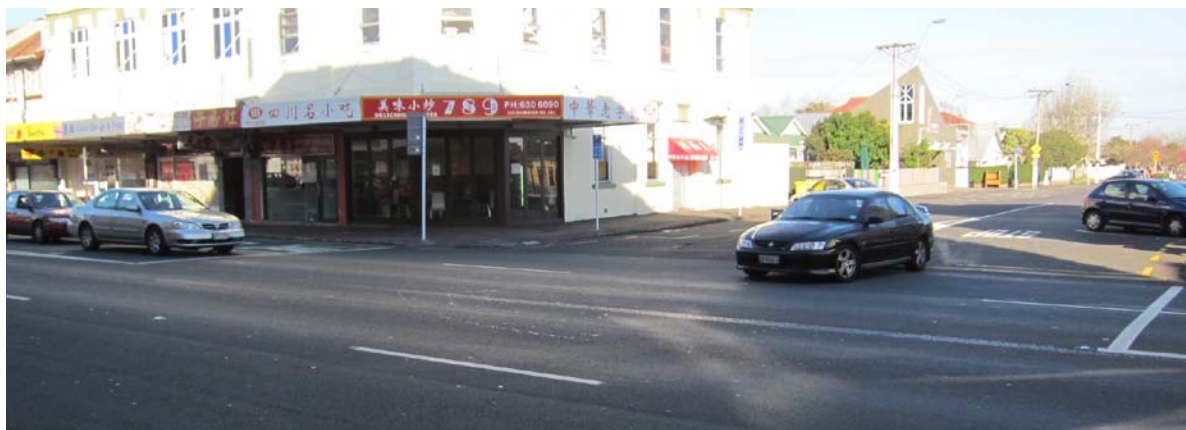
Figure 7 – Wiremu St/Dominion Rd intersection, showing holding lines to encourage better queuing behaviour

In mid-2011, an initial survey was undertaken at four Dominion Rd side street sites - one with a holding line ahead of a side street, one with holding lines on both sides of a side street (see Figure 7) and two with no treatment.

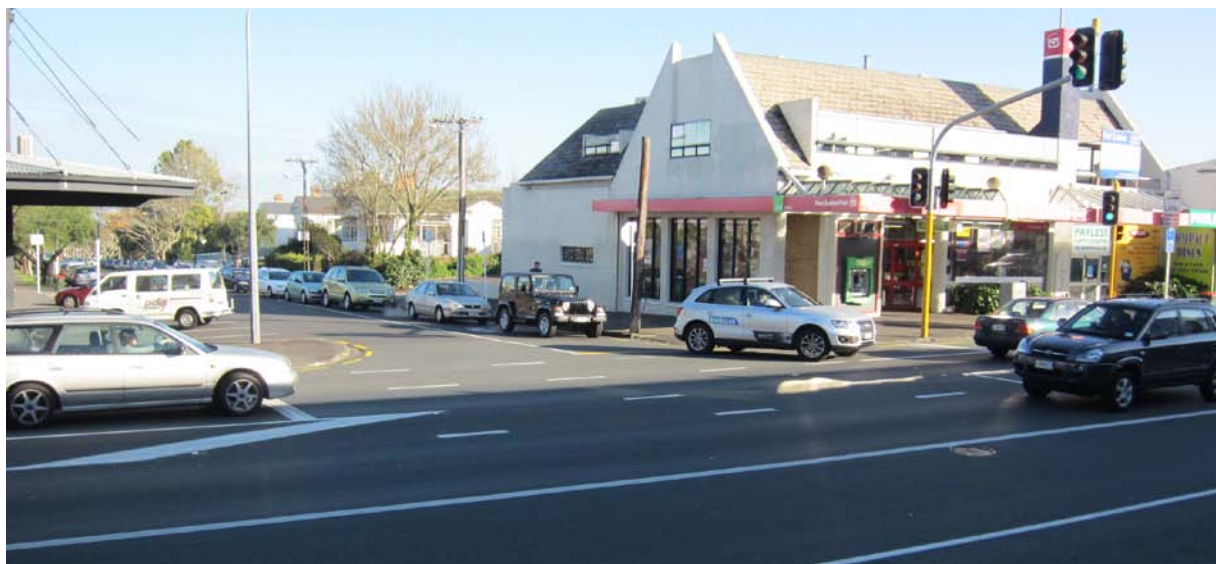
Figure 8 – King Edward St/Dominion Rd intersection - Example of a vehicle observing a holding line and providing a sufficient gap at a side street

The survey found that where a holding line was present, an average of 57% of drivers observed it, and where no holding line was present an average of 33% of drivers observed the equivalent location (see Figure 8).

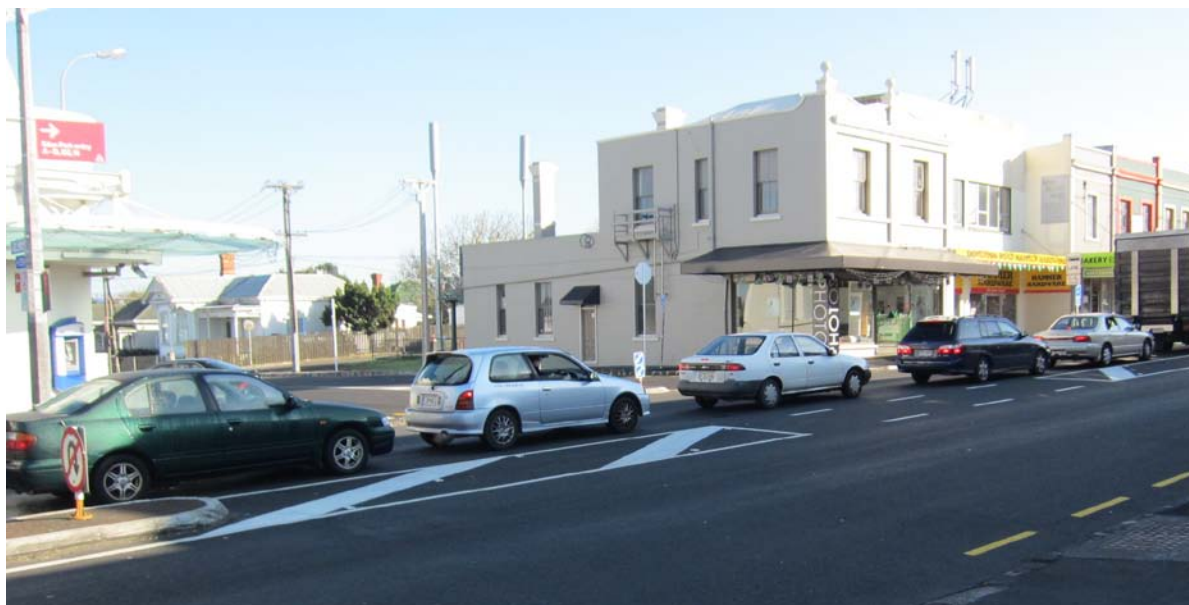
Figure 9 – Bellwood Ave/Dominion Rd intersection - Example of queued vehicles blocking a side street

Conversely, where a holding line was present, an average of 22% of drivers blocked the side street, and where no holding line was present, an average of 51% of drivers blocked the side street (see Figure 9). This indicates that if a holding line is present, more vehicles will queue in a position to provide turning side street vehicles with visibility and, without a holding line, more queuing vehicles will block the side street to turning drivers.

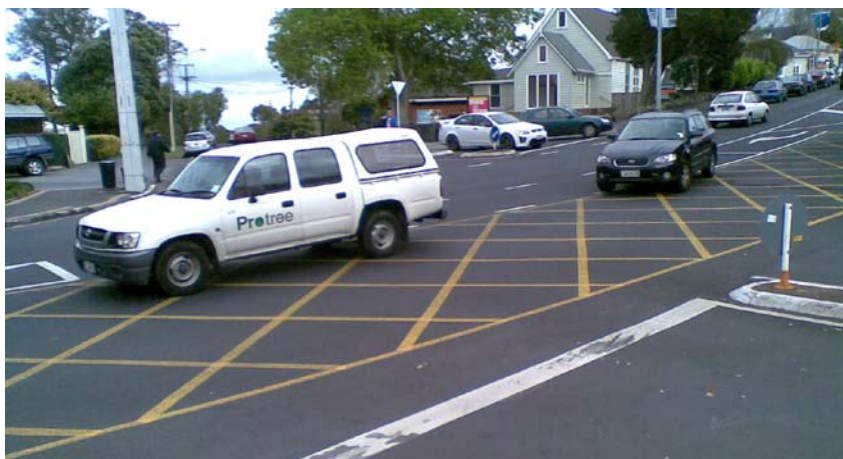
Figure 10 – Queued vehicles upon yellow hatched area

Alternatively, the application of a yellow hatched area is often used in high risk locations or sites with significant queuing issues and is likely to be effective at side streets. However, there is a higher installation and maintenance cost, a higher impact upon street amenity and as Figure 10 shows, hatching is not always effective in preventing poor queuing behaviour.

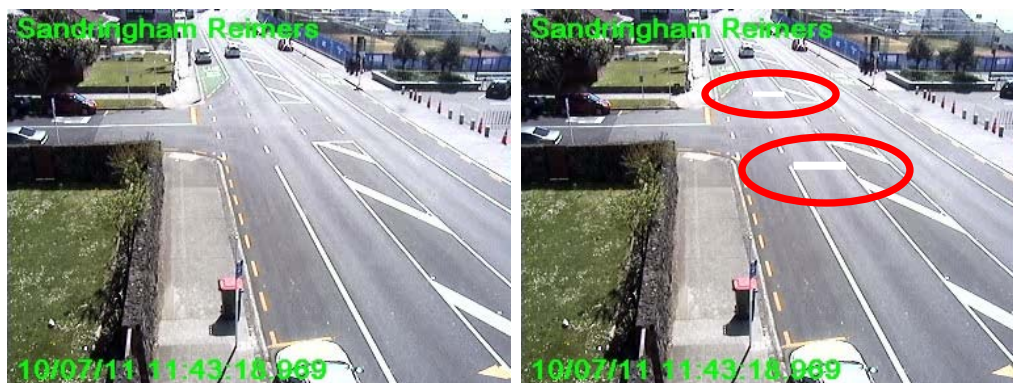
Figure 11 – Example of CCTV image from current trial site – before (left) and after proposed treatment (right)

The author is currently undertaking the 'before' assessment of queuing behaviour at a range of urban bus lane intersections, utilising Auckland Transport's CCTV cameras. It is intended that holding lines will be added in the near future, to enable post-implementation monitoring (see Figure 11 for example).
