# ASSESSMENT OF THE EFFECTIVENESS OF NARROW SEPARATORS ON CYCLE LANES

A wide variety of physical devices and delineators are available to provide separation. This research covers on-road trials of a 100 mm wide raised bicycle lane separator in Christchurch. ViaStrada was commissioned by VicRoads to design the empirical study, and evaluate and report on the findings. Christchurch City Council provided site support and Canterbury University helped to analyse the results.

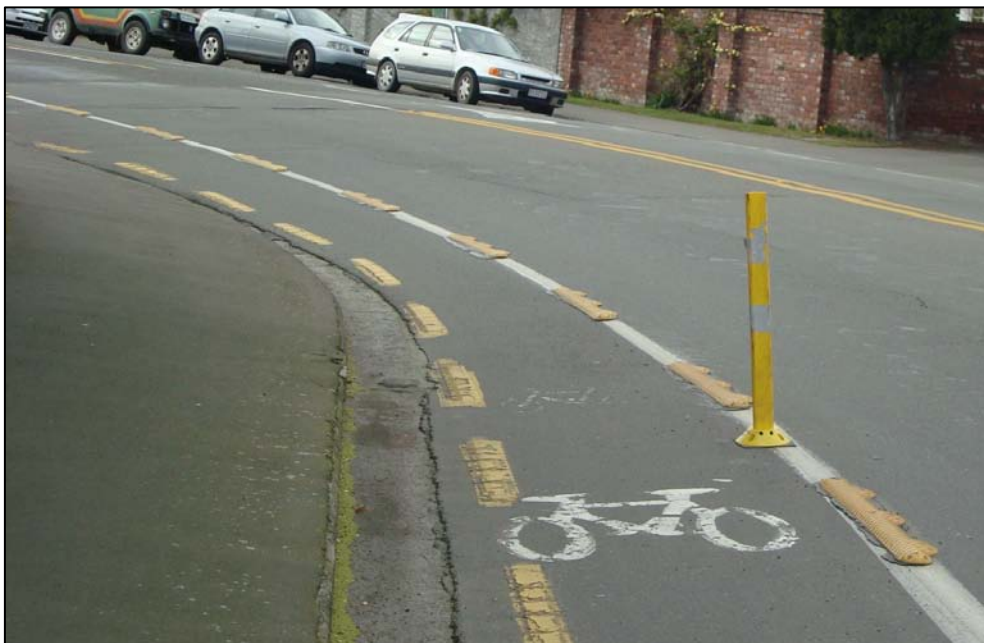
**Figure 1: Riley separators and a vertical post installed on Kotare Street cycle lane line**

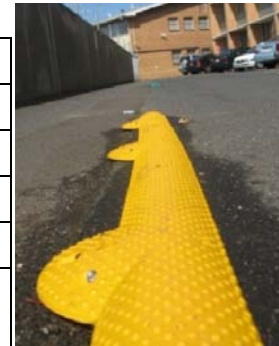
**Table 1: Characteristics of Riley Separators**

<b>Width</b>	100 mm (160 mm to bumps)
<b>Height</b>	25 mm
<b>Edge lip height</b>	2-3 mm
<b>Surface</b>	Moulded pimples rising approx. 2 mm above surface
<b>Reflectors</b>	Small reflectors moulded into leading edges
<b>Comments</b>	1.2 m long sections; may be installed with a gap for drainage and cyclist entry/exit.

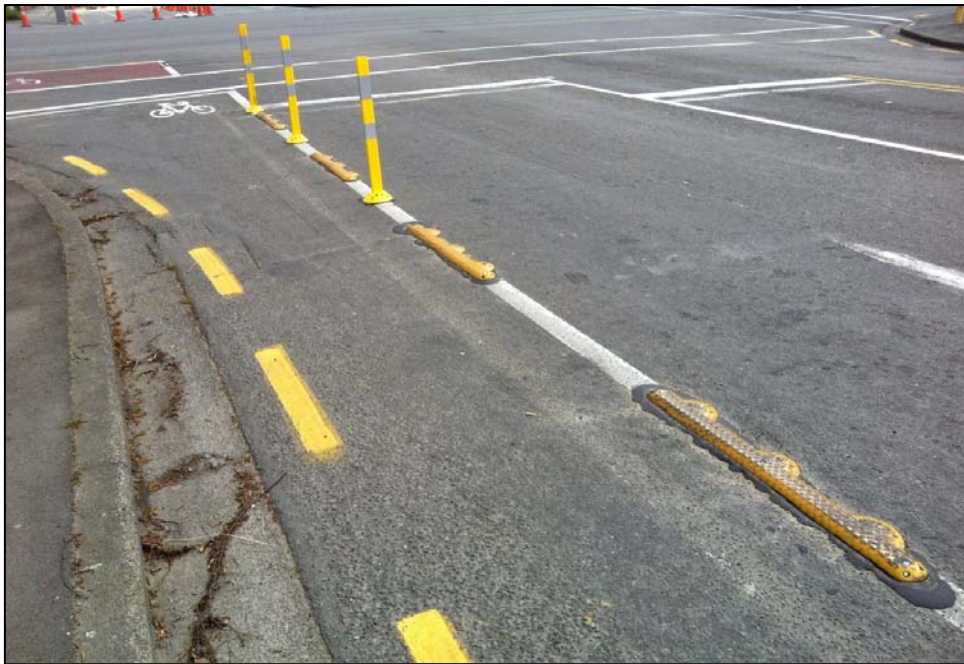
**Figure 2: Strickland Street Riley separators and posts approaching intersection**

After implementing the separators on Strickland Street, their position was re-evaluated. The result was a slight shift of the separators to their current position on top of the existing cycle lane marking. However, the initial post-implementation survey made clear that many motorists were still ignoring the separators. Three flexible posts were subsequently installed to physically underline the separation between cyclists and motor vehicles (see Figure 2) and a third video survey was collected.

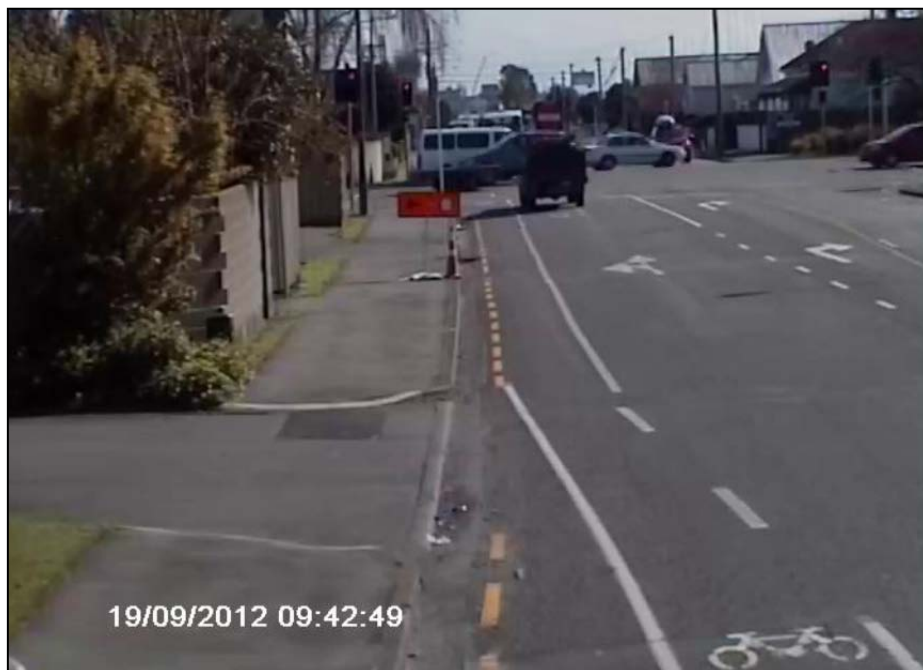
**Figure 3: Camera angle, first post-implementation survey (Strickland Street)**

The first survey was observed from a side-on position that provided good detail at the intersection, but little about the approach. During the first post-implementation survey, the position of the observation vehicle was changed to get a better impression of the queuing behaviour of approaching vehicles (see Figure 3). While the categorisation of driver behaviour remained unchanged, the cyclist waiting area was not clearly visible and, often, the encroachment level of vehicles in this area had to be guessed.

For the second post-implementation survey, the position of the observation vehicle remained the same as during the first post-implementation survey. However, the camera angle was zoomed slightly closer to the intersection to get a better view on the separators.

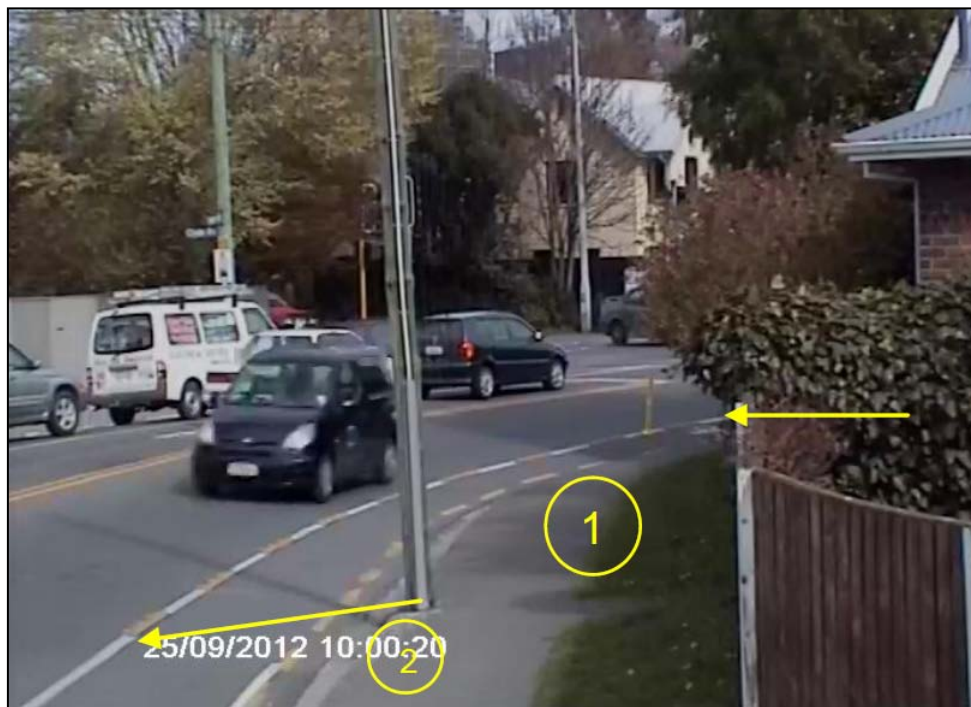
Figure 4: Kotare Street encroachment zones as viewed from camera

During the pre-implementation video evaluation, the research area was split up in three sections. Section 1 covered the length of the separators, Section 2 extended from the end of the separators a similar distance downstream, and Section 3 continued beyond that. During the post-implementation survey, the camera angle mostly focused on Section 1 (see Figure 4). Therefore, the remaining two sections were combined into one.

Vehicle movements were categorised as fully or partly encroaching into any of these sections. Motor vehicles were rated as fully encroaching, when they were taking all space from cyclists. If motor vehicles entered the cycle lane with one wheel or drove on the cycle lane marking, they were categorised as partly encroaching.

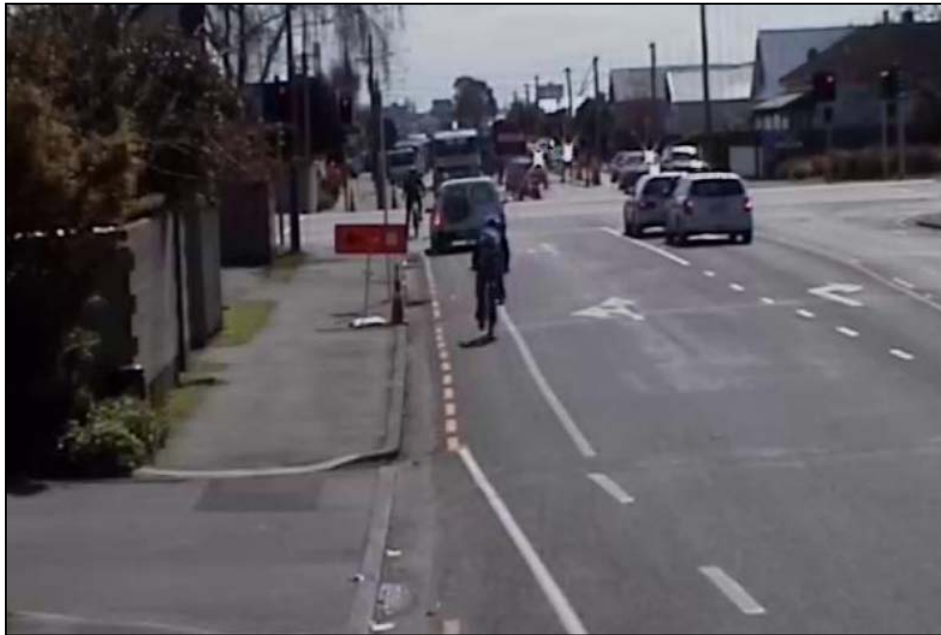
**Figure 5: Full encroaching motor vehicles while cyclists present (Strickland Street)**

Two thirds of the left-turning motor vehicles were encroaching into the cycle lane while the traffic signals were red (see Figure 5). Vehicles entering the cycle lane partly, while they were waiting for signal changing, form the second largest group. The minority of all left-turning vehicles did not enter the cycle lane during the red signal phase. The same was noticed for the green phase, where 3/4 of the left-turning traffic encroached into the cycle lane completely.

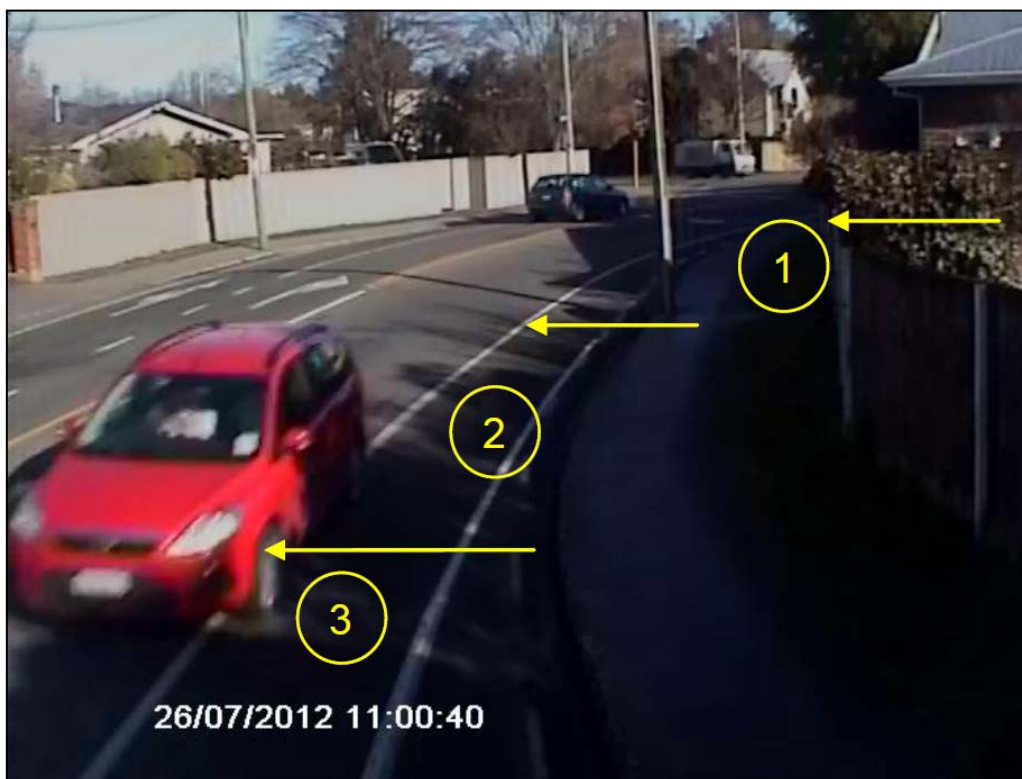
Figure 6: Partly encroaching motor vehicle in Section 2+3 (Kotare Street)

During the survey period on 26 July 2012, over 2500 motor vehicles were observed. Over half of the vehicles did not encroach into the cycle lane at any time while driving along Kotare Street. Motorists entering the cycle lane were most likely to encroach into only one of the three sections, although encroachments of two or three sections were also reasonably prevalent (see Figure 6).

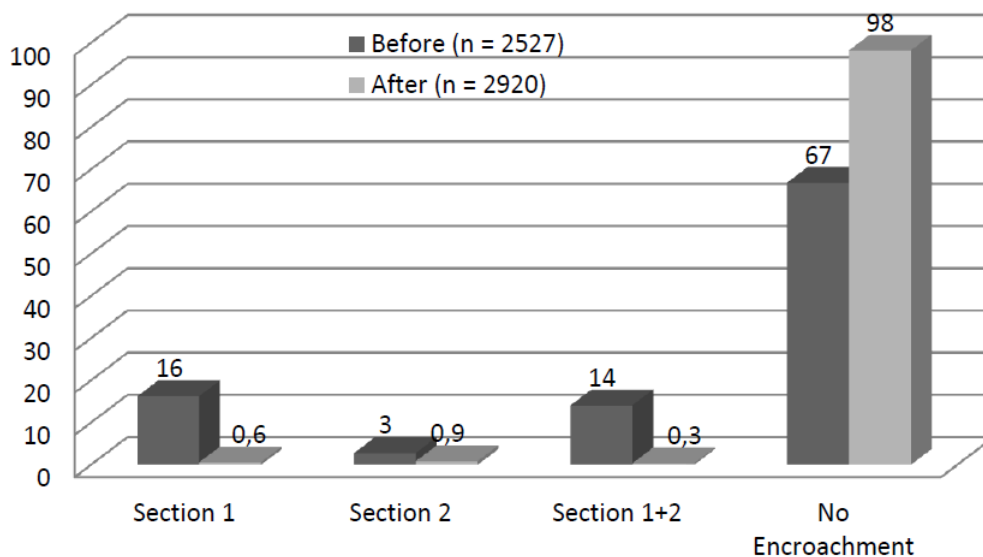
**Figure 8: Before/After: driver behaviour change (Kotare Street)**

As seen in Figure 10, implementing separators and a flexible post on Kotare Street led to a near-elimination of encroachment. This underlines the effectiveness of the treatment at mid-block area. A minority still encroached into the cycle lane, but was significantly reduced compared to the pre-implementation survey results.

The Chi-Square test was used to analyse the statistical significance of the implementation of cycle lane separators and a flexible post on Kotare Street, in terms of encroaching vehicles compared to not encroaching vehicles. With one degree of freedom, the Chi-Square test statistic of  $X^2=974.3$  indicates a high statistical significance of the evaluated behaviour change ( $p<0.005$ ). This result underlines the impression that combining cycle lane separators and flexible posts is effective to prevent motorists encroaching into on-street cycle lanes in mid-block areas.
