## Wide Centreline

State Highway 1 North of Huntly

25 March 2014

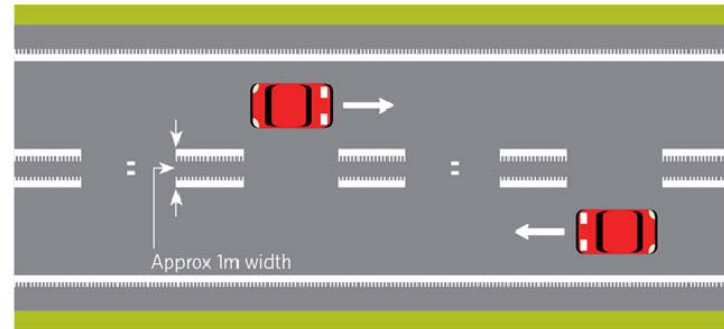
## Wide Centreline Layout

Overtaking permitted when safe to do so

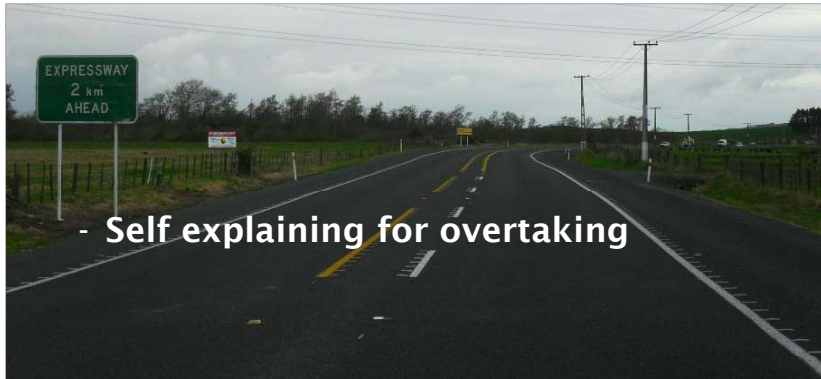
- Self explaining for overtaking

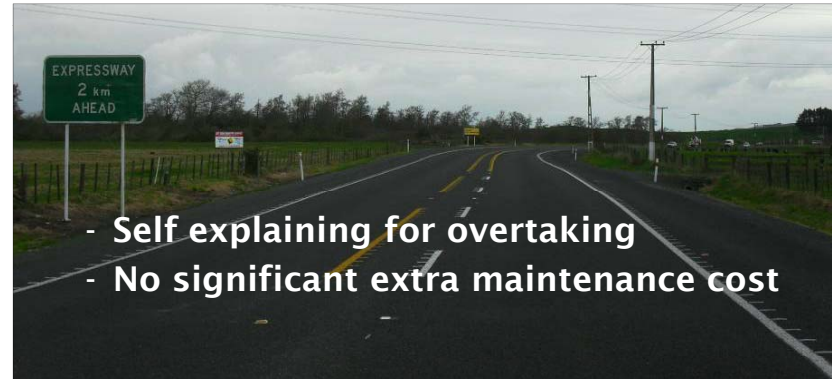
- Self explaining for overtaking  
- No significant extra maintenance cost

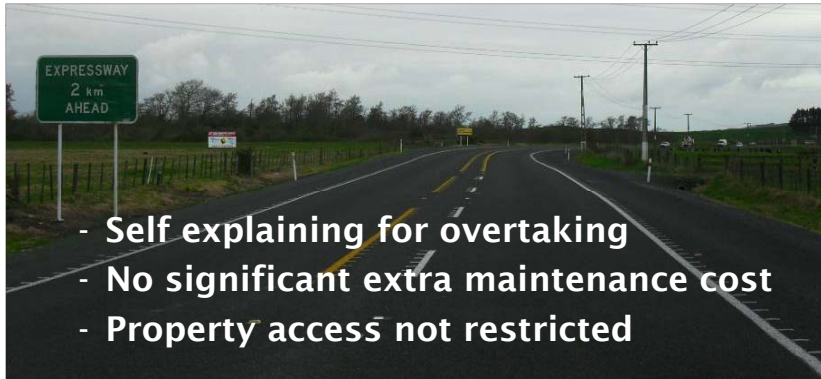
- Self explaining for overtaking
- No significant extra maintenance cost
- Property access not restricted

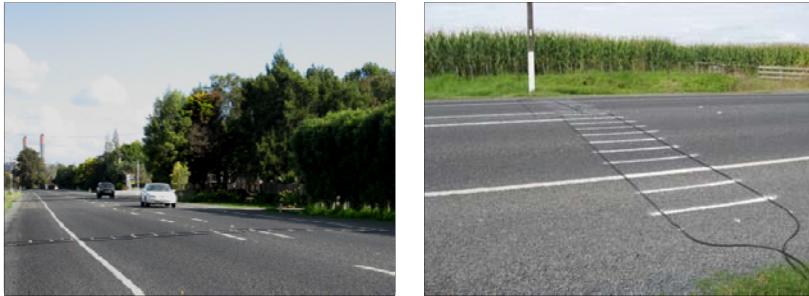
## Evaluation

- No significant change in traffic speeds.
- Traffic is travelling on average 0.15m further from the centre of the road.
- Crash rate for all fatal and serious injury crashes has reduced by 32% for all sites up to September 2013.
- Only one recorded fatal or serious head-on crash at a wide centreline site to date.
- Forty nine people who had driven through a wide centreline site were surveyed and 71% thought it was safer, 19% thought it was less safe, and 10% thought it was the same or were not sure.
