- Reducing injury on all legs of PT Journeys

Bill Frith, Opus Research
Margaret Trotter, Opus Research
Joel Burton, Opus Research

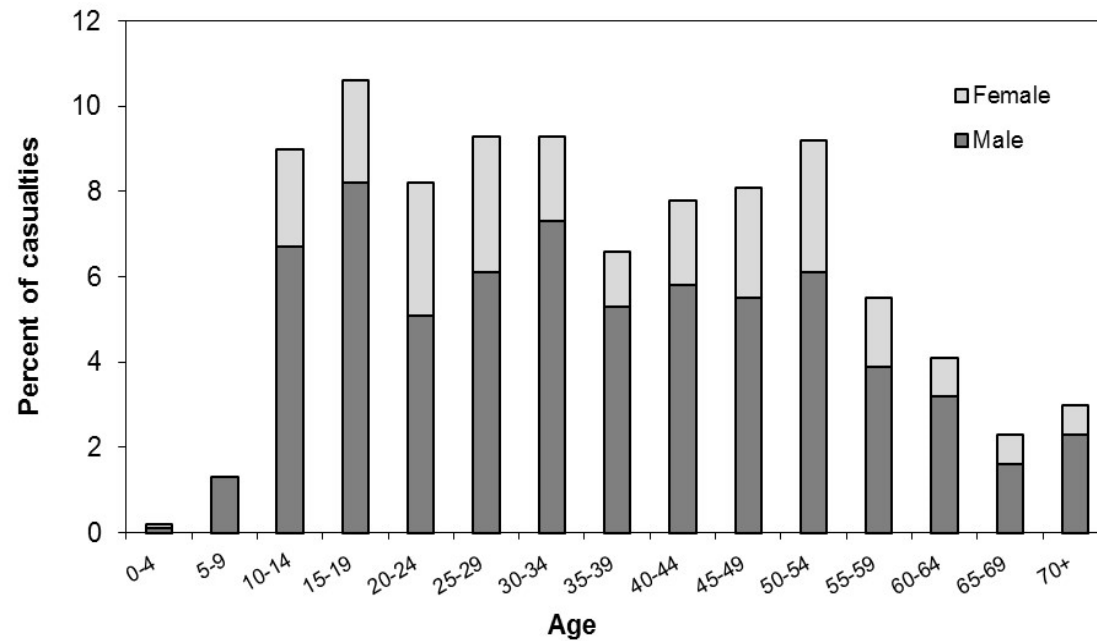
• Cyclist injuries

- Non-motor vehicle related cycling injuries by age and gender- Source MoT from hospital admissions data.

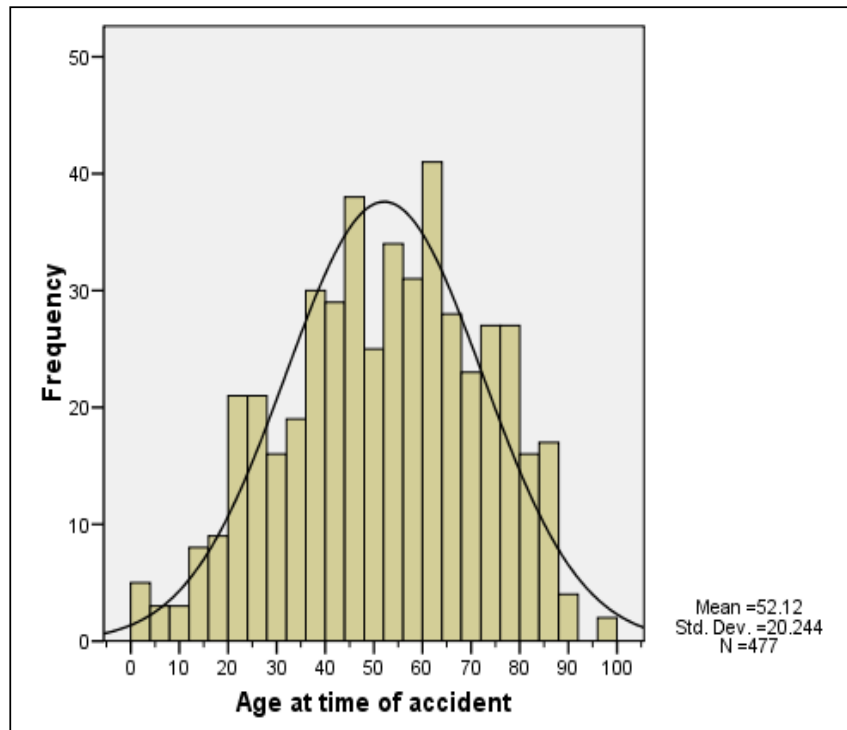
Study results

- As expected, the sample was age-biased.
- Percentage of sample 64+ was 29%, while the estimated population percentage 65+ was 13%.
- This relates to increased pedestrian fragility with age.

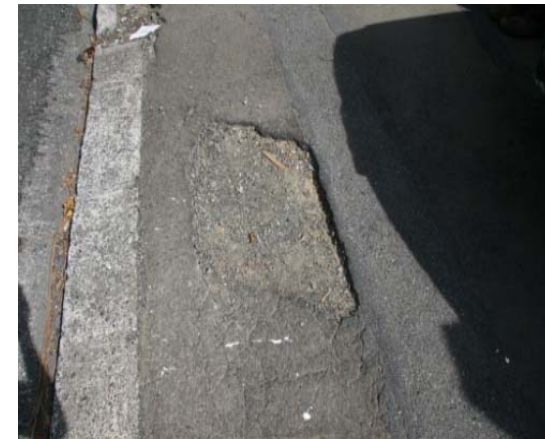
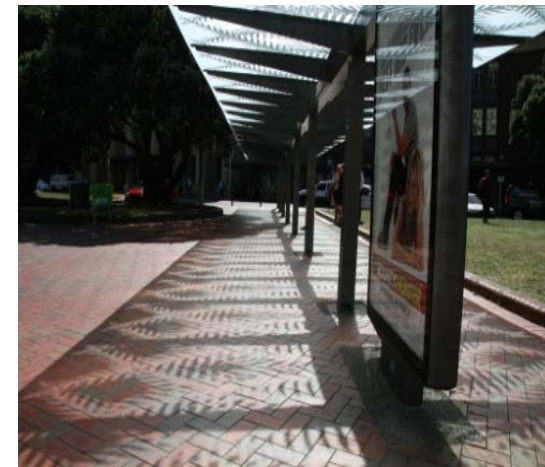
- Poorly maintained surfaces are ranked as a more persistent cause of accidents than design issues.
- Poor maintenance includes:
 - Uneven construction (e.g. cracks)
 - Temporary deterioration
- Design issues include:
 - Vertical changes (e.g. kerbs), particularly when stepping up (as opposed to down)
 - Slippery surfaces

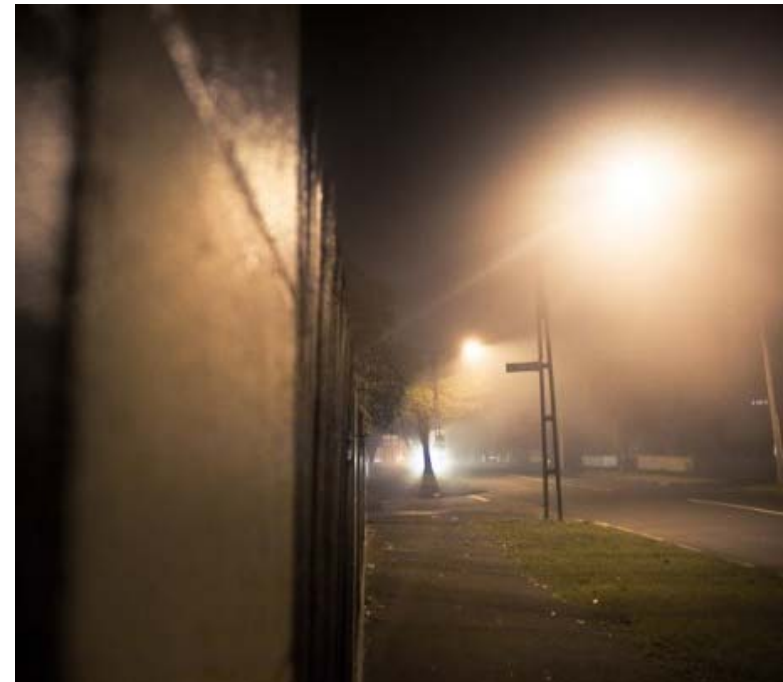
- 13% of accidents occurred where lighting is perceived to be poor.
- These were overwhelmingly in artificially lit areas.
- Indicates that:
 - Current artificial lighting may not always be adequate.
 - Possible hazards may need to be “flagged” in some way if they cannot be removed.

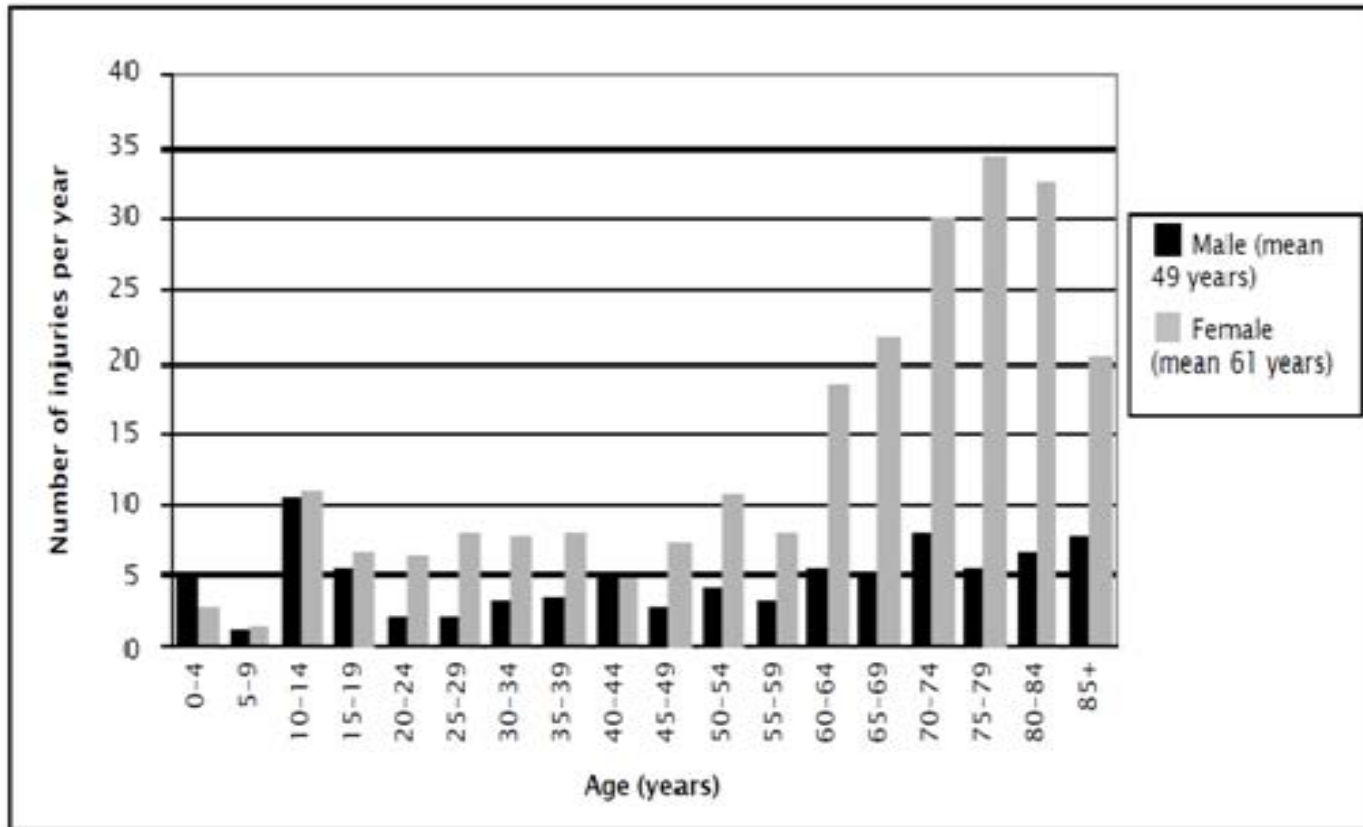
Non-crash injuries on London buses

Age/gender in non- collision bus injuries in Britain from 1994 to 1998
