# Where the streets have no name

**Fiji Transport Corridor Studies 2016**  
**Chris Baker, Transport Engineer, WSP Opus**

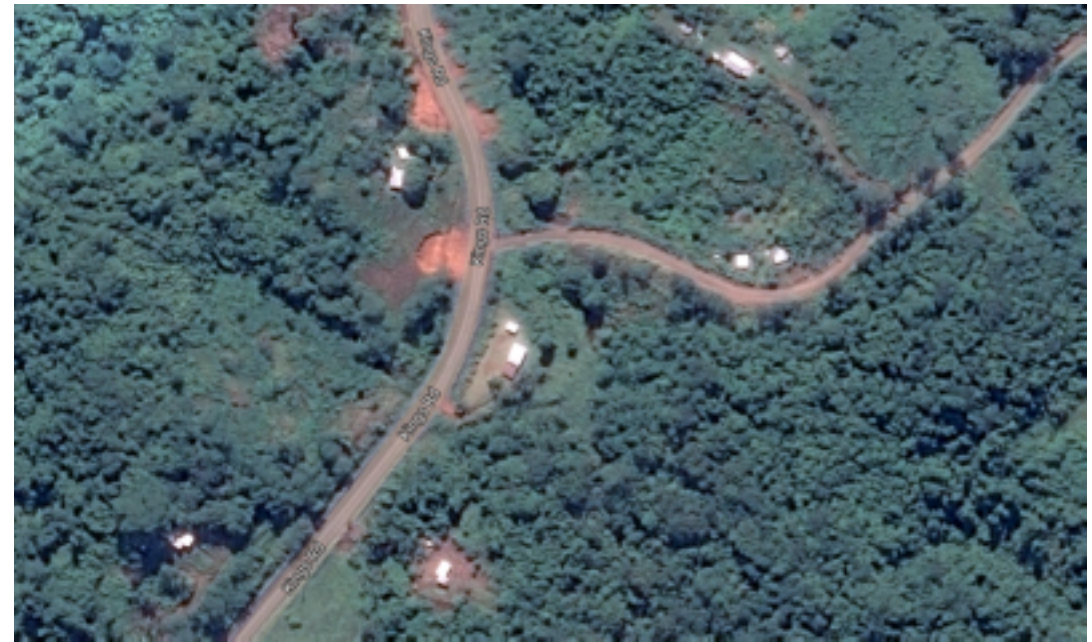
2008 Count

Kings/Namara Rd Junction						OK		
	A		B		C		DEC_76A	DEC_76B	DEC_76C
	↑	↗	↖	↗	↖	↑	A	B	C
MCycles	0	0	0	0	0	0	0	0	0
Cars&Taxis	92	5	8	1	1	98	203	15	192
Vans & 4x4	222	5	7	3	1	227	461	16	453
Light Trucks	46	4	5	0	0	41	96	9	87
Medium Trucks	21	1	3	0	0	26	51	4	47
Heavy Trucks	48	0	0	0	0	27	75	0	75
Buses	30	1	1	0	0	28	60	2	58
Total	459	16	24	4	2	447	946	46	912

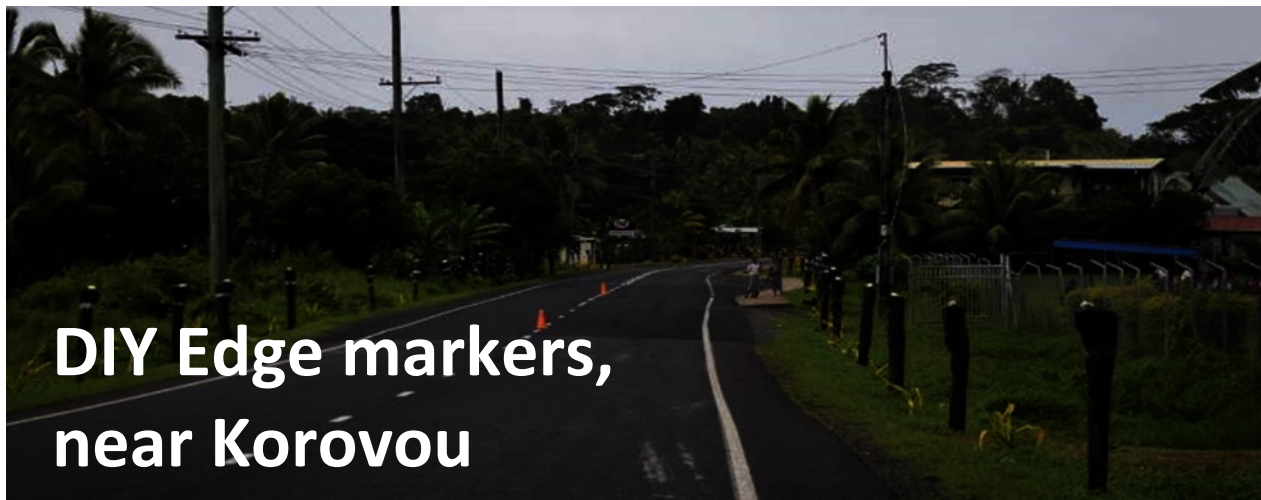
**DIY Edge markers,  
near Korovou**
