Tamaki Drive Cycle Route

“Shaping Tamaki Drive for the Future”

Transportation Group Conference 2021

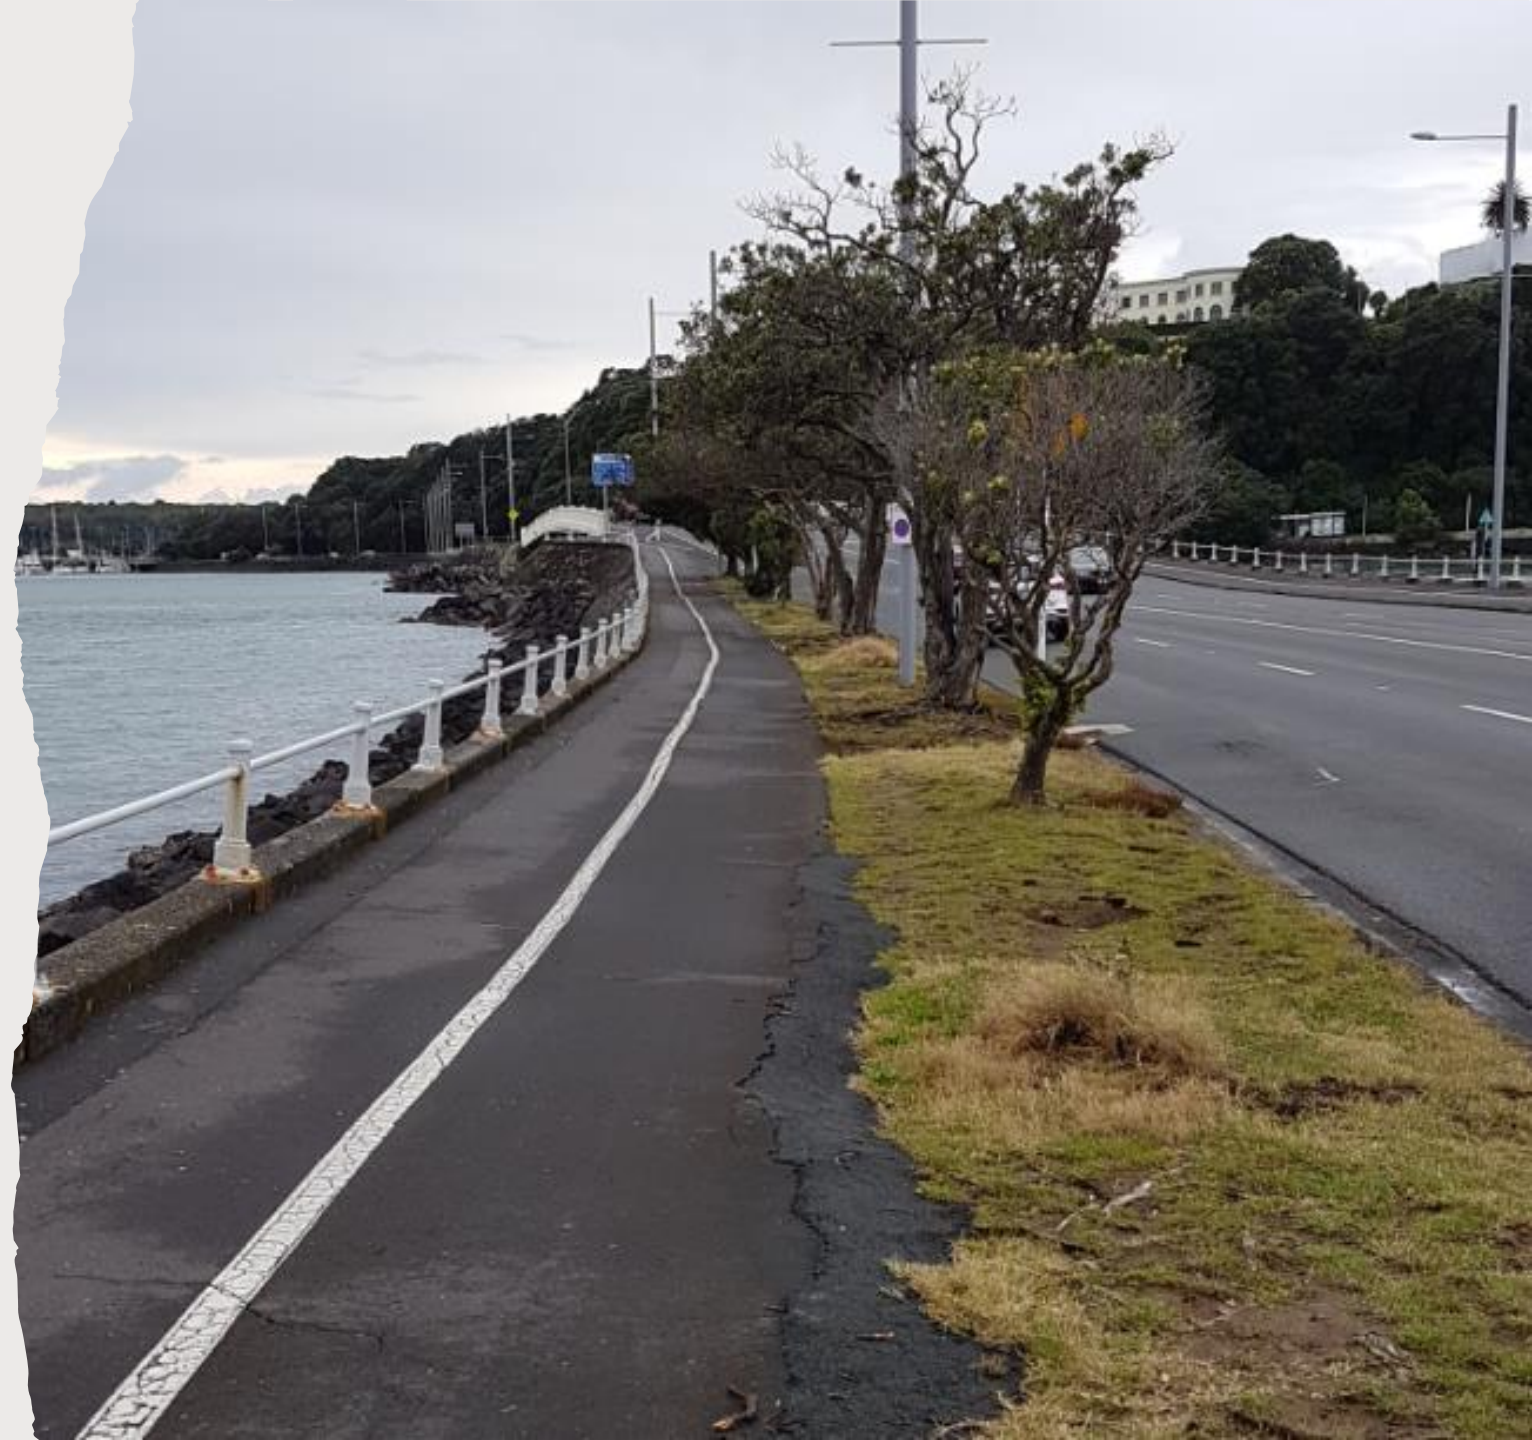
- Inadequate cycling facility to cater for 1,500 cyclist trips per day (on average) plus pedestrians
- Corridor unable to meet demand to meet safety, amenity, and performance needs of users
- Lower level of service compared to other cycleways nearby
- Arterial road carrying over 30,000 vehicles per day

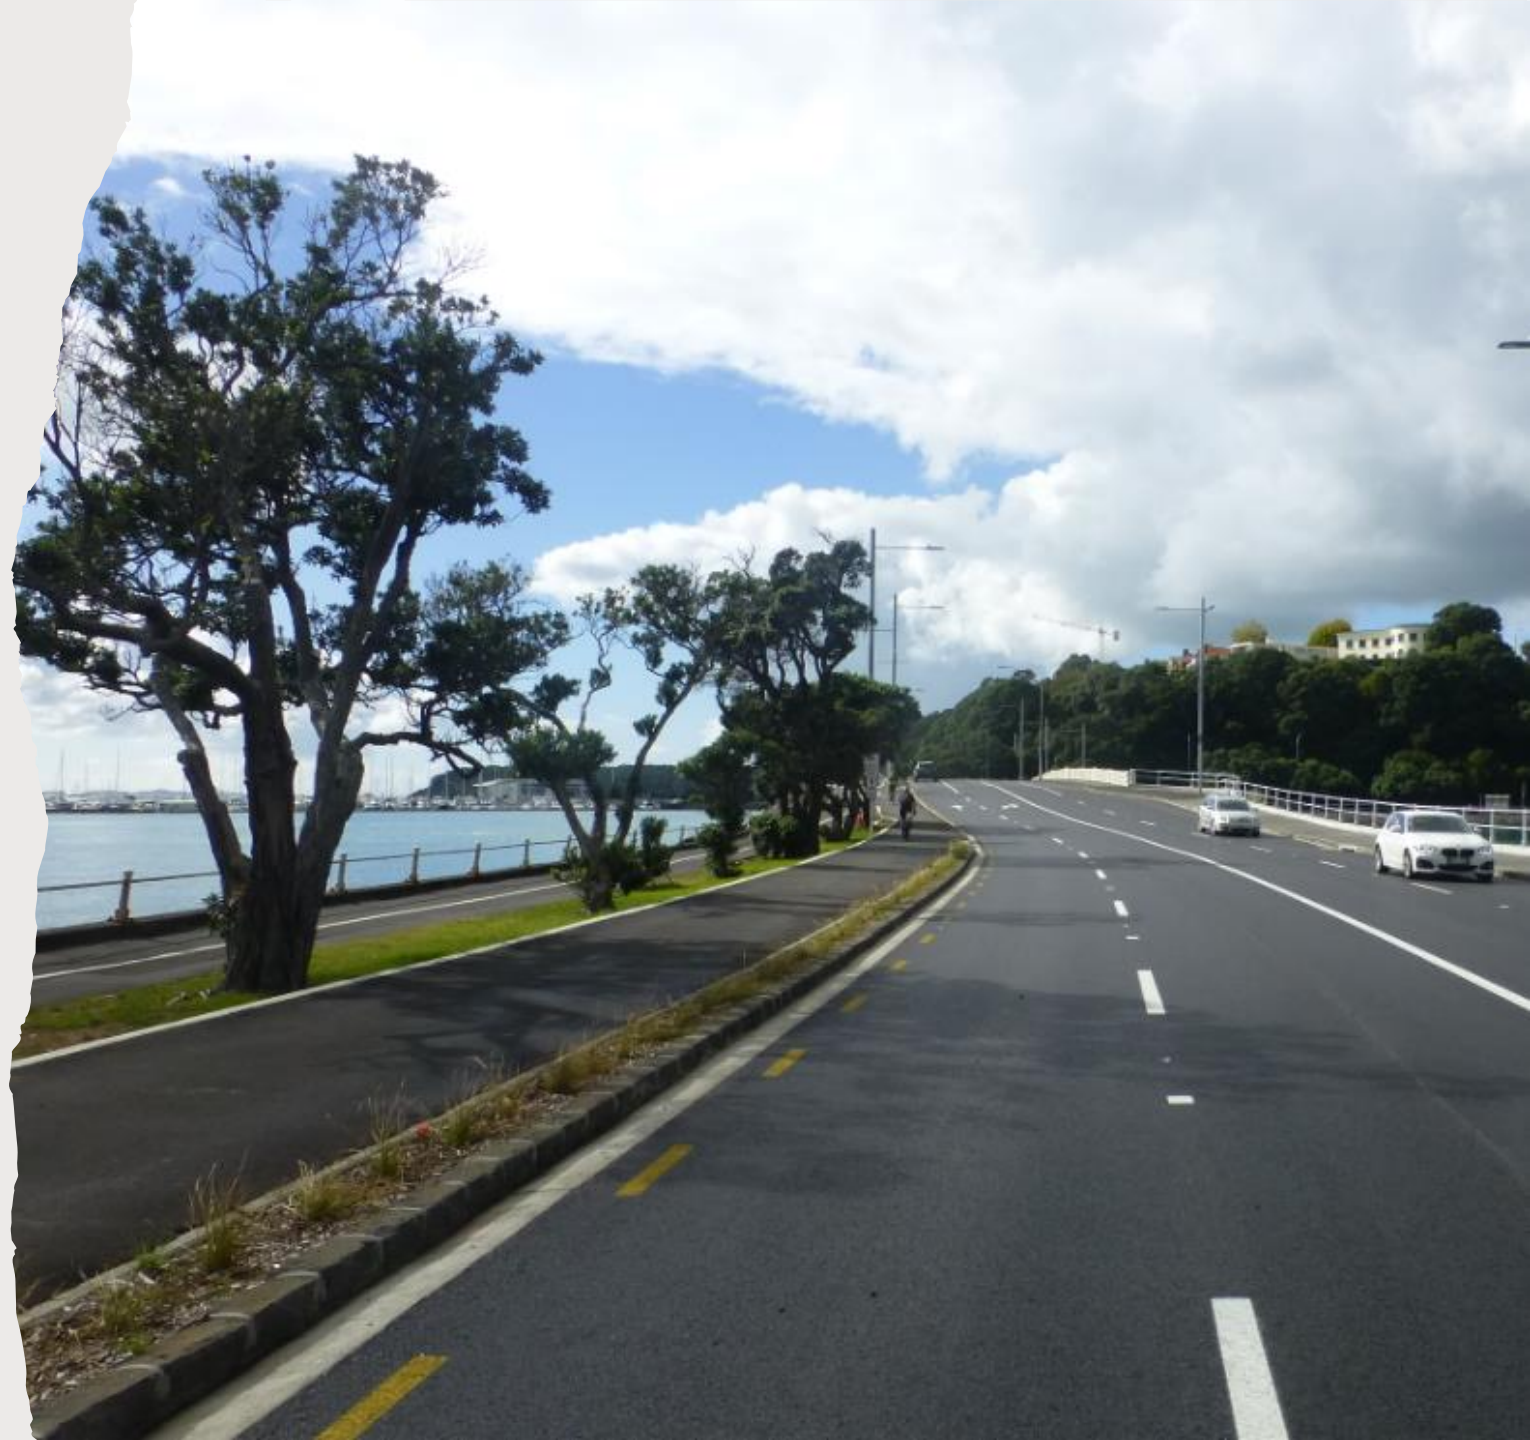
2.4km long cycleway
(extension of the existing
cycleway from Quay Street
to Ngapipi Bridge)

Intersection
Improvements

New Pt
Resolution
Footbridge

Coastal Resilience
Improvements (raising the
road by up to 0.5m in two
locations)

Road widening on the
southern side

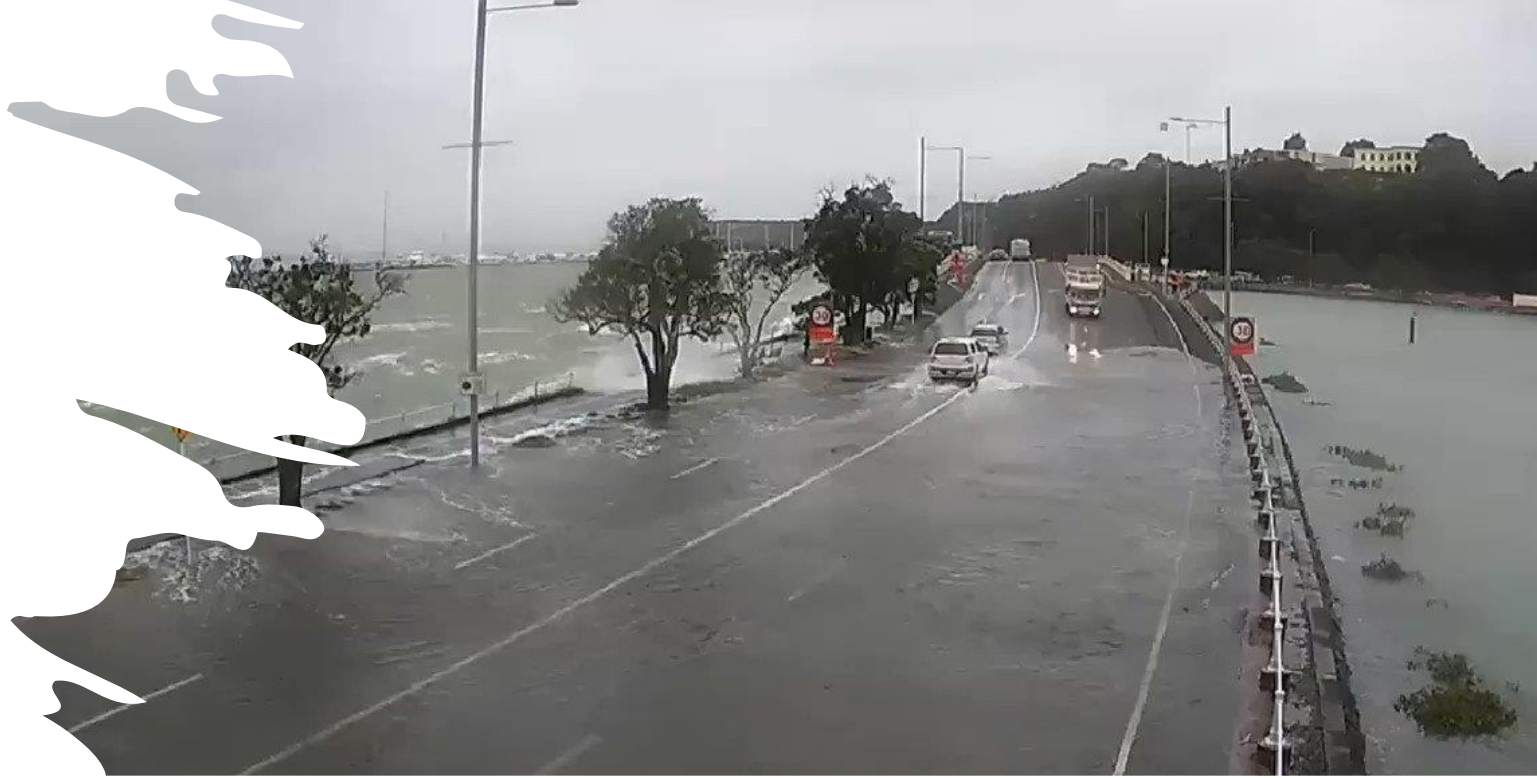
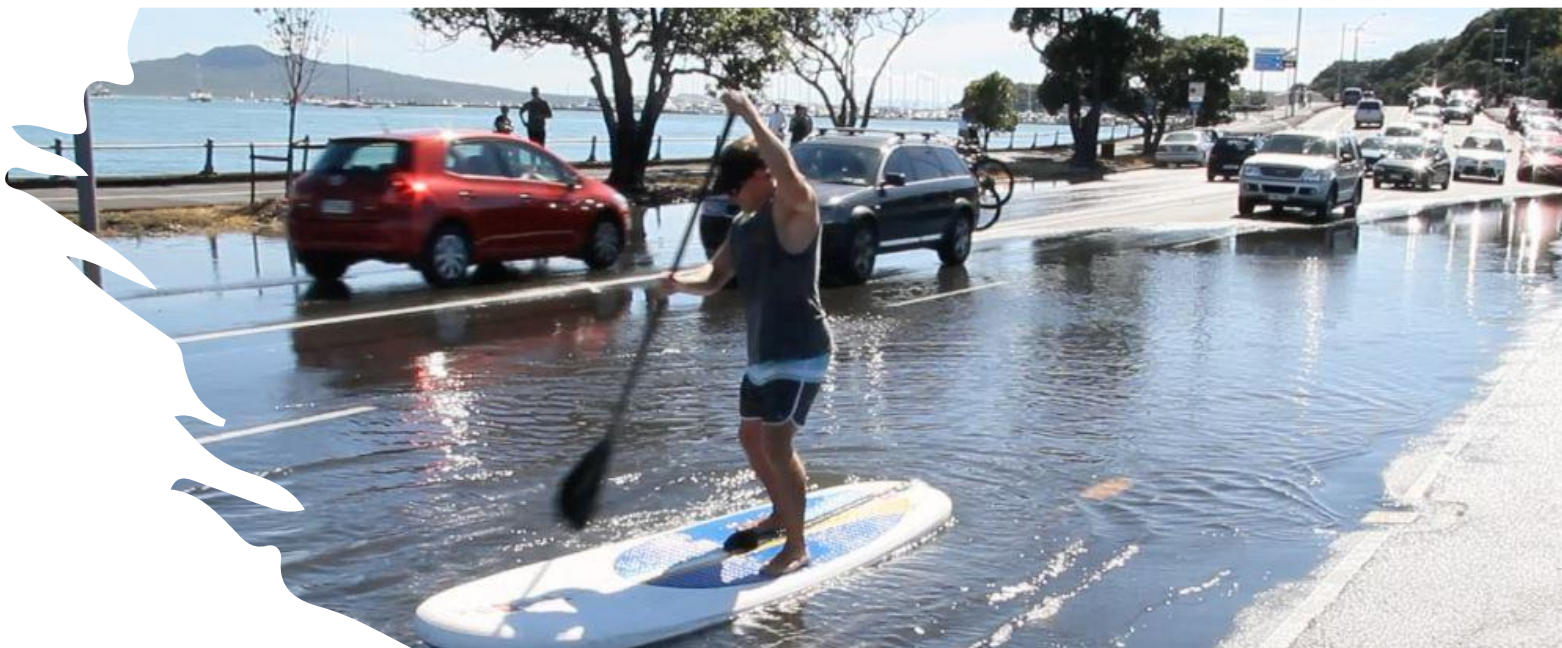
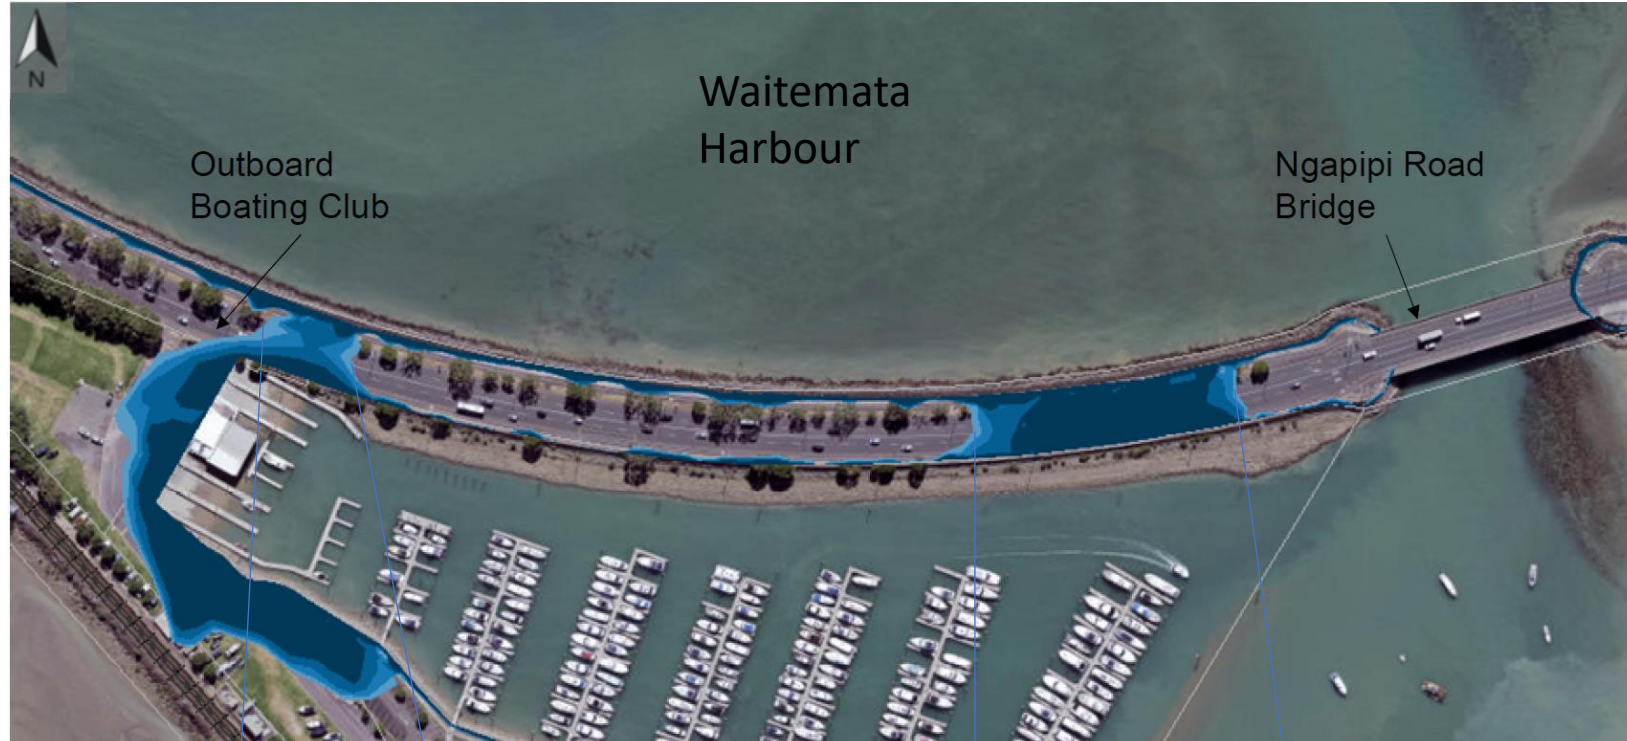
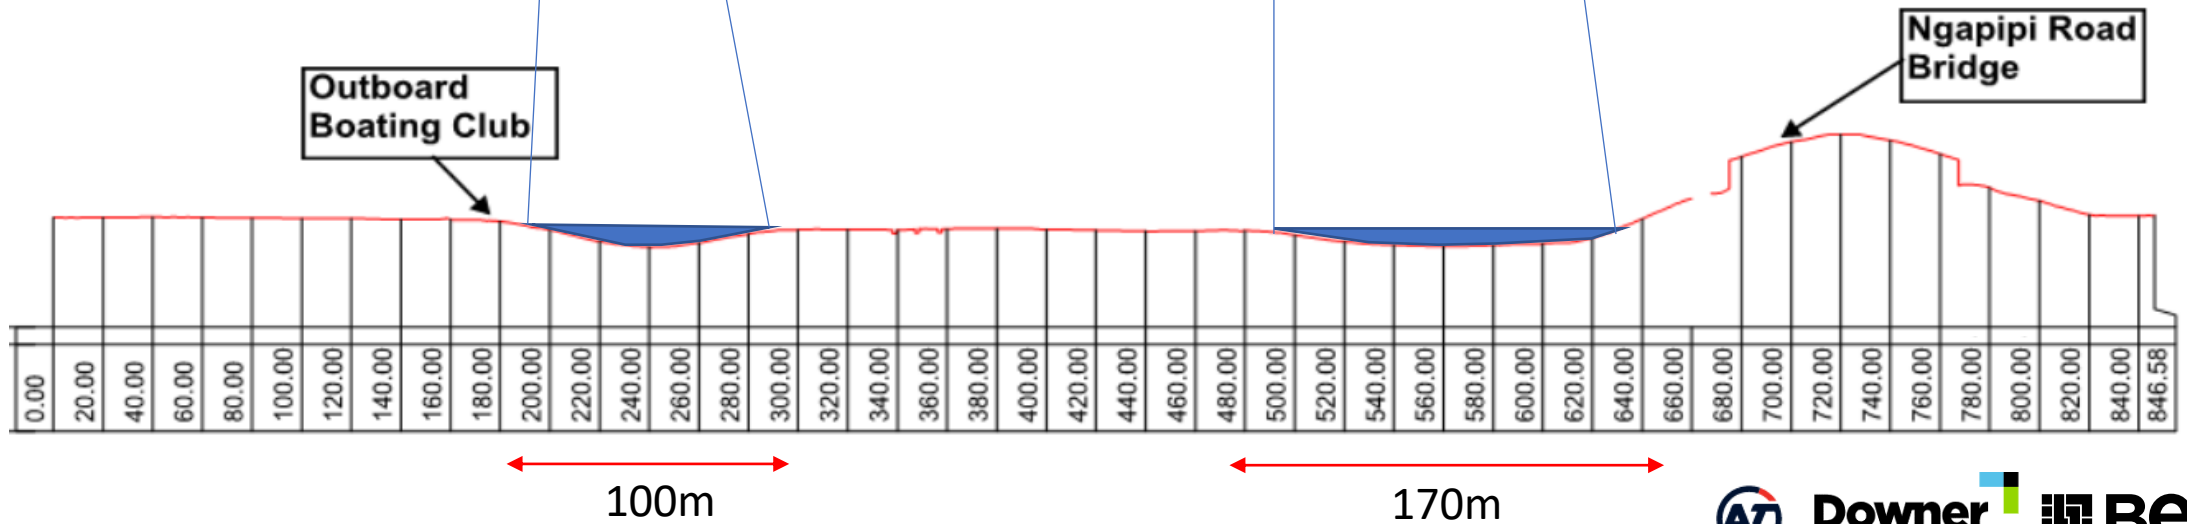
Coastal Resilience – the Problem

- Partially closed approximately 6 times per year
- Fully closed once per year due to tides
- Fully closed every second year in a storm event
- Duration of closures is between 1.5-3.0 hours

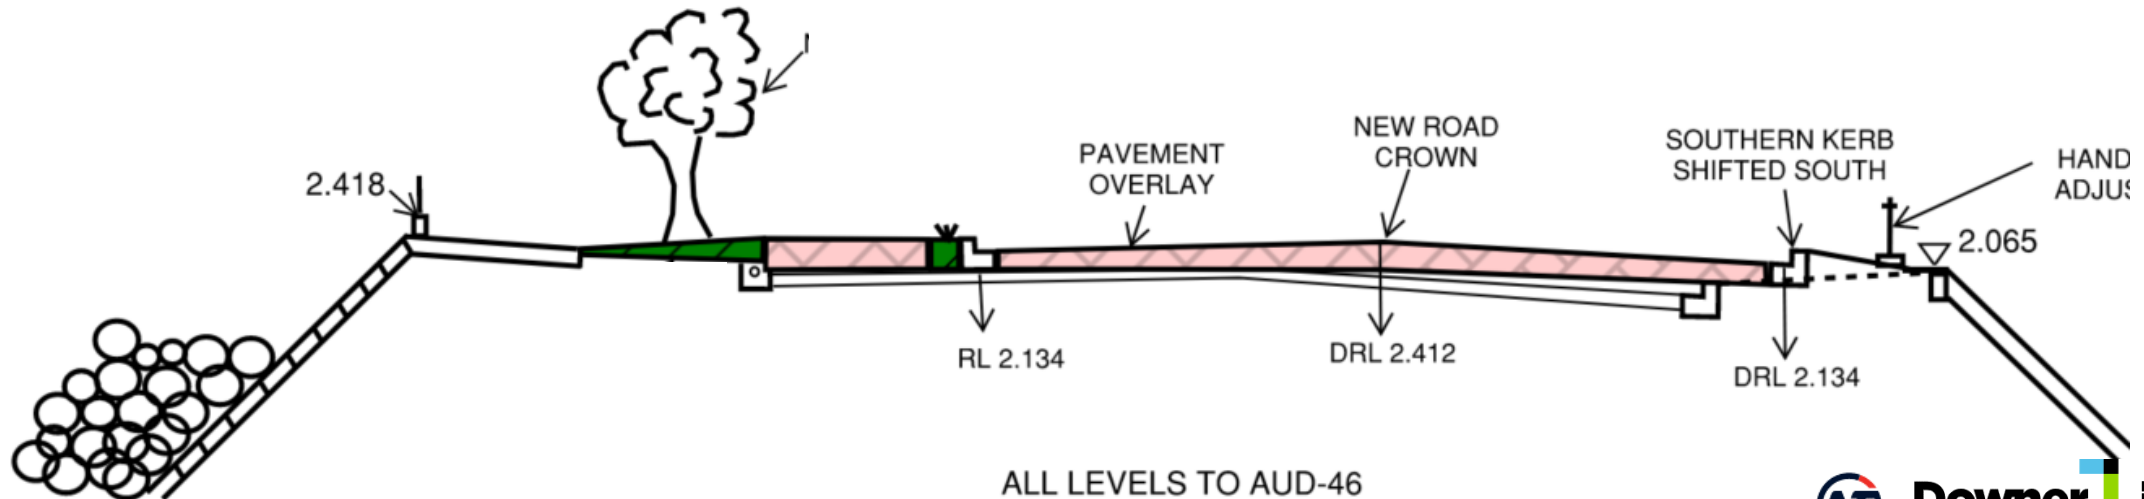
Preferred Solution - Raise road as far as practical

Lift the road within the existing kerbs lines

Catchpit levels will be raised

Existing seawalls and Pohutukawa Trees remain

Reduce the impact of the still water sea level inundation the road

ALL LEVELS TO AUD-46

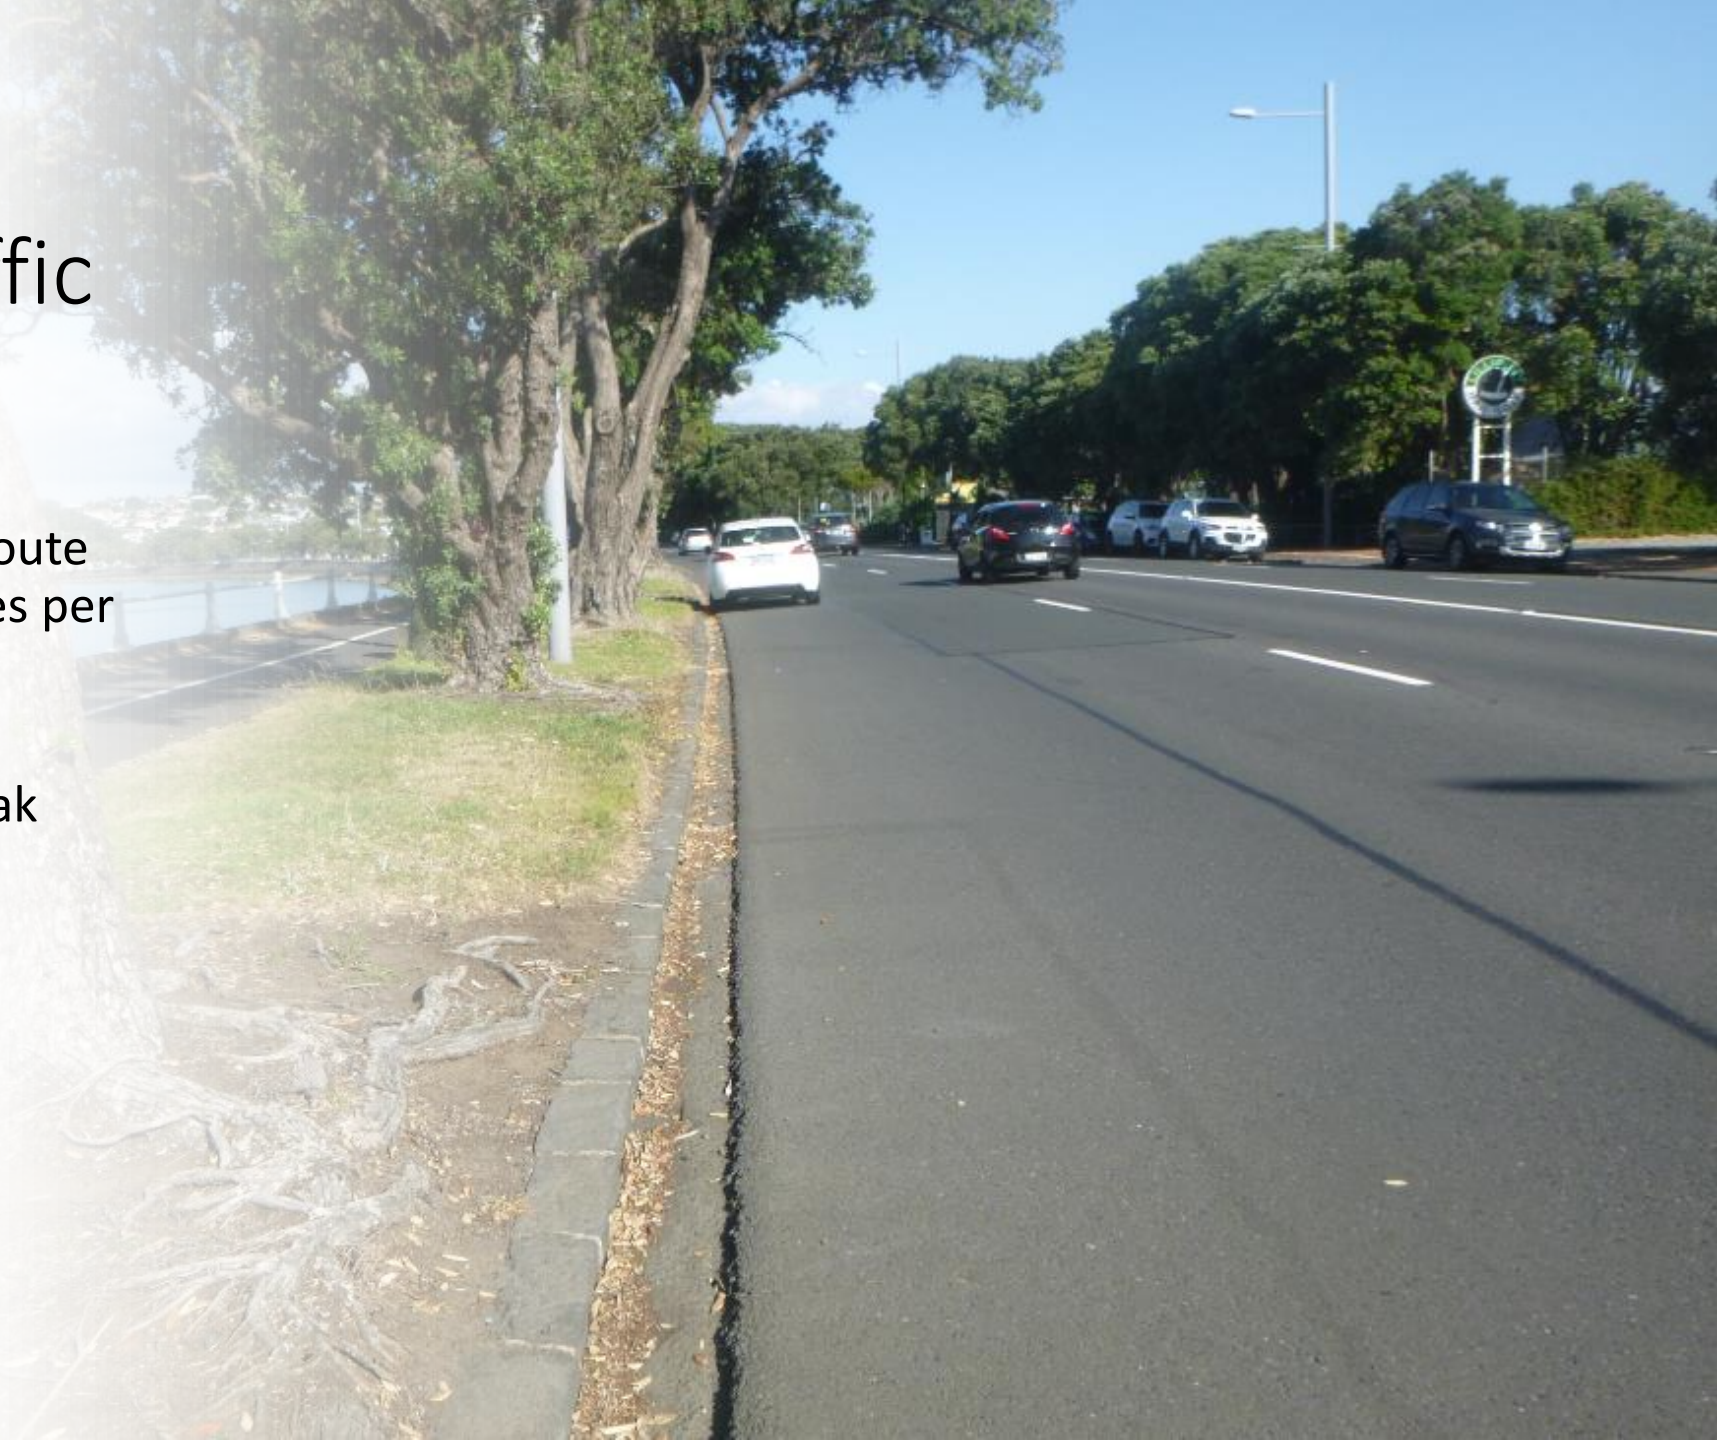
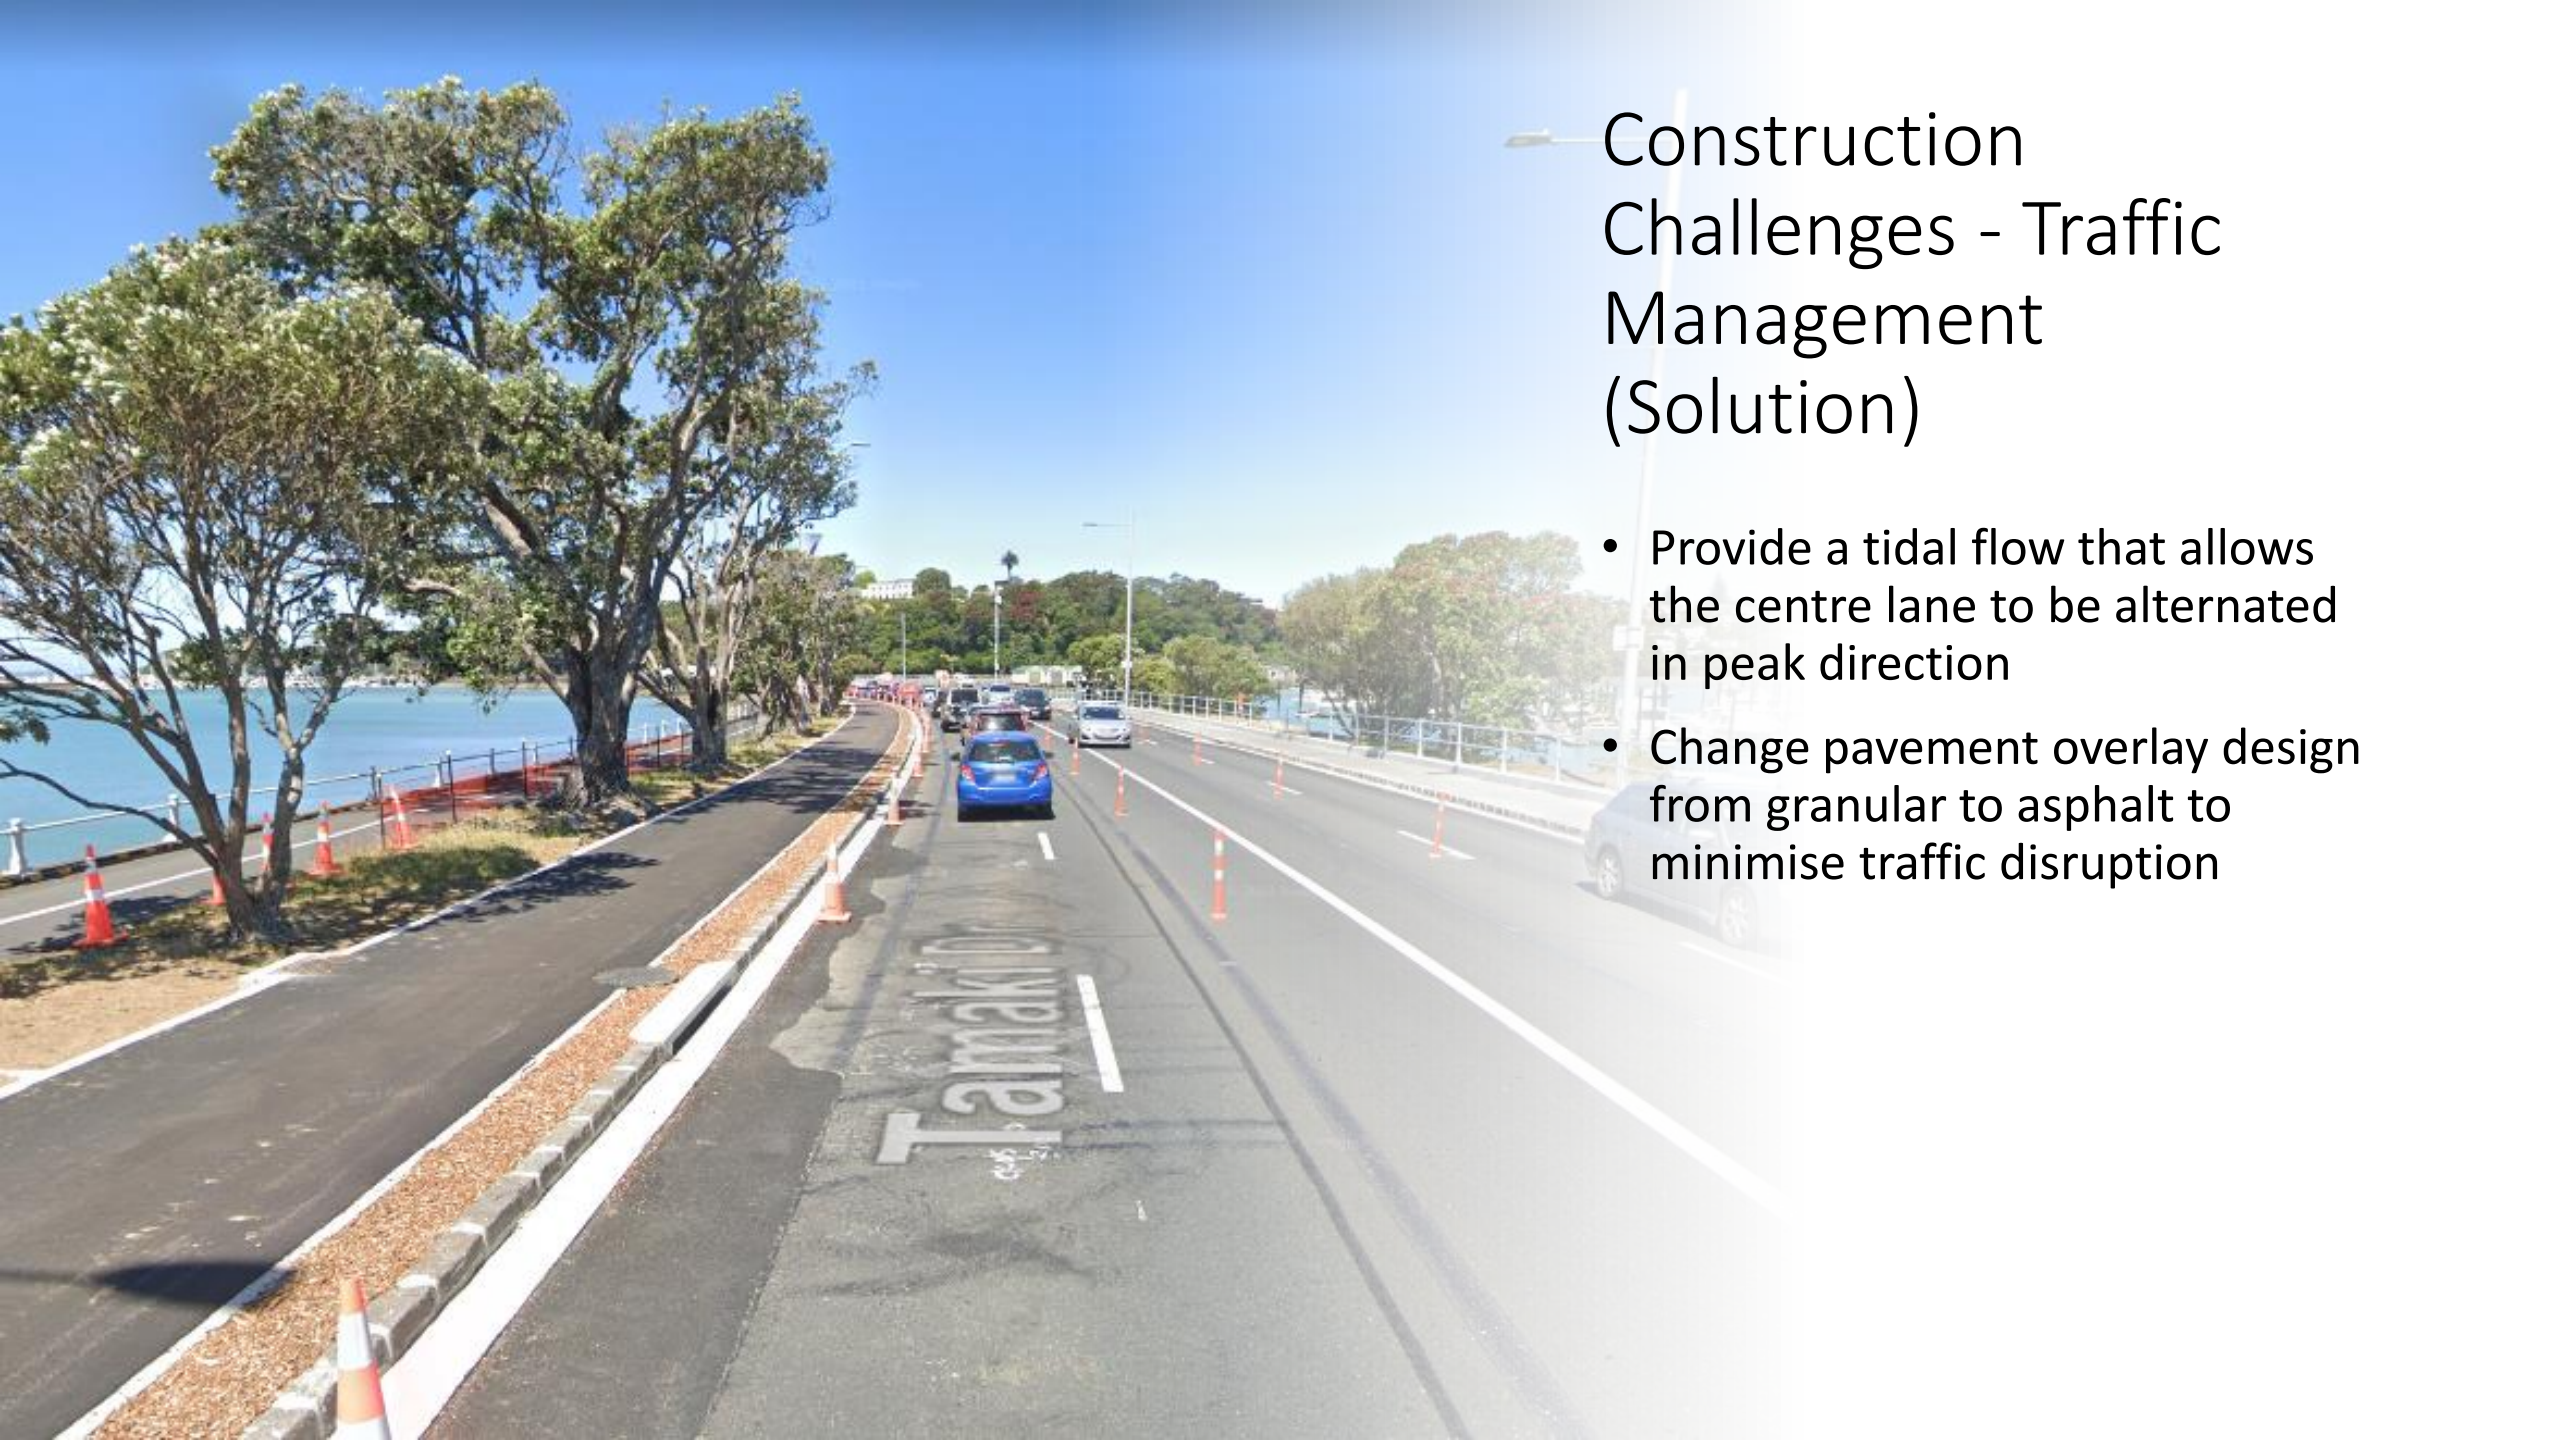
Construction Challenges - Traffic Management

- Tamaki Drive is an arterial route carrying over 30,000 vehicles per day
- 3 lanes therefore must be maintained open during peak periods
- Long-disruption to traffic anticipated at the start
- Heavy freight route

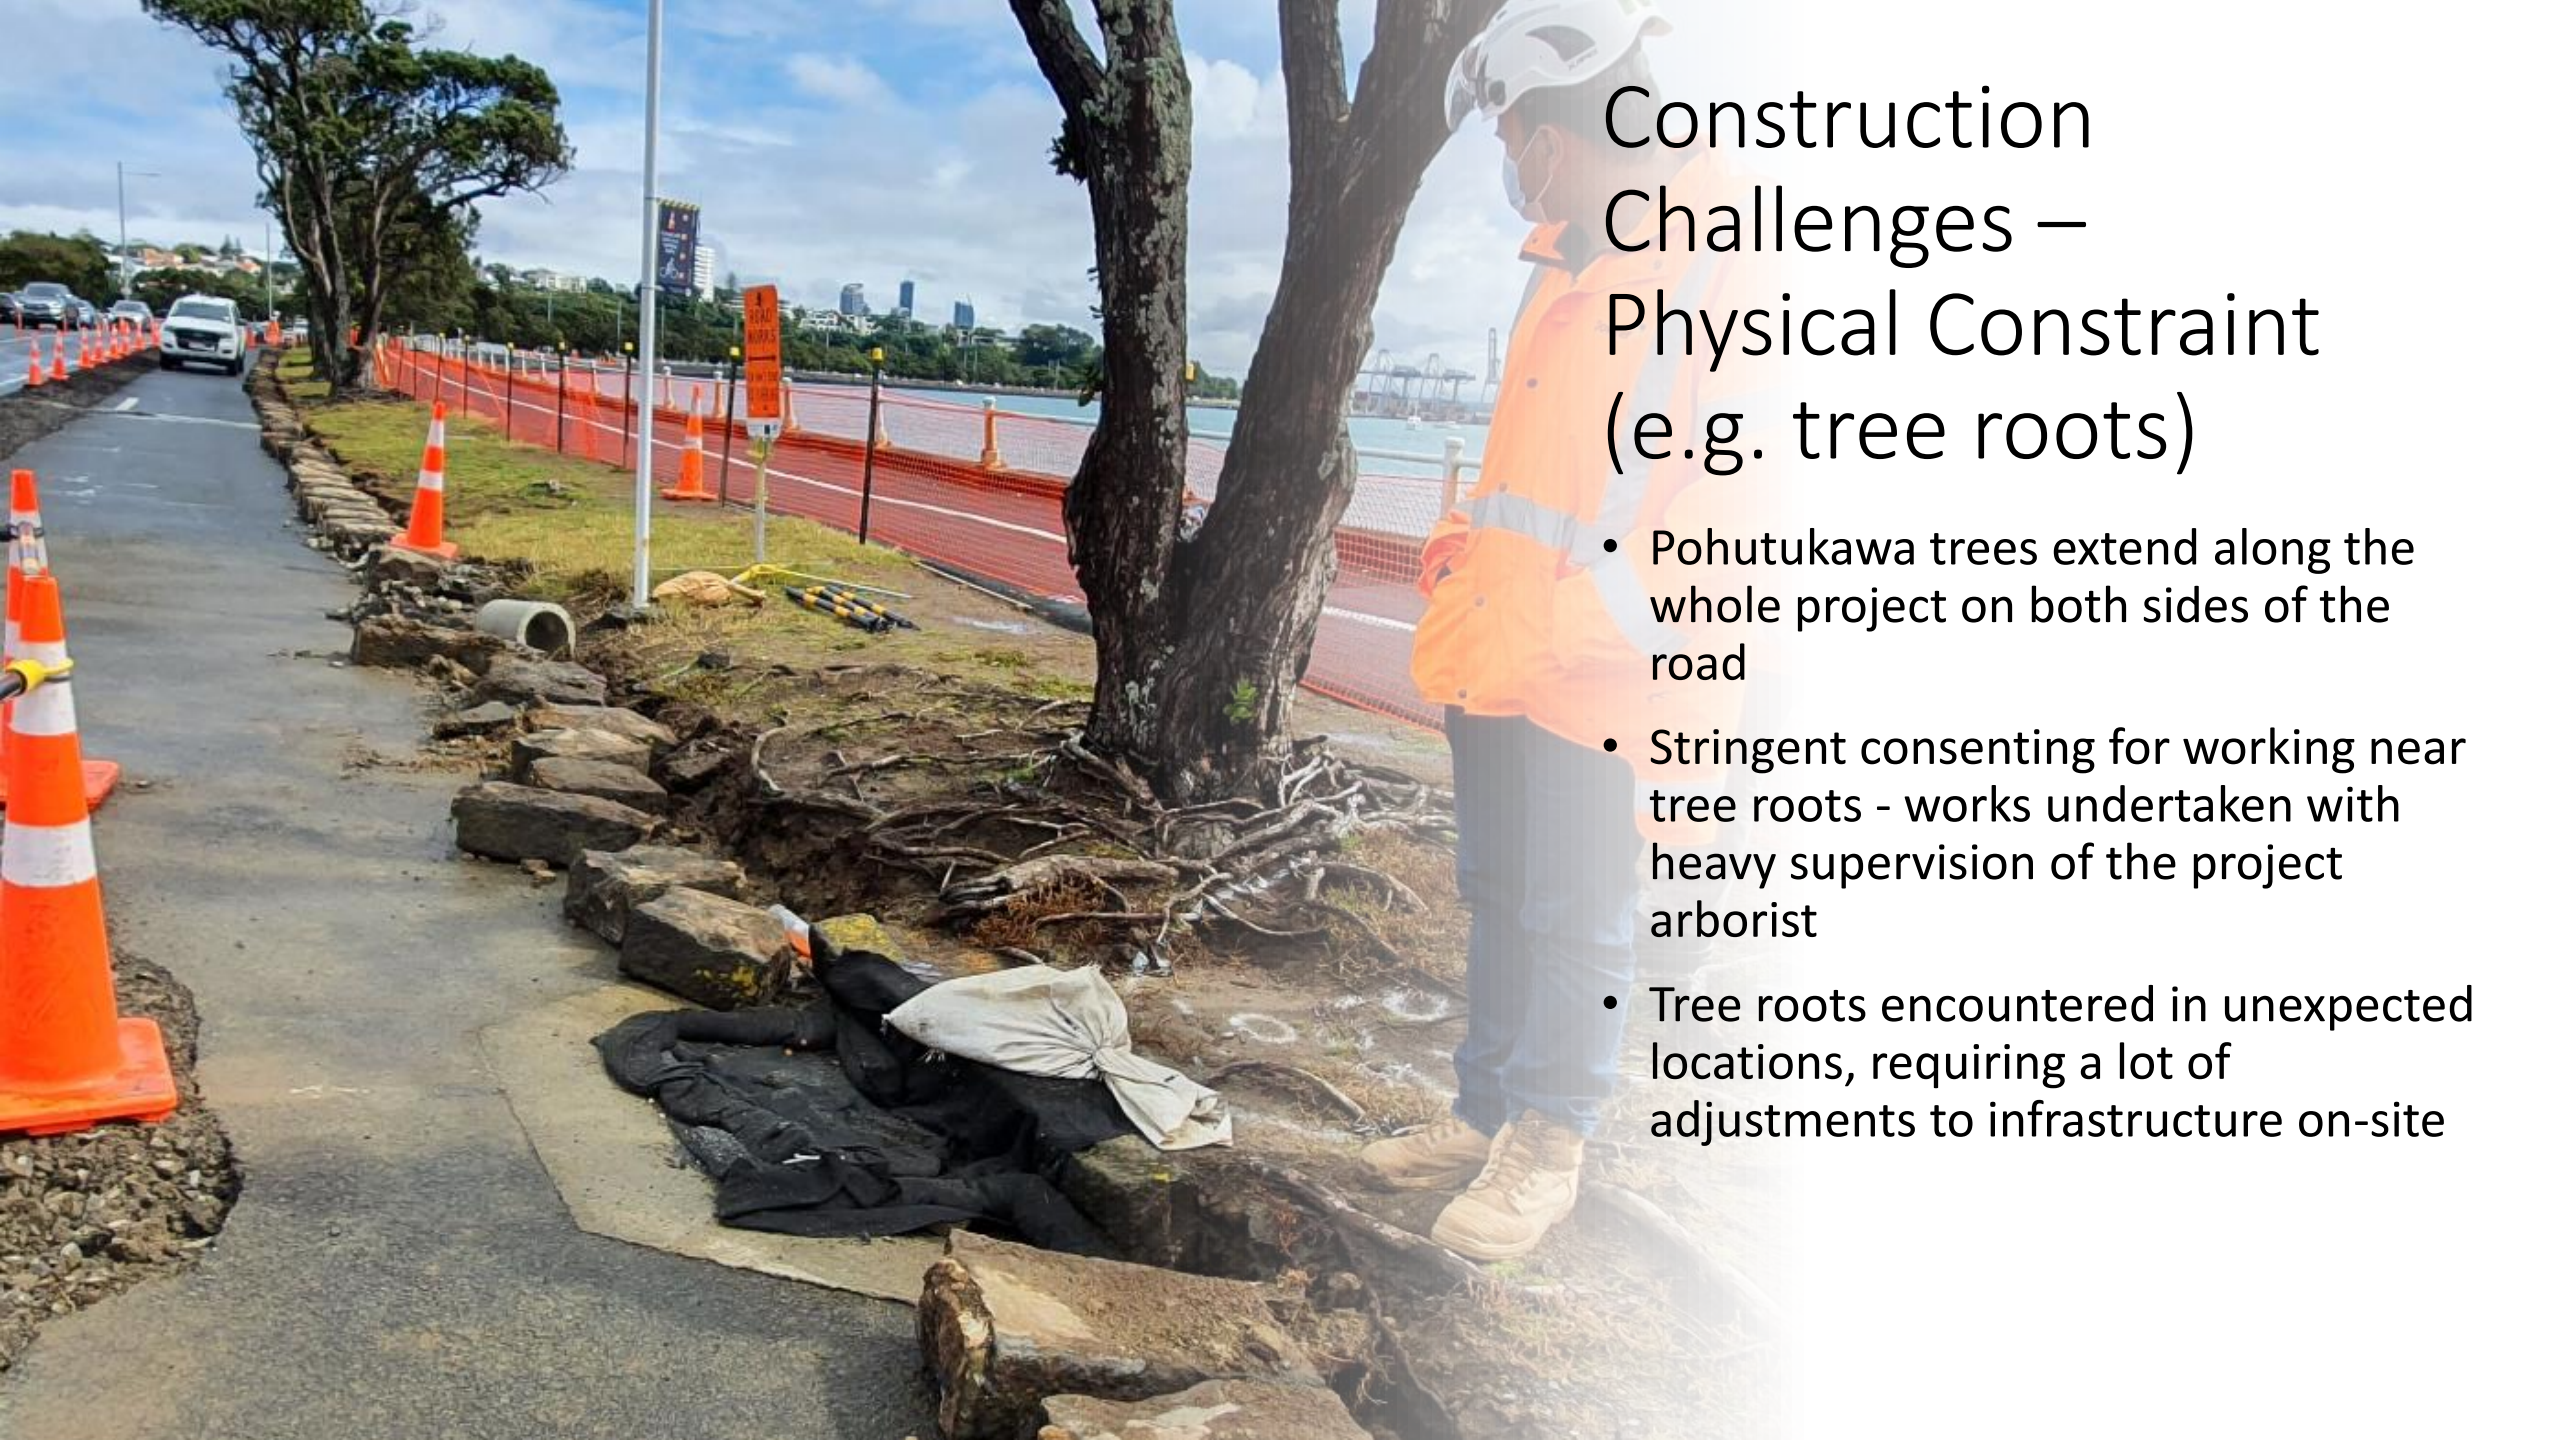
Construction Challenges - Traffic Management (Solution)

- Provide a tidal flow that allows the centre lane to be alternated in peak direction
- Change pavement overlay design from granular to asphalt to minimise traffic disruption
