## DO 'SAFE-HIT' POST MEDIANS HAVE A PLACE IN NEW ZEALAND'S SAFE ROADS SYSTEM?

Hamish Mackie (presenter), PhD, Human Factors Consultant, TERNZ Ltd, h.mackie@ternz.co.nz  
Fabian Marsh, National Traffic and Safety manager, NZ Transport Agency  
Mike Pilgrim, Regional Safety Engineer, NZ Transport Agency

### ABSTRACT

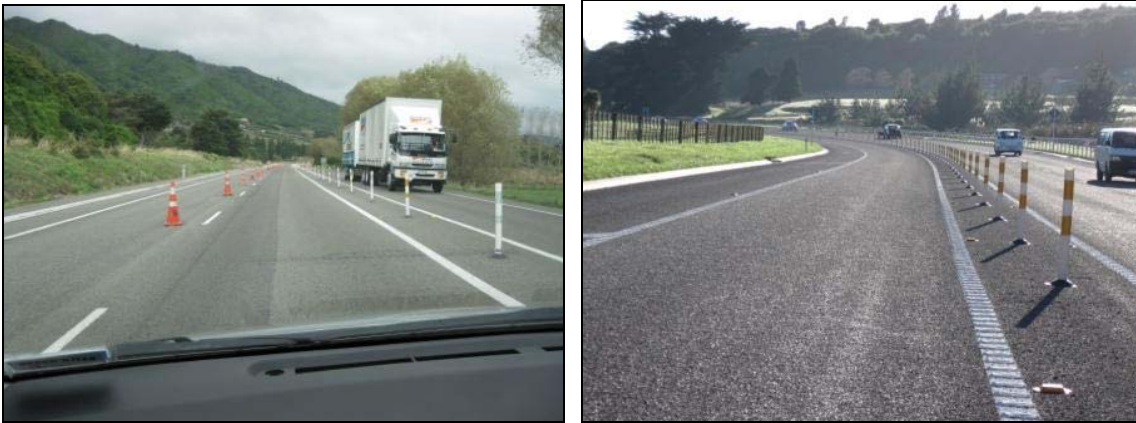
Figure 1. Peka Peka passing lane southbound (left) and northbound (right) with safe-hit post median treatment.

A unique median treatment that includes the use of plastic 'safe-hit' posts, without the normally associated wire rope, has been installed at a newly constructed passing lane at Peka Peka (SH1) on the Kapiti Coast, which opened on the 24<sup>th</sup> March 2010. The unique median design includes a 1.5m flush median with audio tactile profiled (ATP) roadmarking on the right-hand edge lines (both directions) with safe-hit posts at 5m centres (Figure 1). This configuration allows wire ropes to be added in the future as funding allows, while hopefully giving an improved level of safety compared with a conventional double yellow painted line road layout. It is anticipated that the proposed trial layout will go some way towards reducing the likelihood of crashes that result from centreline or median crossing.

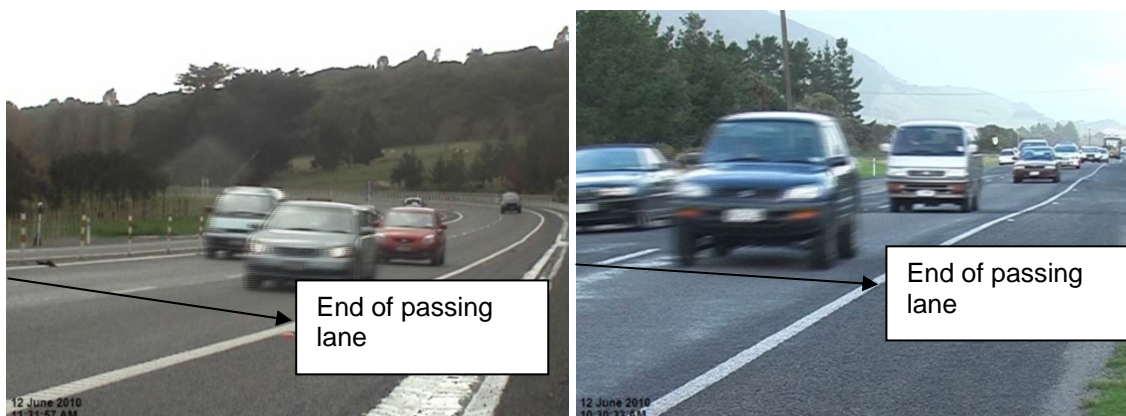
**Figure 3. Examples of Level 2 merging behaviour at Sites 9 (left) and 4 (right). In each example, some action would need to be taken by at least one of the motorists in order to maintain a safe separation between vehicles**

Sites 9 (treated) and 4 (untreated) were used to compare merging behaviour (Table 5, Figure 3).

Based on this relatively limited analysis the treated (Peka Peka) merging site appeared to have slightly fewer level 2 interactions (some avoiding action taken by either or both vehicles) than the untreated site, but there may be factors that caused this other than the median treatment design such as passing lane length and location (which could affect driver urgency and frustration). Notwithstanding this, the median safe-hit posts may have the effect of forcing drivers to accept their place in the traffic queue earlier by limiting the overall road width available to merging traffic. At untreated sites, although highly risky, the double yellow centreline can easily be crossed during interactions between merging vehicles. This concept is speculation and remains untested.

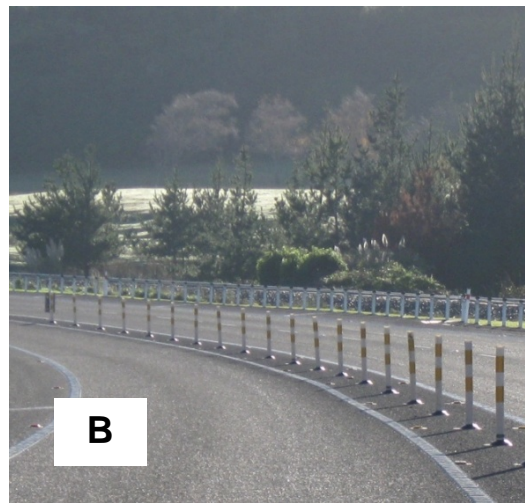
Figure 5b. Treated site

Figure 6c shows that respondents clearly felt that the treated road section at Peka Peka (with wide median and safe-hit posts, Figure 4b) provides a higher level of safety than the untreated section (Figure 4a). This finding was statistically significant (Chi Square,  $P < 0.01$ ).

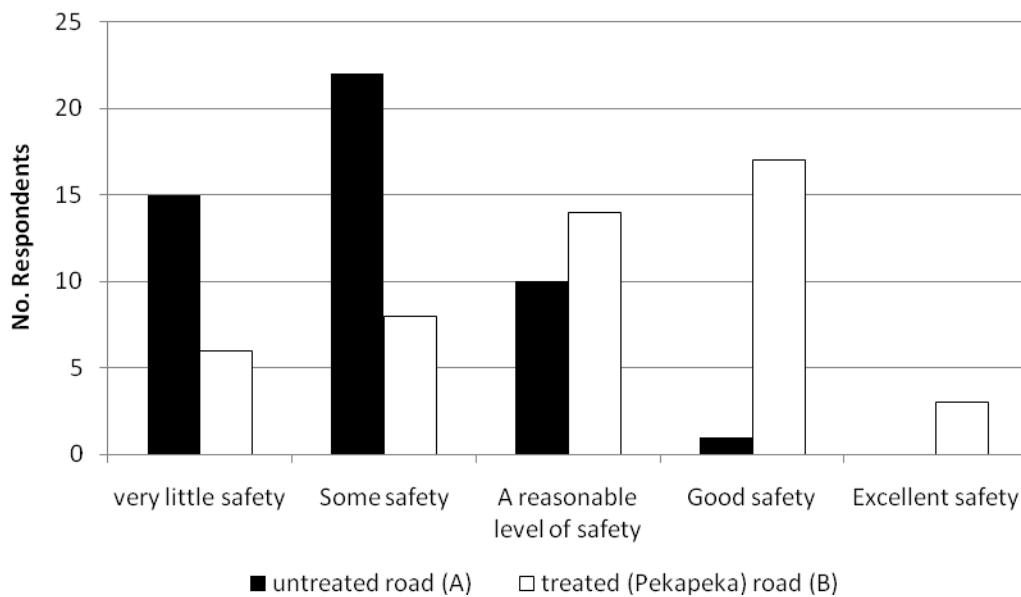
Figure 6c. Responses to survey question 2: Please circle the number that most closely represents the level of safety you feel is provided by the double yellow centrelines (A) / central median (B)?

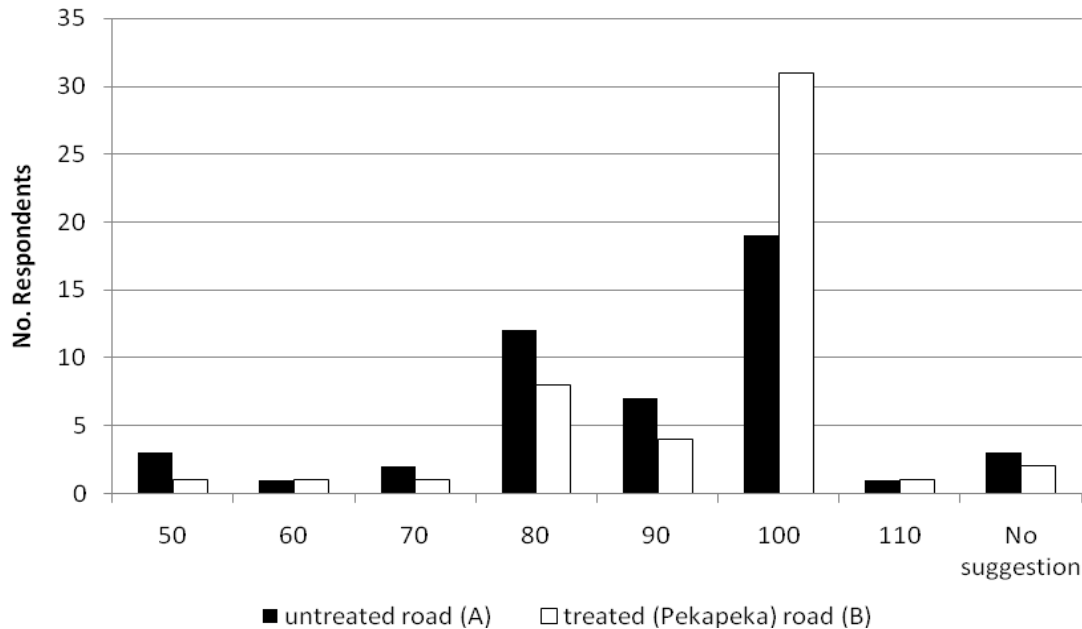
**Figure 7. Responses to survey question 3. What do you think is a safe speed (km/hr) to travel along road (A&B)?**

Figure 7 shows that respondents thought that a safe speed to travel along the treated road (B) was higher than for the untreated road (A). This finding was statistically significant (Paired t-test,  $P < 0.01$ ). The mean speed that respondents considered safe for the untreated road (A) was 88 km/hr and for the treated road (B) was 94 km/hr.
