**DO 'SAFE-HIT' POST MEDIANS HAVE A PLACE IN
NEW ZEALAND'S SAFE ROADS SYSTEM?**

**Hamish Mackie (TERNZ)
Fabian Marsh (ex NZTA)
Mike Pilgrim (NZTA)**

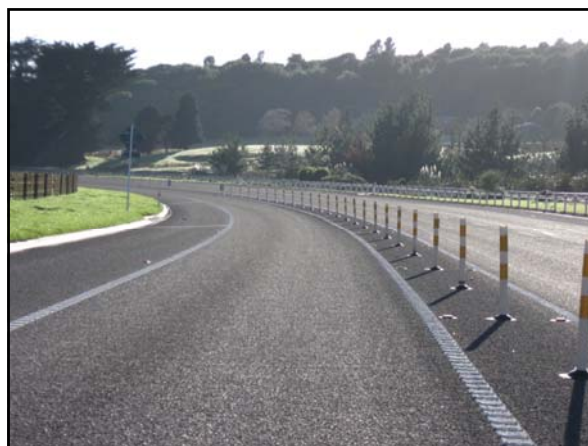
Rationale for 'safe hit' post median treatment

Hopefully an improved level of safety compared with double yellow audio tactile lines

Cheaper road safety option that might be installed in advance of wire or solid barriers
