NO ROOM FOR A MEDIAN TREATMENT? – THINK AGAIN

Rob Partridge (Presenter)
BE (Hons) Civil, GIPENZ, ANZIM
National Discipline Leader – Road Safety
MWH New Zealand Ltd (Wellington)
Rob.D.Partridge@mwhglobal.com

ABSTRACT

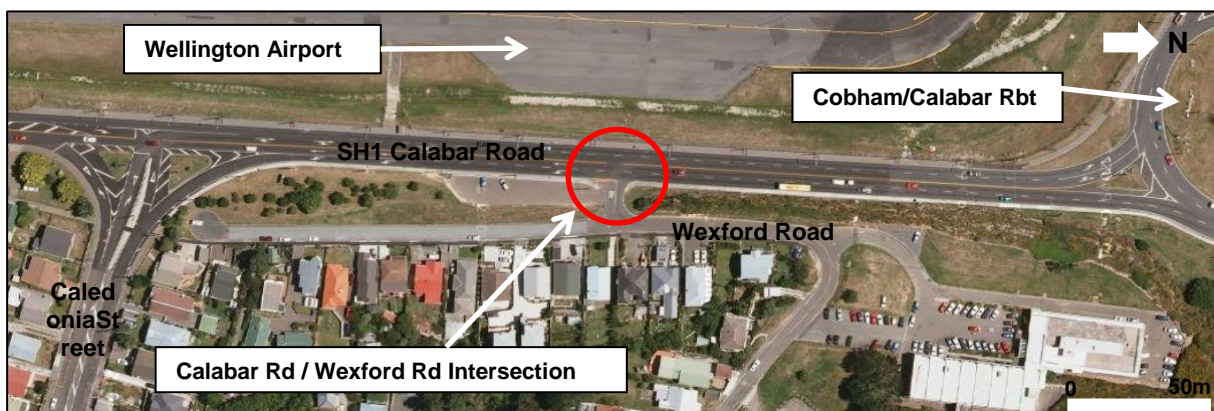
Figure 1: Site location

The particular section of Calabar Road of interest, as shown in Figure 1, is at the intersection with Wexford Road. Wexford Road is a minor side road located on a crest curve with movements in/out of less than 750 vehicles per day. Other than for residential access, Wexford Road provides access to two viewing areas for planes and commercial premises for Weta Digital. Visibility to the north, for vehicles exiting Wexford Road, is limited by a high bank to 20m from 5m behind the kerb line and 50m from 3m behind the kerb line. These values are well below the minimum safe intersection sight distance (SISD) for a design speed of 65km/h of approximately 125m¹. Visibility to the south is 60m from 5m behind the kerb line and over 200m from 3m behind the kerb line.

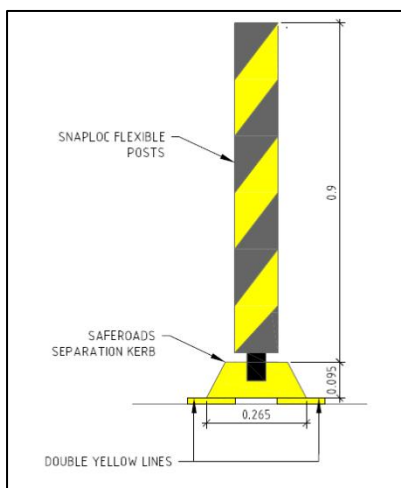
Figure 2: Separation Kerb Treatment

In light of the risk of a serious or fatal right turning crash still occurring at the intersection, consideration was given to installing ground mounted flexible posts along the centreline. It was agreed that this again would not completely remove the risk but rather further discourage it, and certainly not prevent motorcyclists or cyclists undertaking right turning movements. At this point a new road safety product came to our attention that could potentially solve the problem without fully closing the side road. The product was the Saferoads Separation Kerb with the option of Snaploc flexible posts on top. With a base width of only 265mm, refer Figure 2, the separation kerb could simply be placed within the footprint of the existing double yellow lines without any need to widen.

The NZTA agreed to the proposal of installing this product as a trial on Calabar Road for 340 metres, from Cobham Drive to Caledonia Street, with the knowledge that it could be removed easily if necessary. The length was chosen to discourage U-turning on the state highway by forcing vehicles to use an alternative route or the roundabouts at either end of Calabar Road. Snaploc flexible posts were placed at 4.5m centres, except for 21m either side of the Wexford Road where they were spaced at 1.5m centres to further discourage vehicles from driving over the kerb.

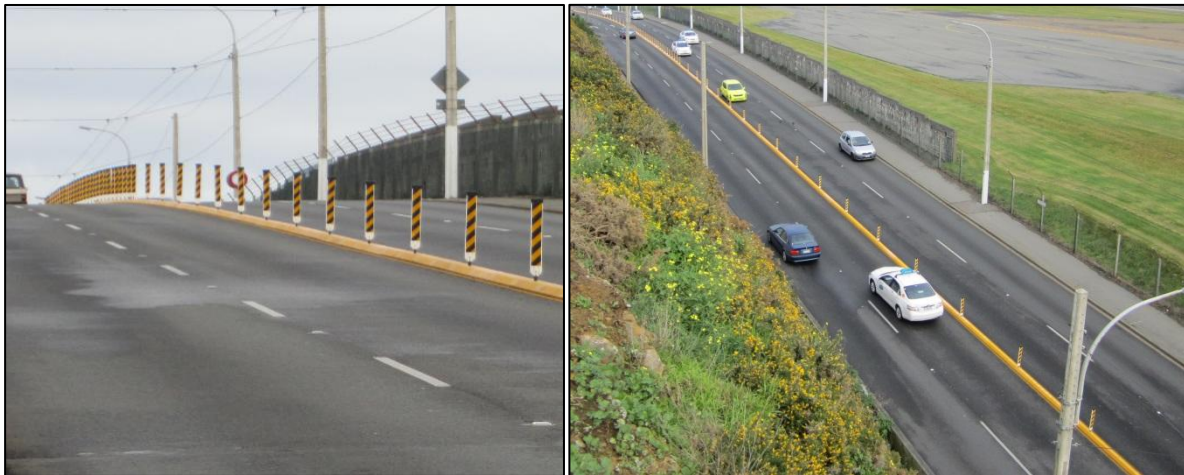
Photos 1 & 2: Separation kerb with flexible posts at completion

Due to the high traffic volumes on Calabar Road installation was required to be undertaken at night which included noise restrictions after 11pm. The noise from the generator and drill were the main concerns and the contractor, Fulton Hogan, worked closely with the Wellington City Council to enable work to occur throughout the night. A noise box was created that moved with construction, reducing the noise to acceptable levels for nearby residents. Installation was completed in six nights, at the end of June 2011, at an average rate of 56 metres per night.
