Submitted to  
IPENZ Transportation  
Conference March 2015

# No Room for a Median Treatment? Think Again

To provide feedback to the industry on the application and performance of a median separation kerb and flexible post treatment

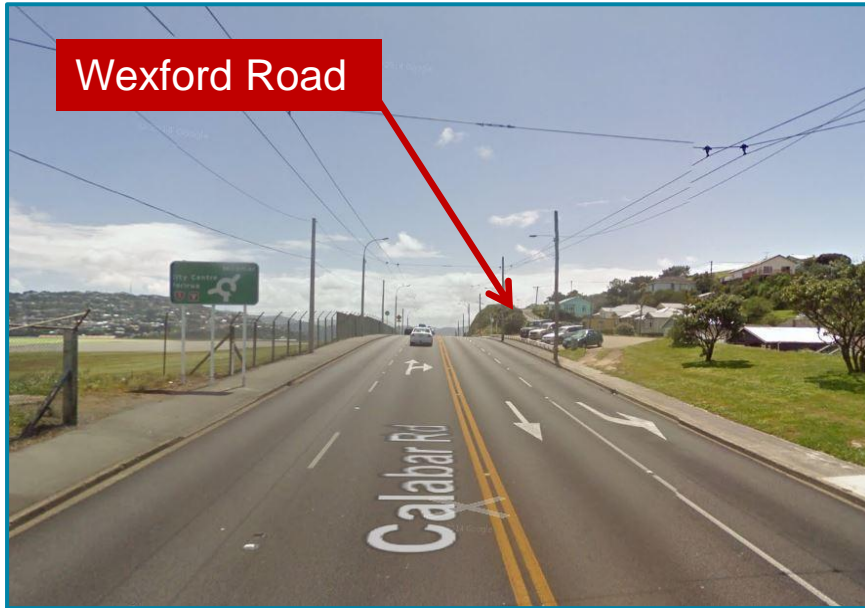
# Setting the Scene – Calabar Road

Northbound (from Airport)

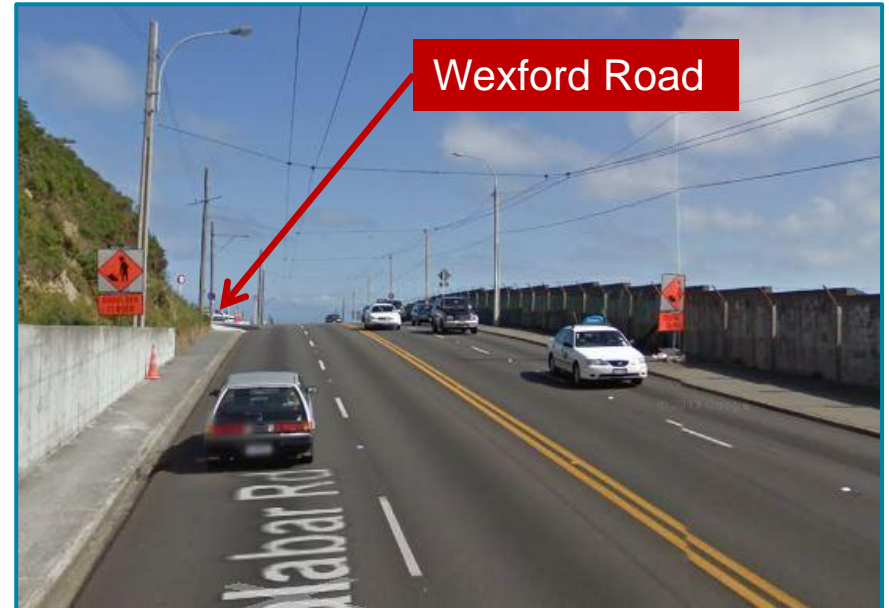
Southbound (to Airport)

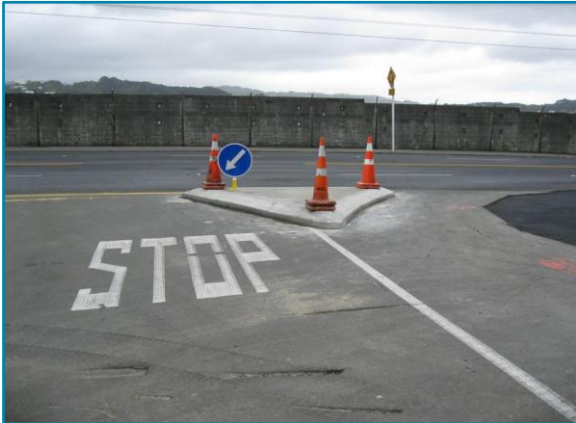
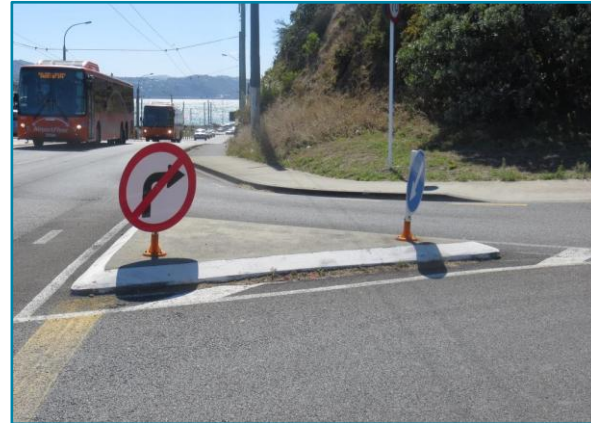
# Initial Treatment

Low cost treatment included:

- A splitter island and minor widening for the left 'in' movement
- 'No Right Turn' signs - both in and out movements
- Removal of gap in yellow lines and turn arrows

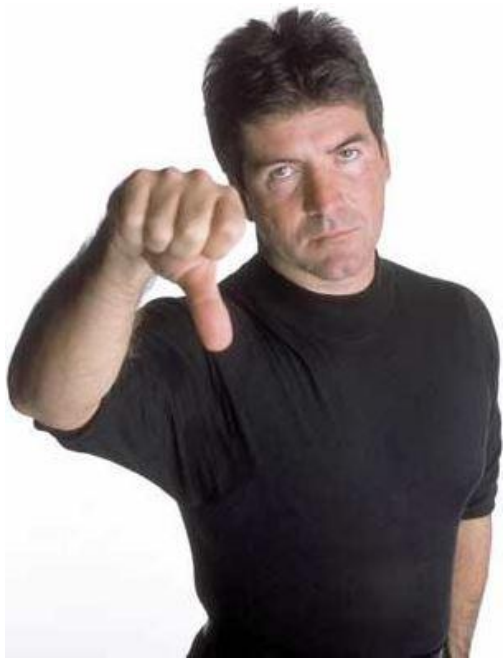
# Initial treatment – Did it work?

No,  
Not Really

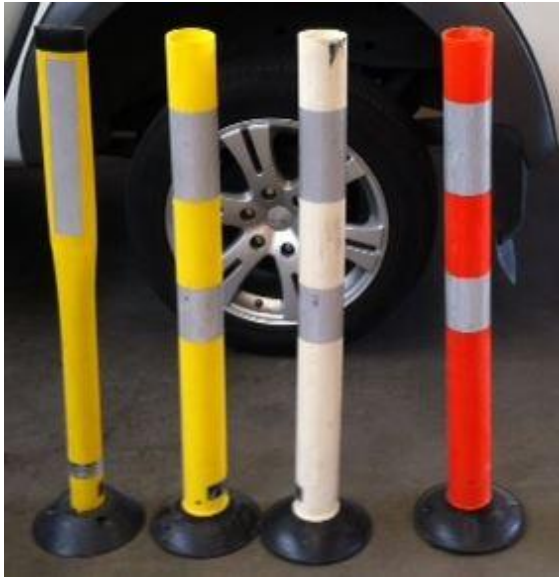
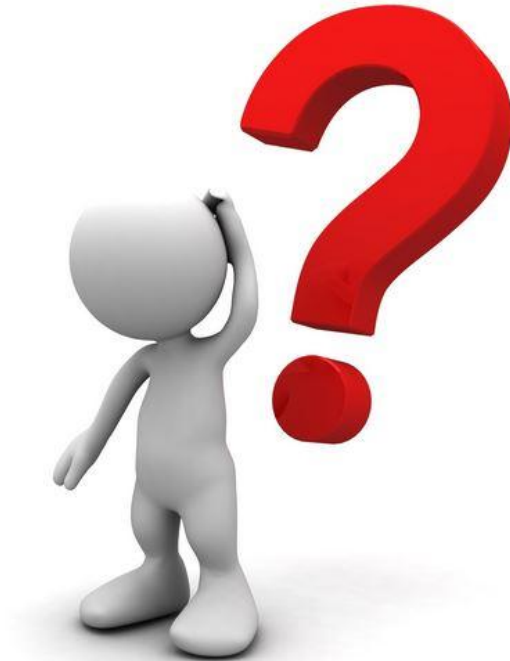
# Flexible posts

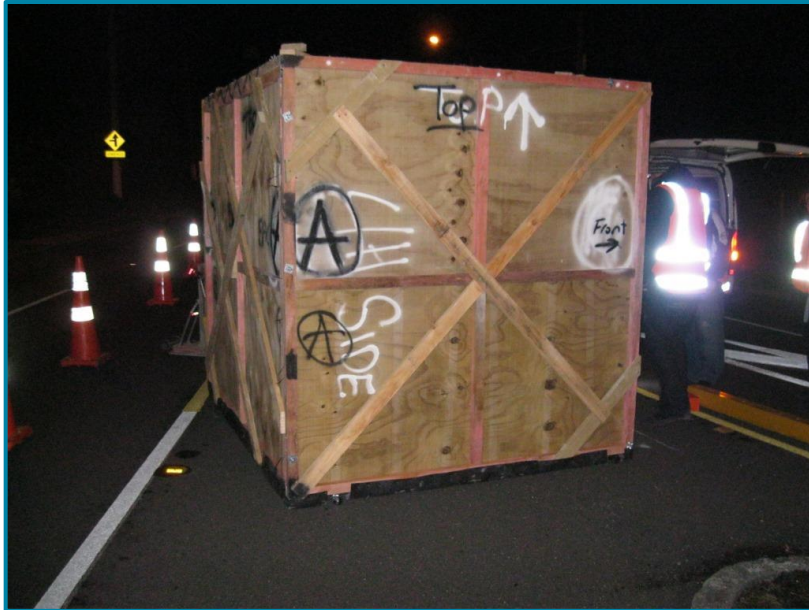
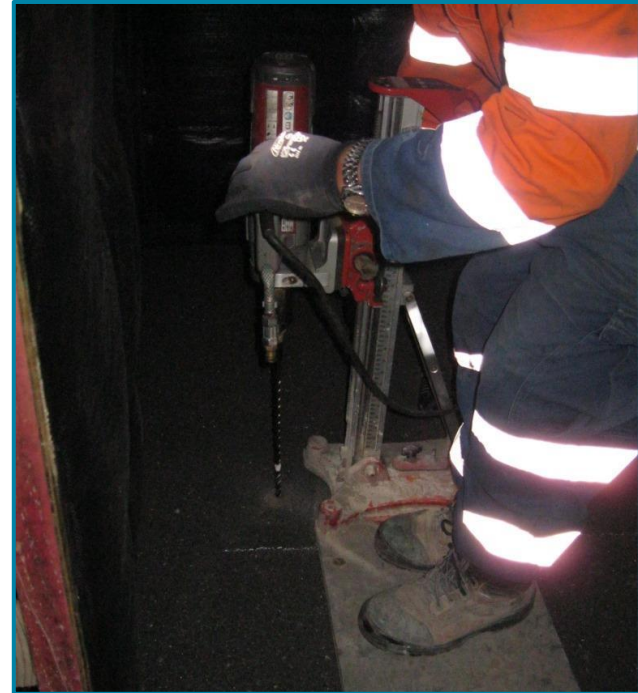
- Installed 340m - Cobham Drive to Caledonia St
- Snaploc flexible posts @ 4.5m centres, however they were @ 1.5m centres at the intersection
- Could be removed if necessary

# Separation Kerb Treatment – Installation

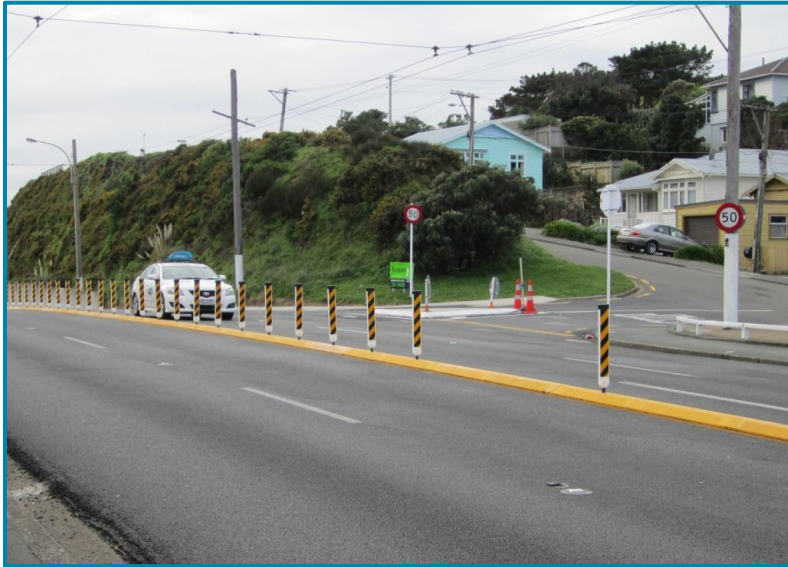
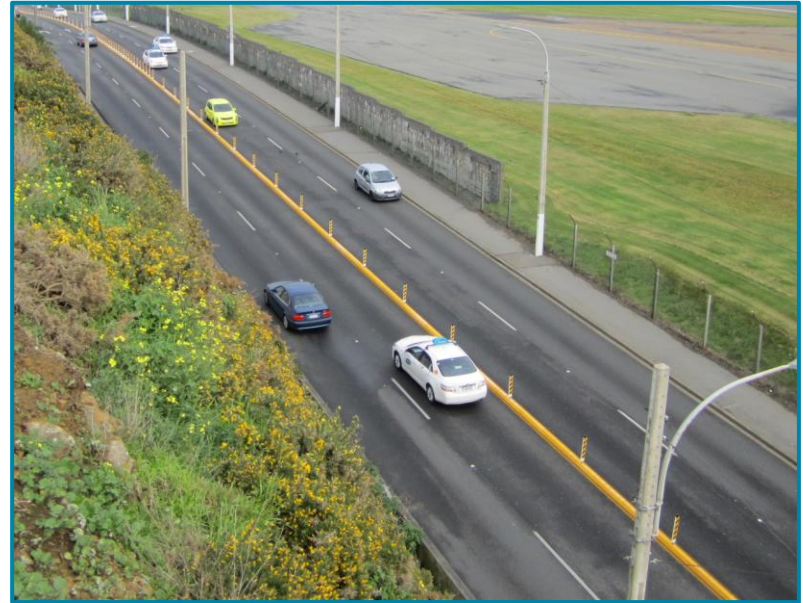
# Separation Kerb Treatment – End Result

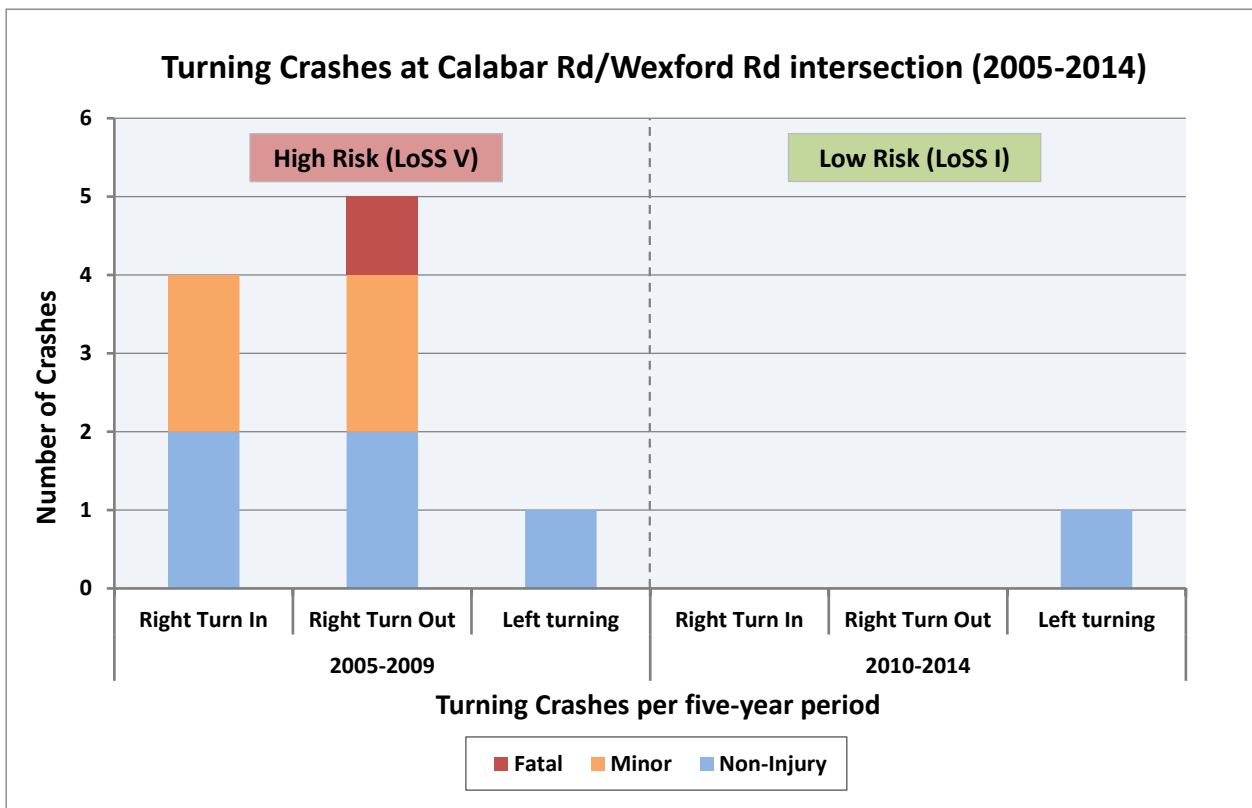
# Post-Construction Assessment Safety Performance

Successfully eliminated our crash problem

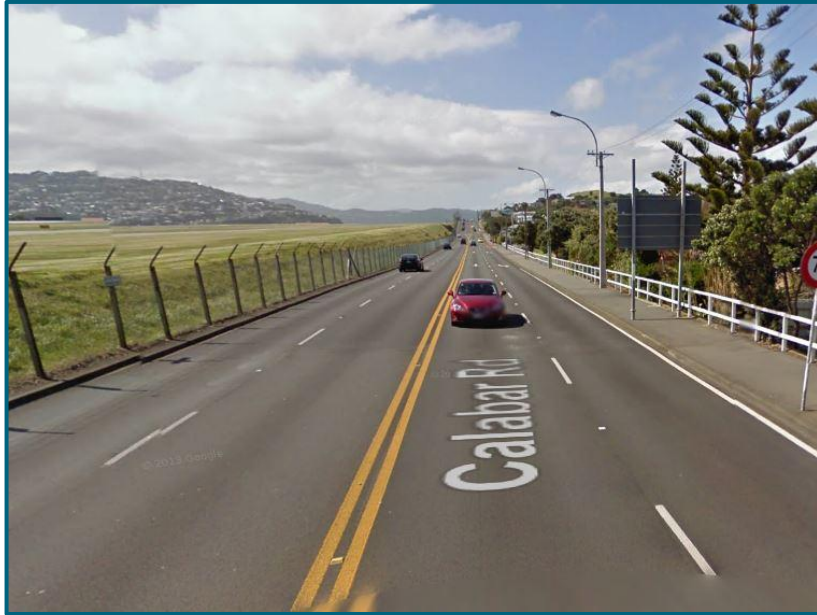
# Post-Construction Assessment Impact on Speed

Northbound approach (from Airport)

Reduced free flow mean speeds by approx. 10%

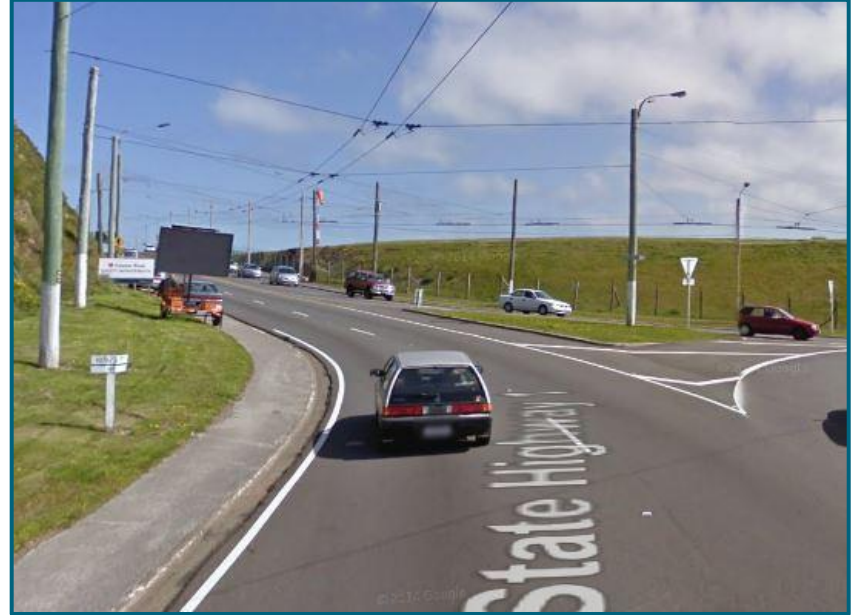
Southbound approach (to Airport)

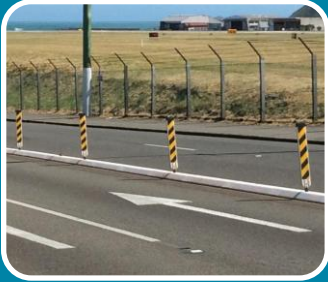
- Generally the kerb and posts are in very good condition after 3 ½ years
- Appear to be more robust than ground mounted flexi-posts

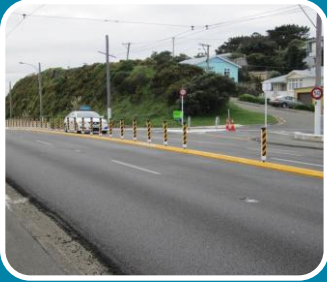
- No issues with resurfacing
- No drainage issues or build-up of detritus
- Water spraying/blasting has been successful for cleaning
